## CONWAY LAKE DAM

NH 00318

### PHASE I INSPECTION REPORT NATIONAL DAM INSPECTION PROGRAM

NOVEMBER 1978

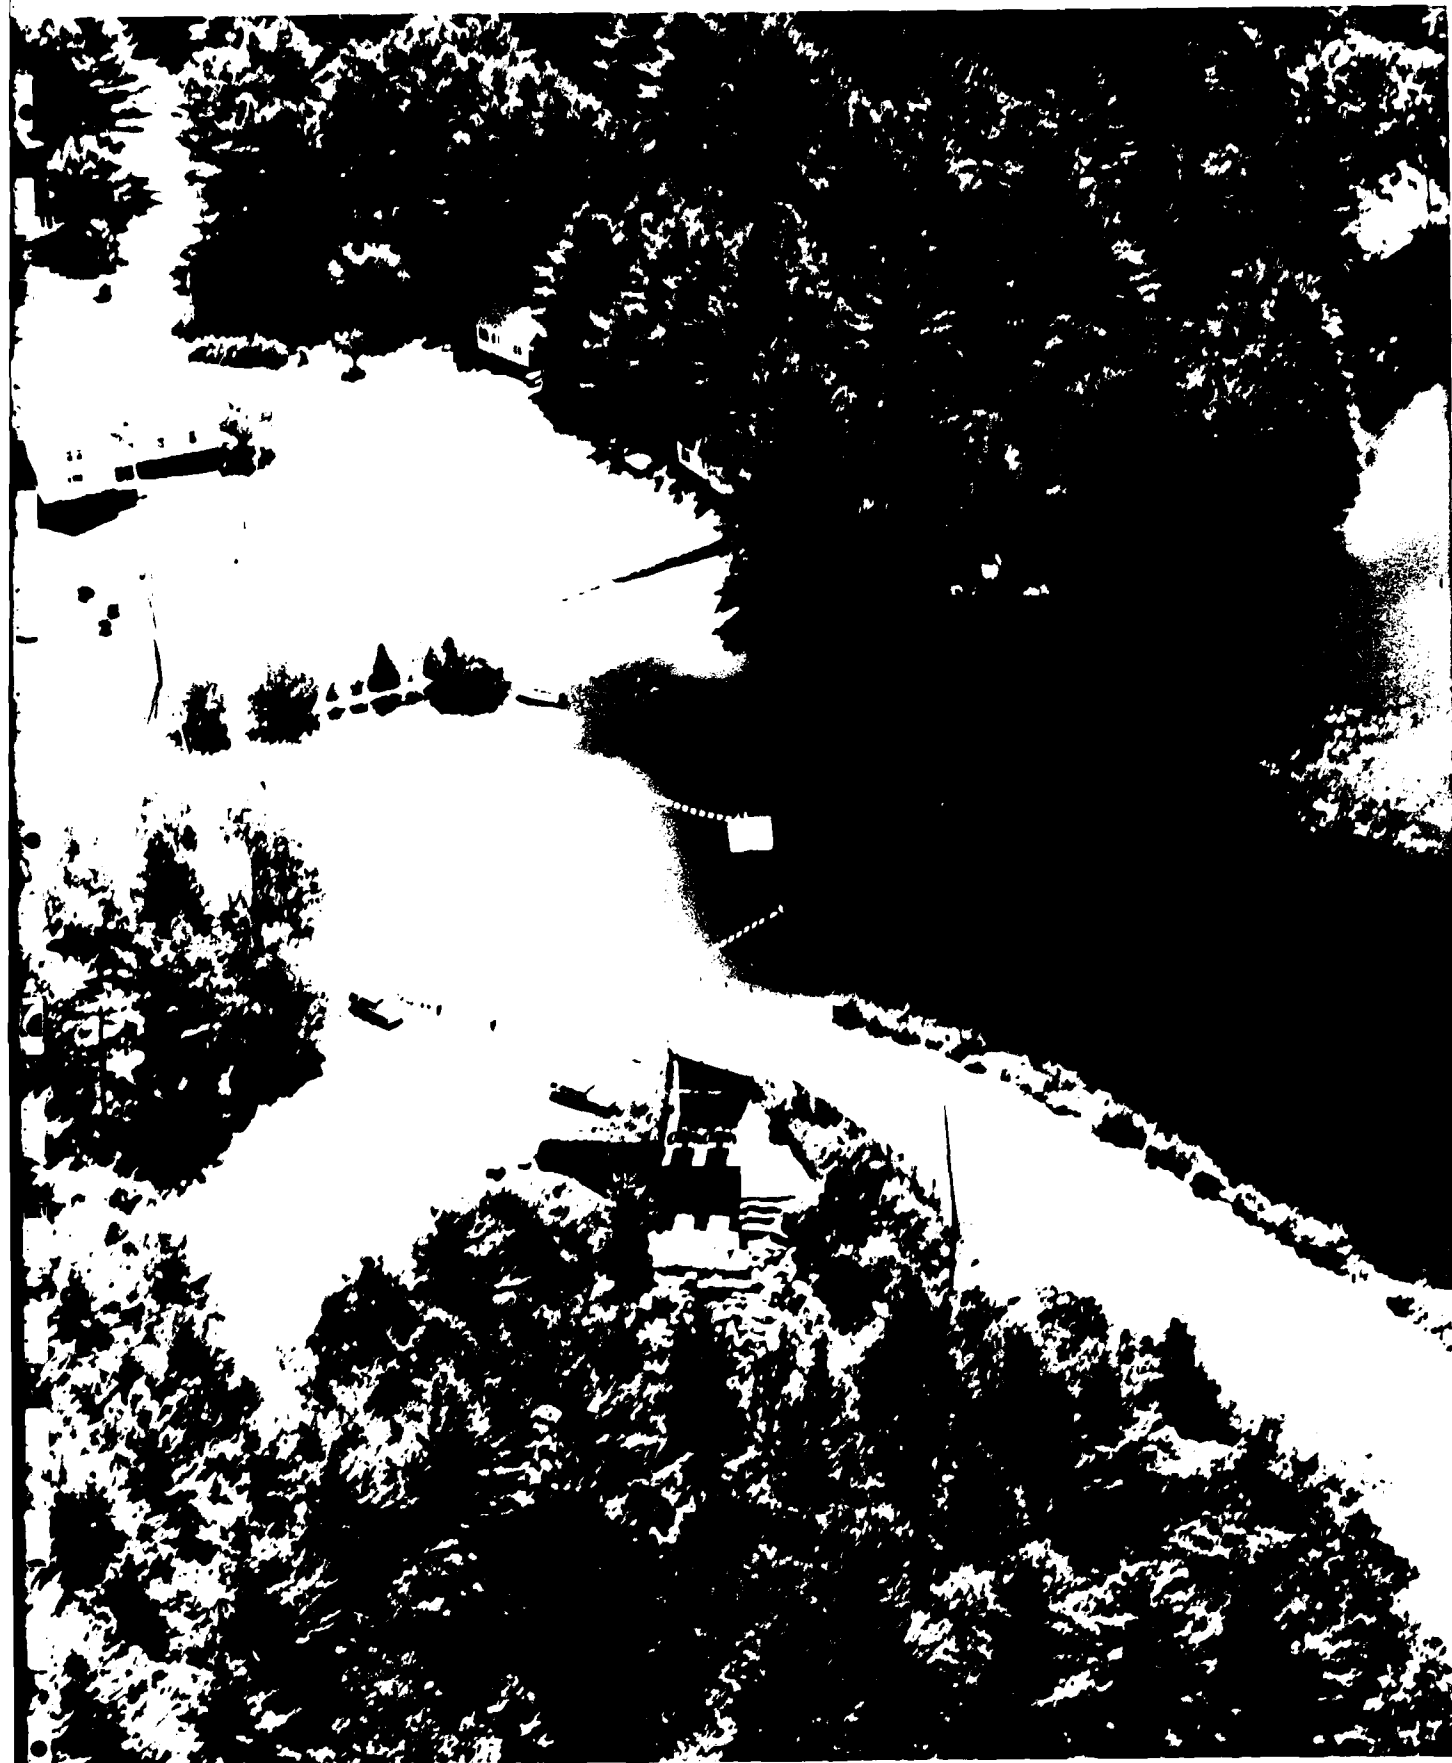
CONWAY DAM - Overview looking upstream

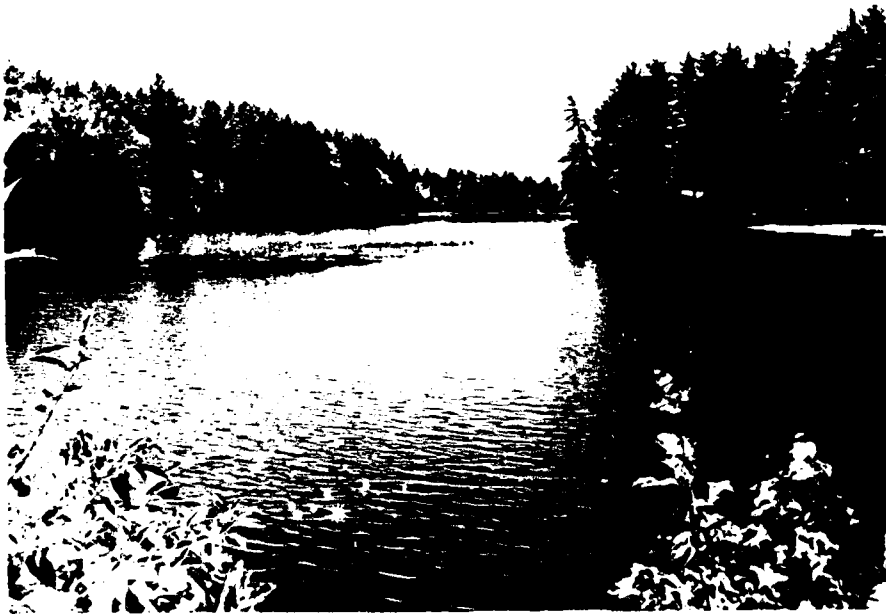
PHOTO NO. 1 - General view of reservoir from dam.

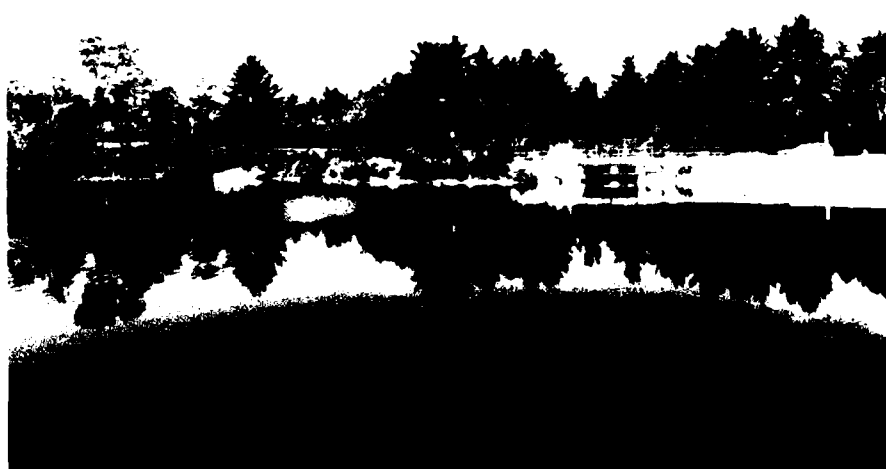
PHOTO NO. 2 - View of reservoir and dam from  
right reservoir side.

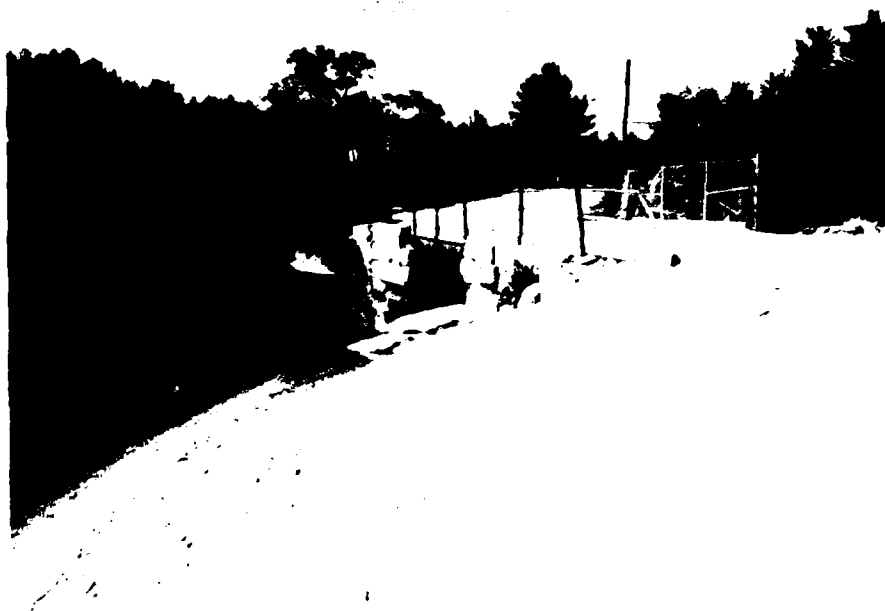
PHOTO NO. 4 - View of dam and roadway bridge from  
right abutment (Upstream Slope).

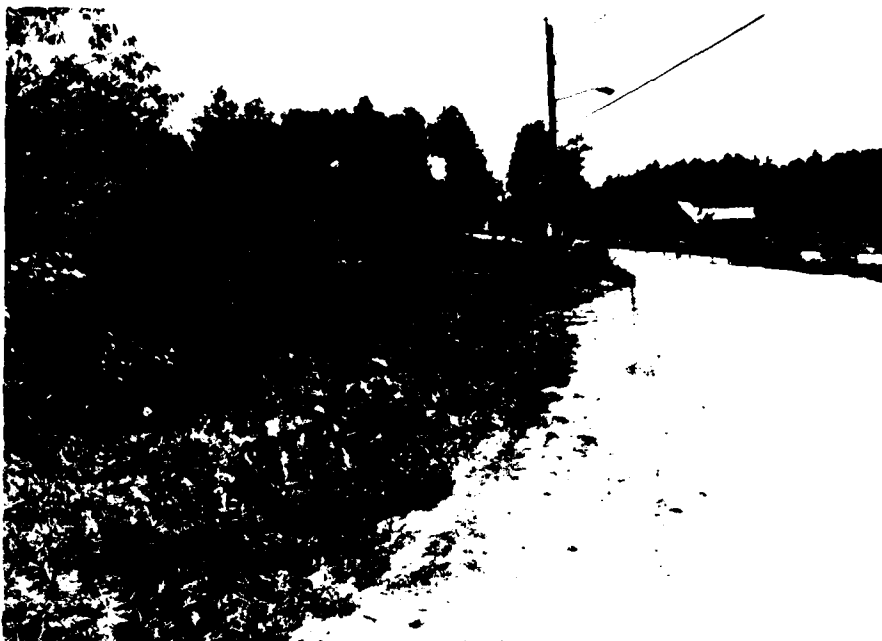
PHOTO NO. 5 - View of dam from left abutment  
(Downstream Slope).

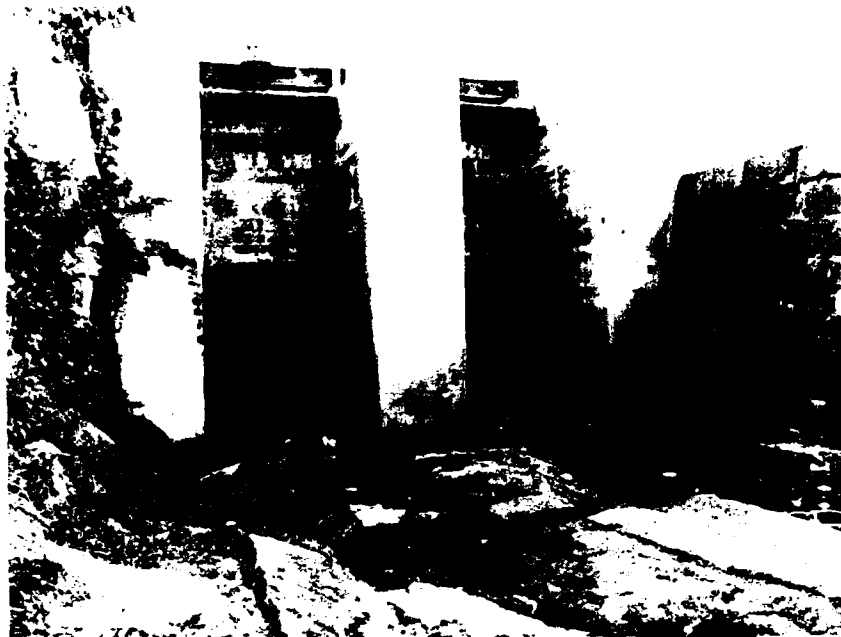
PHOTO NO. 11 - View of outlet works structure,  
downstream side.

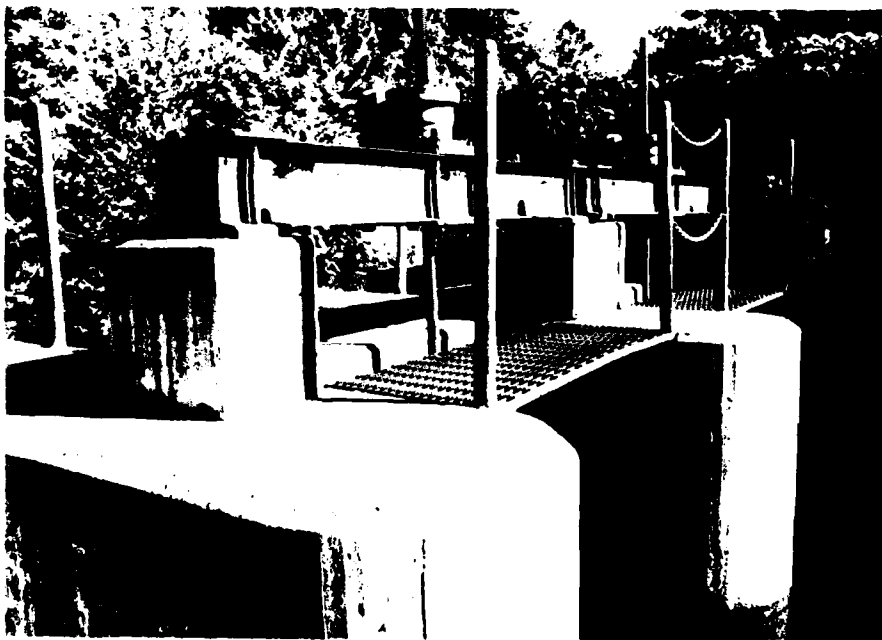
The mechanically operated wooden gates and the concrete surface of this structure are in good condition. The stem of the left gate is, however, bent and causes difficulty in operation. Both gates were reported operational by the owner. Some debris appeared to have worked its way between the top of the gate and the outlet works structure allowing water to pass through the gate at this point. The steel walkways and handrails appeared rusty but structurally sound.

PHOTO NO. 16 - View of control (gate) mechanism at  
outlet works structure.
