MERRIMACK RIVER BASIN
NEW LONDON, NEW HAMPSHIRE

PLEASANT LAKE DAM

PHASE I INSPECTION REPORT
NATIONAL DAM INSPECTION PROGRAM

NOVEMBER 1978

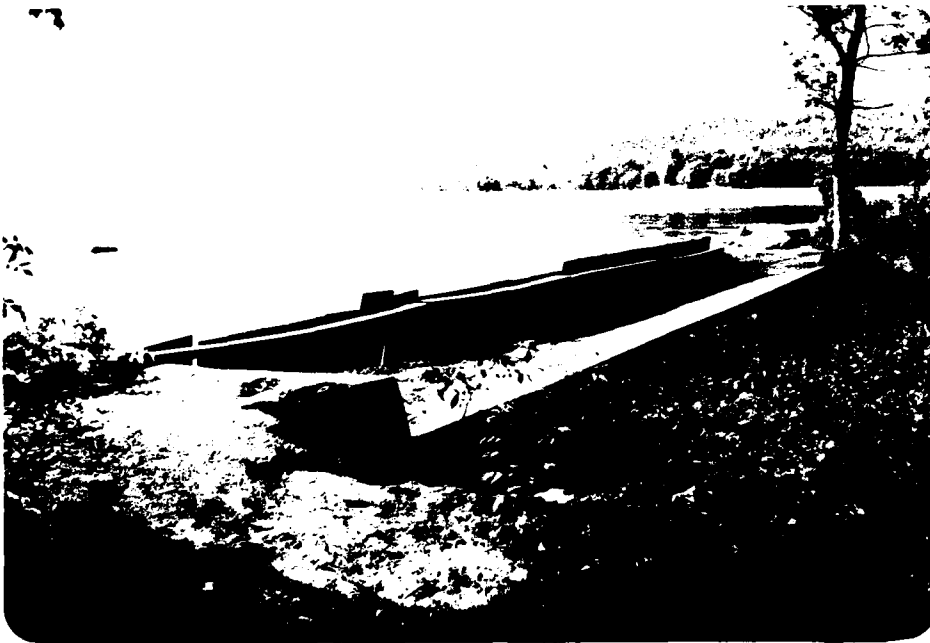
Overview of spillway from right side

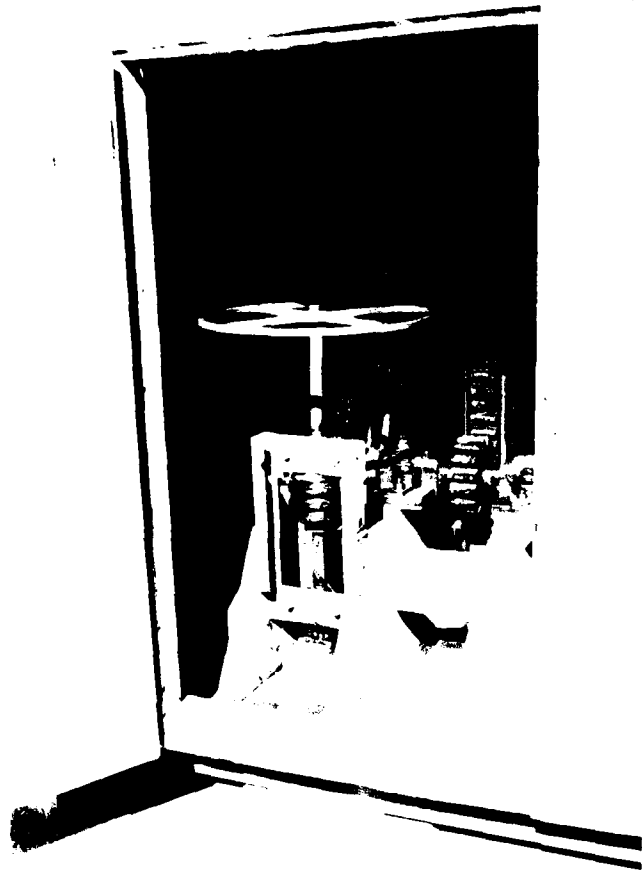
The deterioration of the steel sluice gate led to the NHWRB recommending that it be removed after construction of the stoplog weir. The present weir requires little maintenance. While the sluice gate serves no further purpose, its mechanical operating system was rebuilt 5 years ago and is very well maintained.

5. View of gate operating mechanism
