MERRIMACK RIVER BASIN  
NEW DURHAM, NEW HAMPSHIRE

NEW DURHAM DAM  
NH - 00345

PHASE I INSPECTION REPORT  
NATIONAL DAM INSPECTION PROGRAM

MARCH 1979

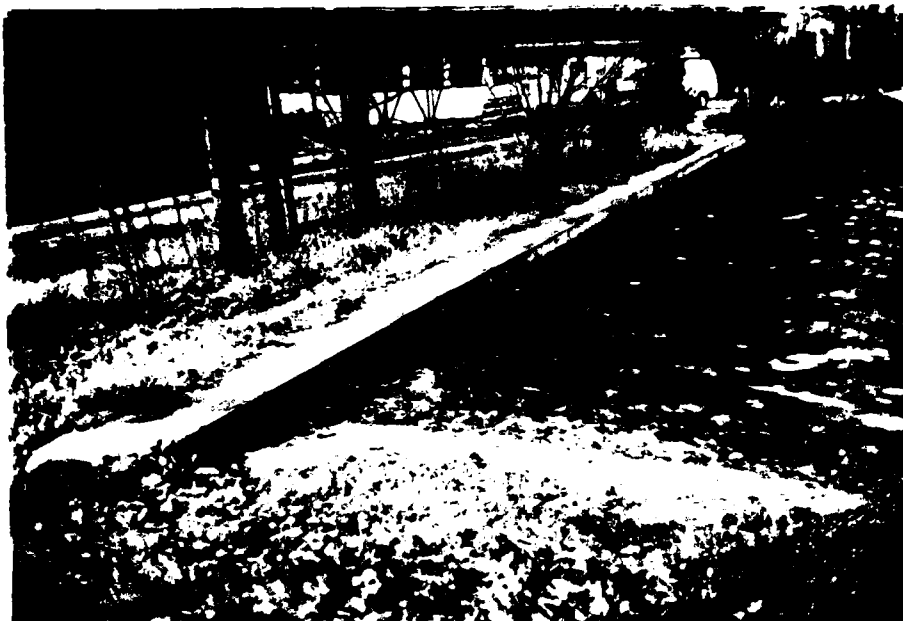
11

DIKE WITH CONCRETE WALL AT ROADSIDE  
ABOUT 200 FEET WEST OF NEW DURHAM DAM

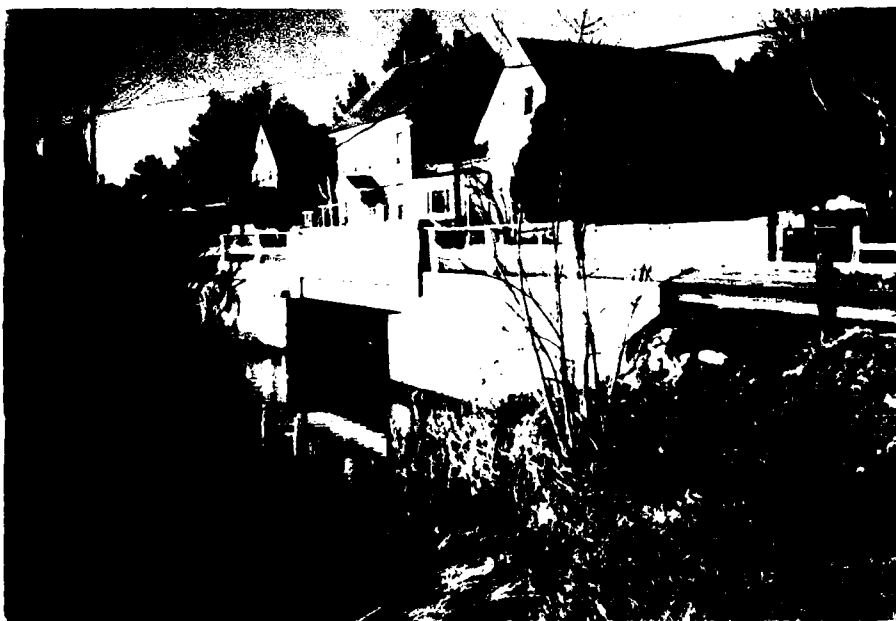
12

DOWNSTREAM VIEW OF BRIDGE 0.7 MILES DOWNSTREAM  
FROM NEW DURHAM DAM
