PISCATAQUA RIVER BASIN
ROCHESTER, NEW HAMPSHIRE

BAXTER LAKE EASTERLY DIKE
NH 00391

PHASE I INSPECTION REPORT
NATIONAL DAM INSPECTION PROGRAM

JULY 1978

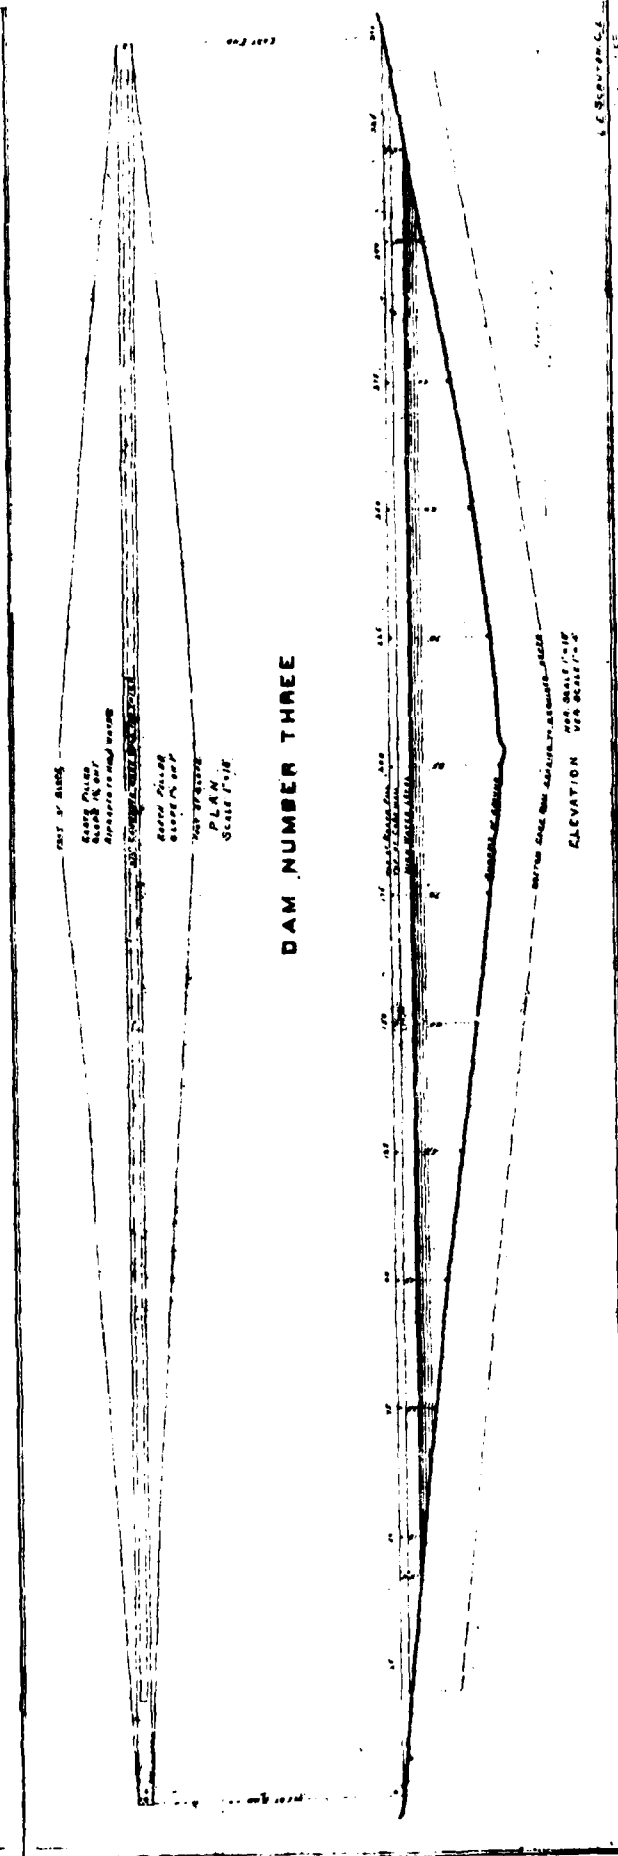
DAM NUMBER THREE

The visual inspection did not reveal any evidence of the concrete core wall noted on the plan labeled "Dam Number Three" as drawn by L. E. Scruton, C. E. (See Appendix B.)

b. Design and Construction Data. An available design drawing, labeled "Dam Number Three", indicates the presence of a concrete core wall along the center of the dike. However, no information is available about the as-constructed dimensions or conditions within the dike, the foundation or the character of the earthfill used in constructing the dike.
