SPOFFORD LAKE DAM

NH 00356

PHASE I INSPECTION REPORT  
NATIONAL DAM INSPECTION PROGRAM

NOVEMBER 1978

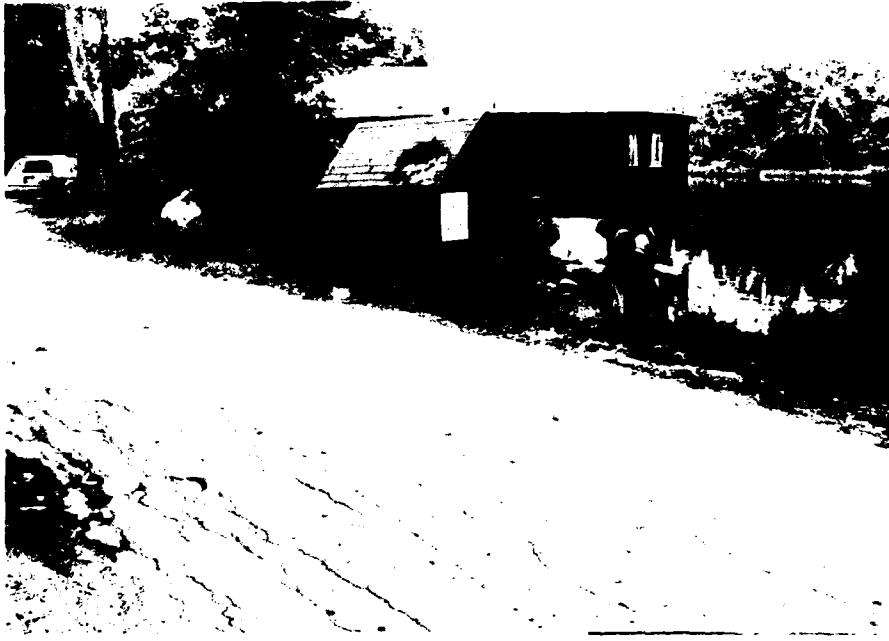
Overview of dam from left abutment showing gate house and approach channel

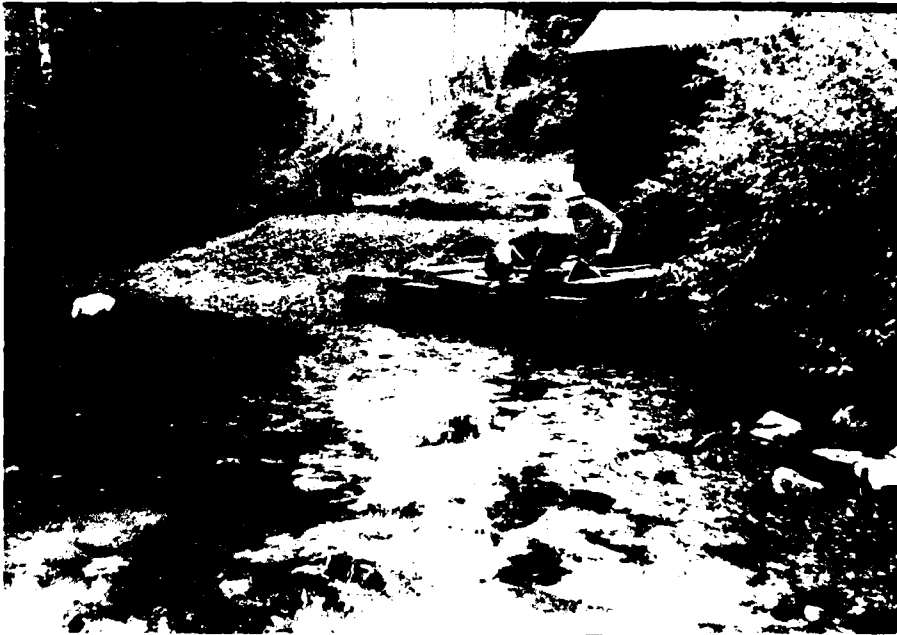
Overview of dam from right side upstream showing inlet area

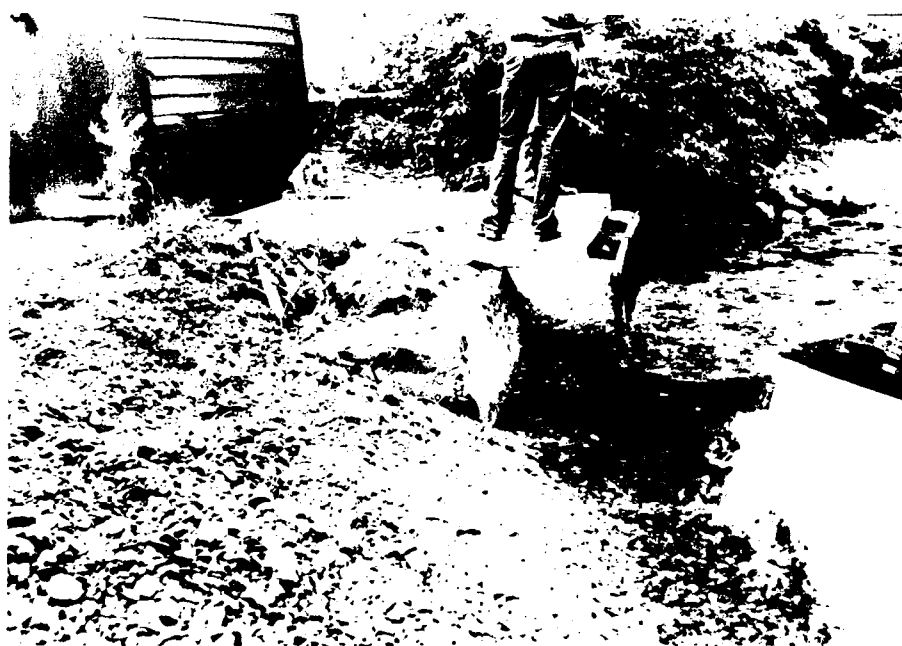
The two inlet walls are in fair condition despite surface erosion exposing aggregate, minor spalling, random hairline cracking and some deterioration at joints. The soil under the walls has been eroded to a depth of at least 6 inches.

The two smaller walls parallel to the front face of the dam display identical deficiencies. Erosion is occurring at the ends of these walls, resulting in 6 to 12 inches of the walls acting as a cantilever.

2. View of inlet area from left side showing erosion of concrete
