LOVELL LAKE DAM
NH 00223

PHASE I INSPECTION REPORT
NATIONAL DAM INSPECTION PROGRAM

AUGUST 1978

Identification No.: NH00223
Name of Dam: Lovell Lake Dam
Town: Wakefield
County and State: Carroll County, New Hampshire
Stream: Branch River
Date of Inspection: 19 June 1978

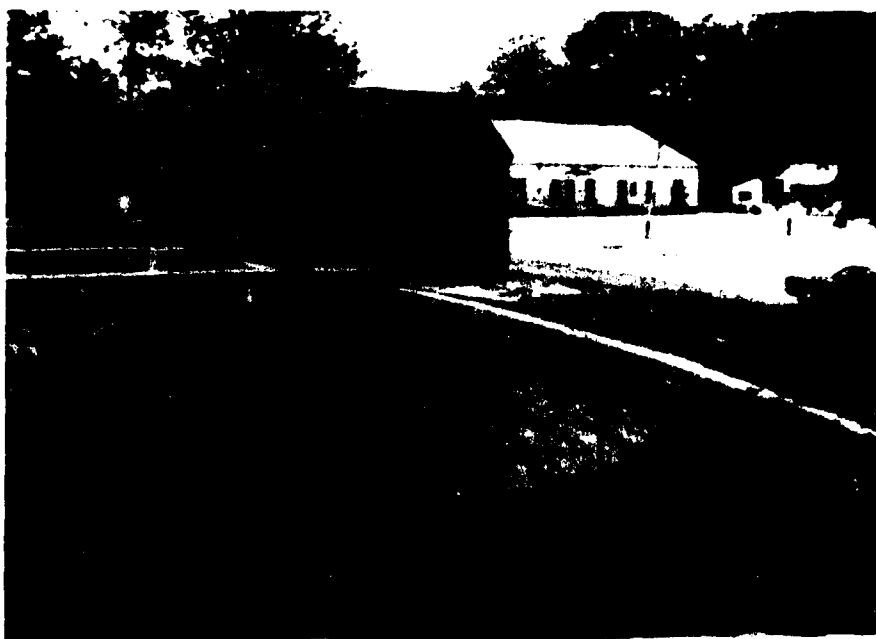
Figure 3 - Looking southwest at the upstream face of the dam.
