CONNECTICUT RIVER BASIN
ROXBURY, NEW HAMPSHIRE

BABBIDGE RESERVOIR DAM

PHASE I INSPECTION REPORT
NATIONAL DAM INSPECTION PROGRAM

AUGUST 1981

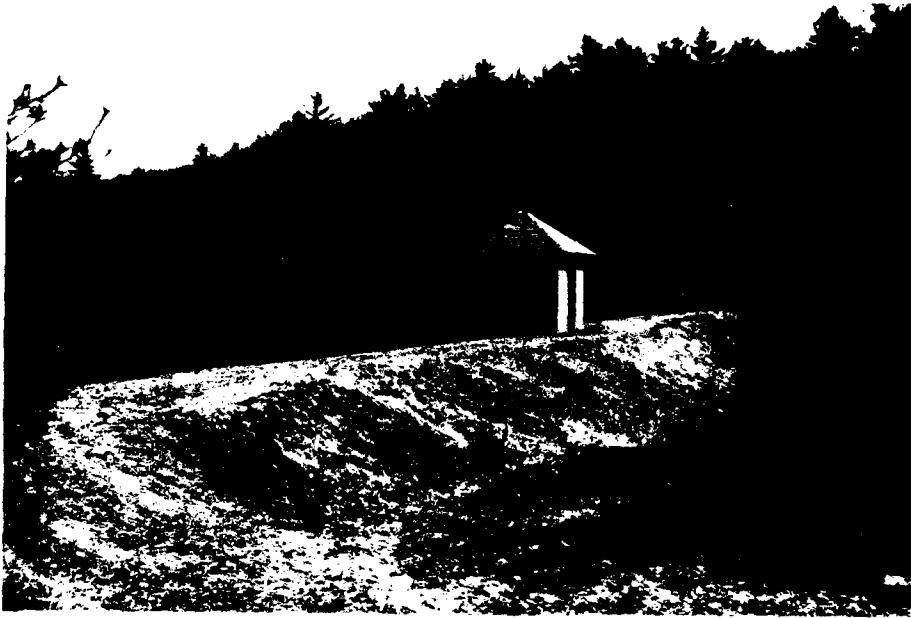
The alignment of the dam along the crest is generally good to slightly irregular. The irregularity consists of a vertical depression near the gatehouse which is visible in Photo No. 1. This depression is due to the manner of construction and is not attributed to movement of the crest. The riprap on the upstream slope is generally in good condition, although there is brush growing through the riprap.

1. Overview of Downstream Slope From
Left Abutment

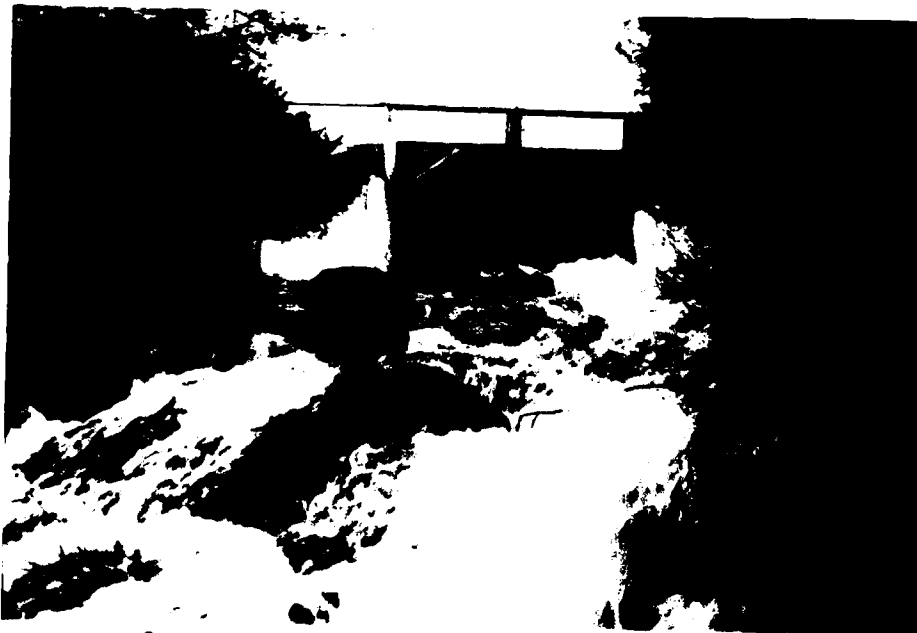
8. Downstream Channel Showing
Retaining Wall
