NATIONAL PROGRAM FOR INSPECTION OF NON-FEDERAL DAMS
WHITEWATER BROOK DAM, U.S. ARMY CORPS OF ENGINEERS WALTHAM MA
NEW ENGLAND DIV WAT 79

PHASE I INSPECTION REPORT

REPORT DOCUMENTATION PAGE		READ INSTRUCTIONS BEFORE COMPLETING FORM
1. REPORT NUMBER NH 00344	2. GOVT ACCESSION NO.	3. RECIPIENT'S CATALOG NUMBER
4. TITLE (and Subtitle) Whitewater Brook Dam No. 2 NATIONAL PROGRAM FOR INSPECTION OF NON-FEDERAL DAMS	5. TYPE OF REPORT & PERIOD COVERED INSPECTION REPORT

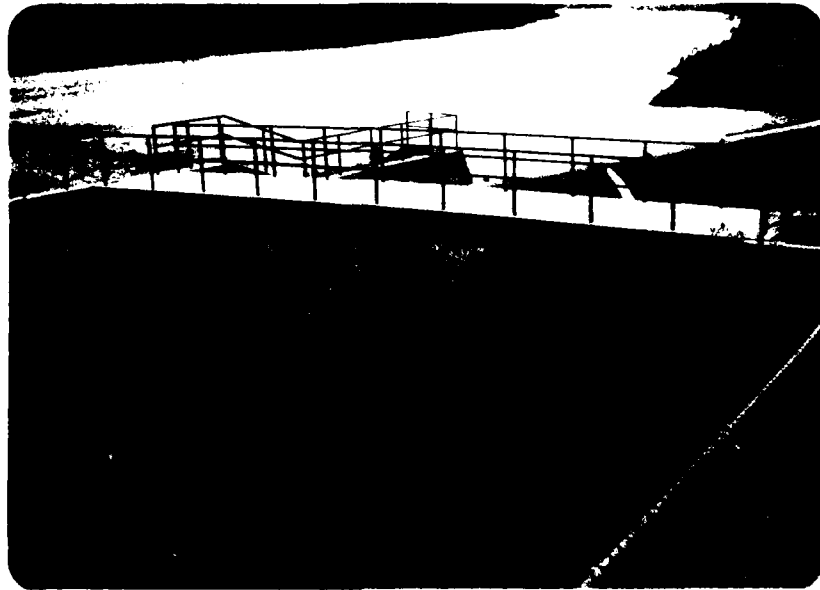
alignment is generally good, and no erosion or cavitation was noted. Patches of the concrete were observed on the downstream face of the spillway. The footbridge was constructed using both precast and cast-in-place concrete. The railing of the bridge, consisting of 1 1/2-inch pipe, was observed to be in good condition (Photographs No. 3, 4, 7, 8, and 13, Appendix C).

7. Service Bridge, Looking North, Showing West Abutment.

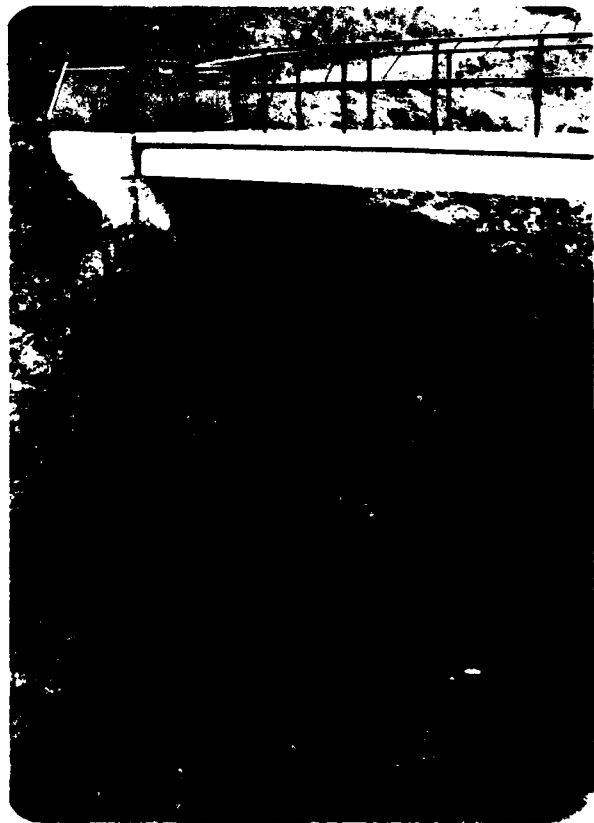
8. East Abutment of Service Bridge.
