MERRIMACK RIVER BASIN
LOUDON, NEW HAMPSHIRE

SANBORN POND OUTLET DAM
NH 00182

PHASE I INSPECTION REPORT
NATIONAL DAM INSPECTION PROGRAM

MAY 1980

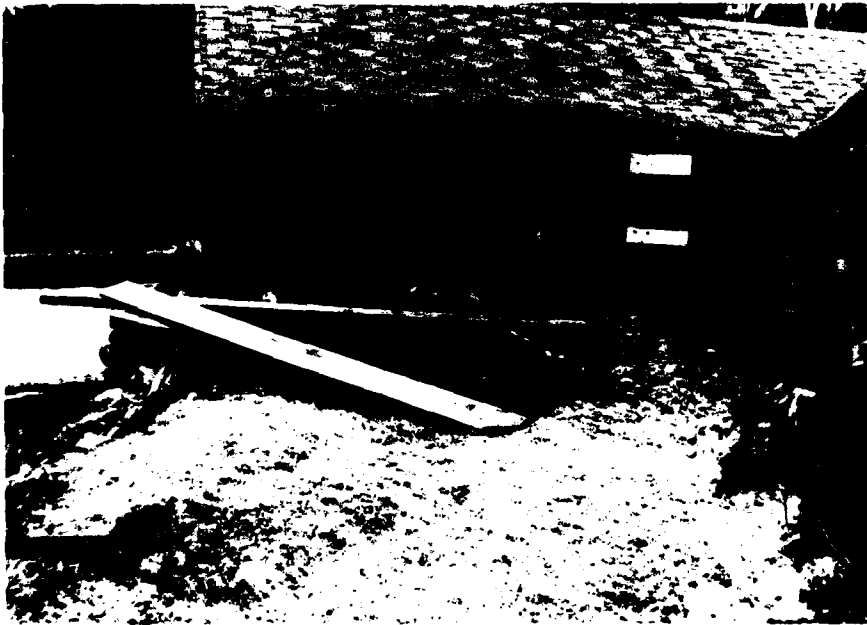
Extensive irregular settlement of the crest of the embankment, the poor condition of the vertical dry stone masonry walls which retain the upstream and downstream faces of the embankment, and the presence of what appears to be a wooden plank cutoff wall in the crest, in the vicinity of the penstock intake structure, all indicate that the embankment is in poor condition and may be unstable.

Photo No. 6 - Wood plank sheet piling and depression in crest of dam to the right of the mill intake structure.

- (1) Investigate the cause of the irregular settlement of the crest of the dam, the poor alignment of the dry stone masonry walls which retain the upstream and downstream faces of the embankment, and the condition of the embankment in the vicinity of the spillway and penstock intake structure, and design remedial measures if needed.
