NATIONAL PROGRAM FOR INSPECTION OF NON-FEDERAL DAMS
MURPHY DAM (NH 00185)...(U) CORPS OF ENGINEERS WALTHAM
MA NEW ENGLAND DIV AUG 81

REPORT DOCUMENTATION PAGE		READ INSTRUCTIONS BEFORE COMPLETING PAGE
1. REPORT NUMBER NH 00185	2. GOVT ACCESSION NO.	3. RECIPIENT'S CATALOG NUMBER
4. TITLE (and Subtitle) Murphy Dam NATIONAL PROGRAM FOR INSPECTION OF NON-FEDERAL DAMS		5. TYPE OF REPORT & PERIOD COVERED INSPECTION REPORT

DAM:Murphy.....
 IDENTIFICATION NO.N.H. 00185.....

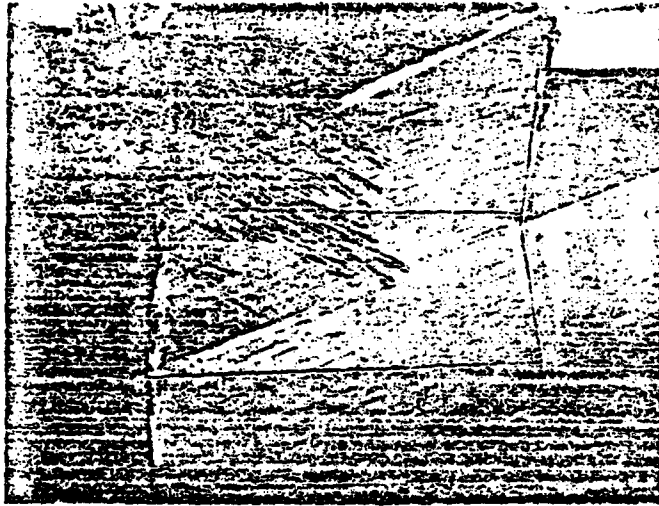
HIGHWAY BRIDGE

1. Reinforced concrete is exposed in at least one spot on bridge roadway. Suggest asphalt paving of roadway to seal concrete.
2. Minor spalling of concrete joints downstream with abutment as shown in attached photo. (see next page.)

Highway Bridge to control house over spillway outlet channel. Shows downstream north abutment spalling.
