MERRIMACK RIVER BASIN
PITTSFIELD, NEW HAMPSHIRE

BERRY POND DAM

NH 00105

PHASE I INSPECTION REPORT
NATIONAL DAM INSPECTION PROGRAM

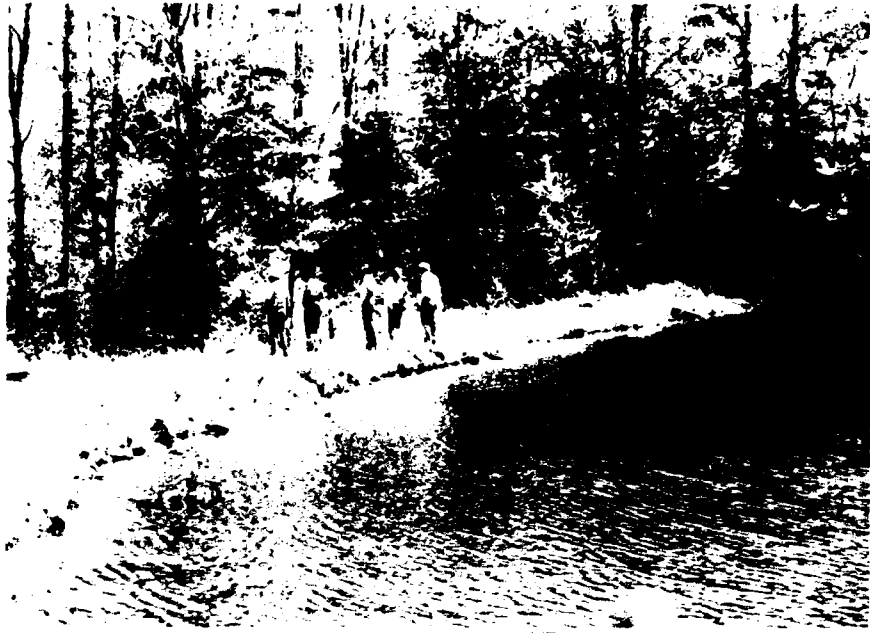
Overview from left abutment

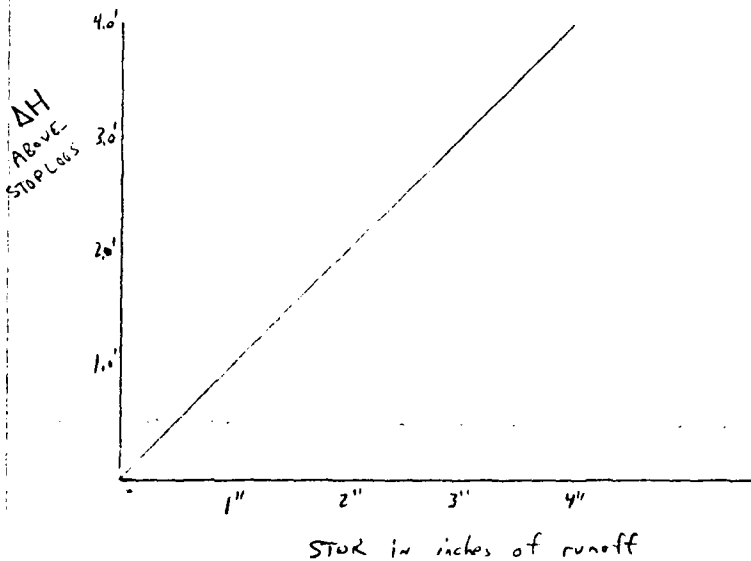
DAMS 148 | BERRY POND #6 | 6-29-78 | DWG 6 of 15

$$Q_{P3} = 260 \left(1 - \frac{1.89}{4}\right) = 137.2 \approx 140 \text{ cfs}$$

Thus the STF results in a $H \approx 1.78$ FT
This is ≈ 0.3 above the overtopping stage.
