CONTOOCOOK RIVER BASIN
ANTRIM, NEW HAMPSHIRE

GREGG LAKE DAM
NH-00056
NHWRB-9.03

PHASE I INSPECTION REPORT
NATIONAL DAM INSPECTION PROGRAM

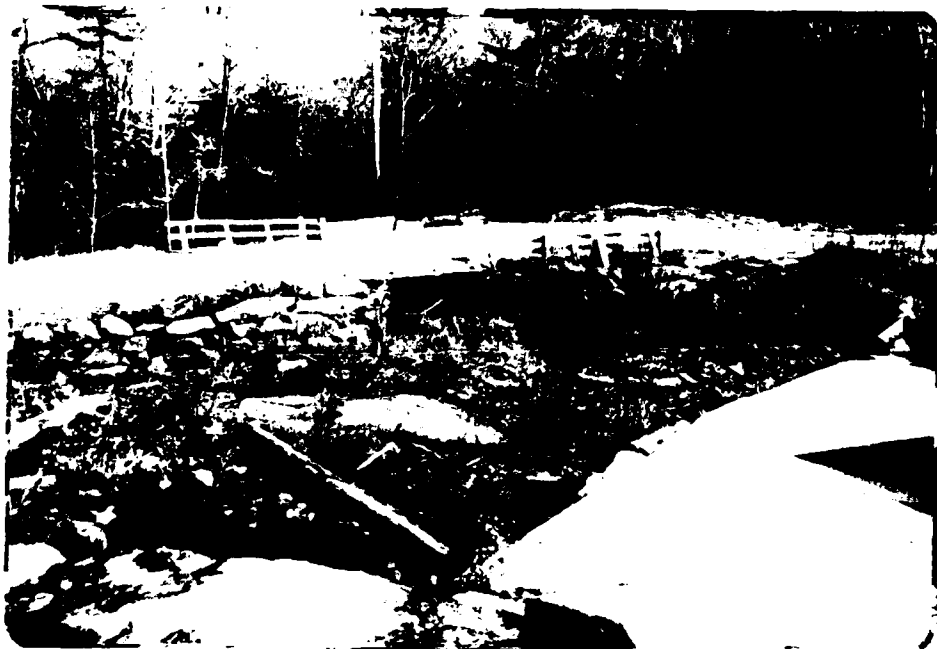
e. Downstream Channel. Great Brook immediately below the dam is composed of two channels which consist of ledge and cobbles as shown in Photos No. 2 and 3. The two channels join about 200 feet downstream of the dam. The banks of both channels are forested. Great Brook joins the Contoocook River about 3 1/2 miles below Gregg Lake Dam. The downstream channel is generally clear of debris and obstructions except for a road bridge which is located about 40 feet downstream of the dam. The bridge does not appear to cause submergence of the dam (see calculation Appendix D).

Downstream of Spillway

- (1) Remove trees, and brush, and loose rock overhanging the downstream spillway and sluice gate channels.
- (2) Repair surfaces of dam where cracking and spalling of the concrete has occurred.
- (3) Prohibit the use of the dam embankments as a beach or public landing unless adequate protection of the surfaces is provided.
- (4) Provide around-the-clock surveillance during periods of anticipated high runoff.
- (5) Have inspections of the dam made annually by a qualified registered engineer.

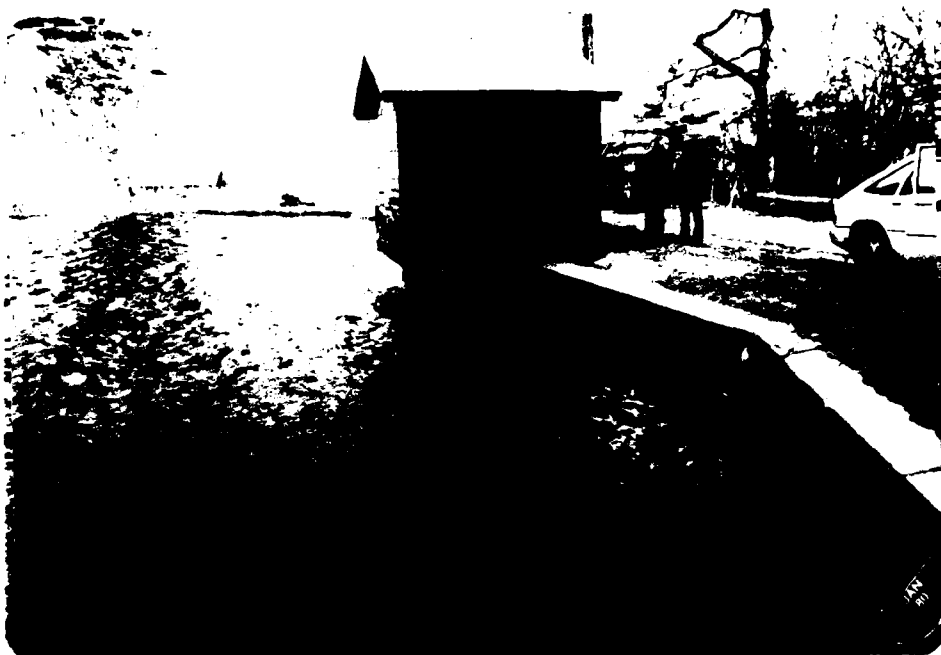
- (a) The upstream face of the right embankment is a concrete retaining wall as shown in photos No. 5 and 6. The concrete visible at the time of the inspection was in good condition. The upstream face of the left embankment is covered with brush, weeds and trees and appears to have some riprap that extends from the spillway 40 feet upstream along the embankment.

Upstream Face of Right Embankment

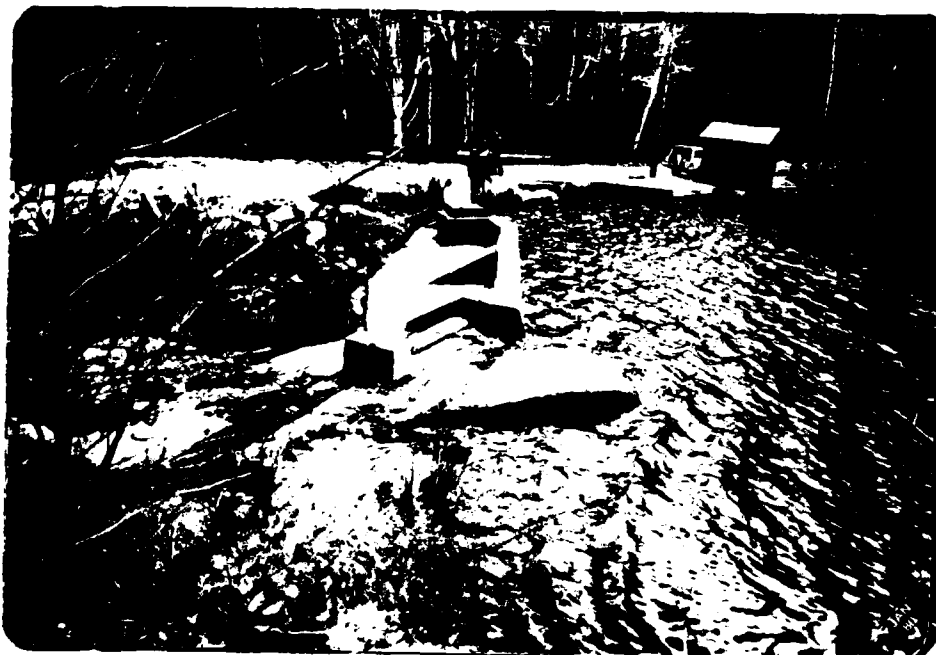
8.

View of Crest From Left Abutment.

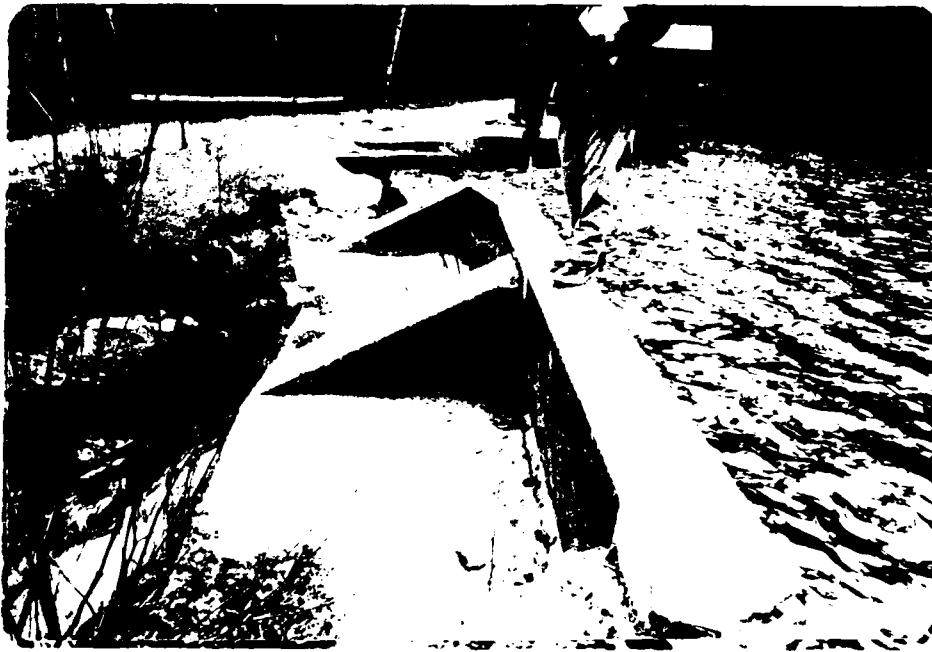
The crest of the dam is about two feet above the downstream concrete cap as shown in Photo No. 9. Concrete buttresses, apparently designed to provide support of the spillway weir, are located on the concrete cap as shown in Photo No. 9. The concrete cap was in fair to good condition except in the vicinity of the low level gated outlet, the buttress to the left of the low level gated outlet where numerous cracks were observed, (see Photo No. 13), and where separation of the concrete cap from the upstream face of the spillway was observed between the low level gated outlet and the left spillway abutment (see Photo No. 10.)

Separation of Buttresses
From Dam Crest

- (1) Analyze the need for increased discharge capacity.
- (2) Evaluate the spillway structure for the purpose of determining the cause of apparent movements observed at the time of the visual inspection and provide recommendations for rehabilitation measures.
- (3) Provide design to raise embankments to prevent overtopping of the dam and erosion of low areas in the earth embankment.
- (4) Provide means for the removal of trees and their root systems on the downstream slope of the right embankment and upstream slope of the left embankment.

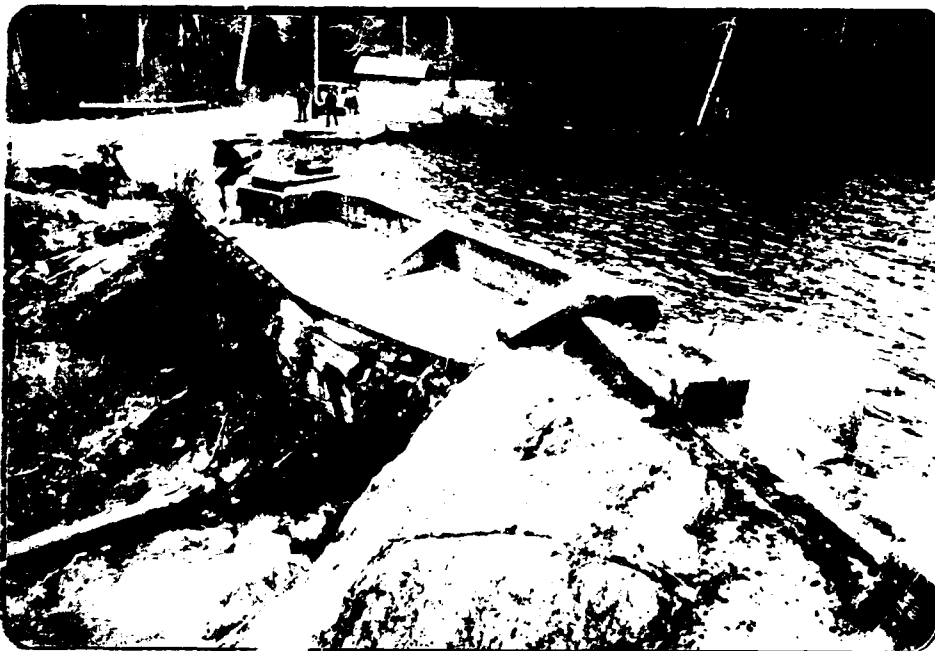
10.

Downstream Face From Left Abutment

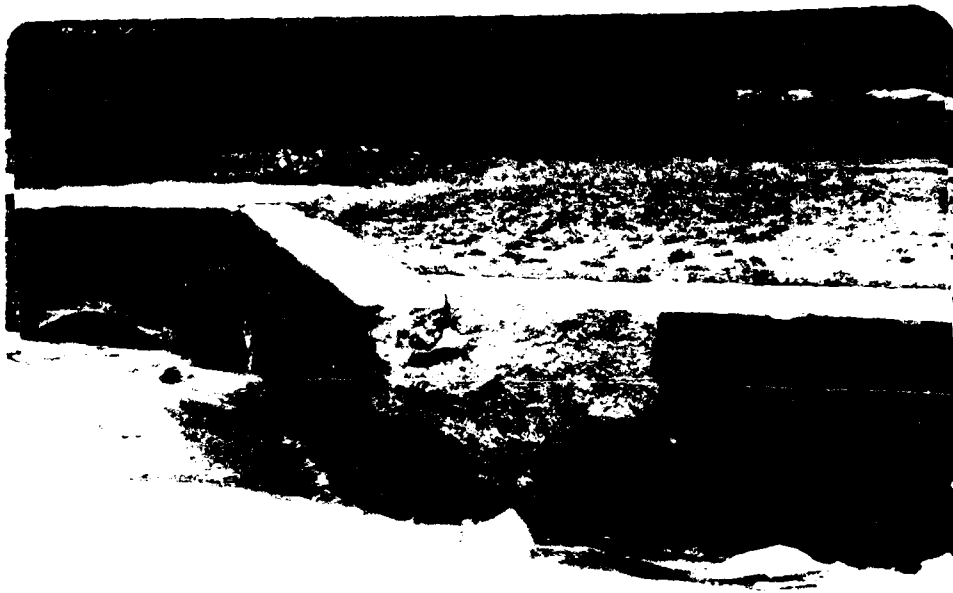
15.

Chipped Concrete - Right Upstream Retaining Wall
