PISCATAQUA RIVER BASIN  
MADBURY, NEW HAMPSHIRE

## BELLAMY RESERVOIR DAM

### PHASE I INSPECTION REPORT NATIONAL DAM INSPECTION PROGRAM

FEBRUARY 1979

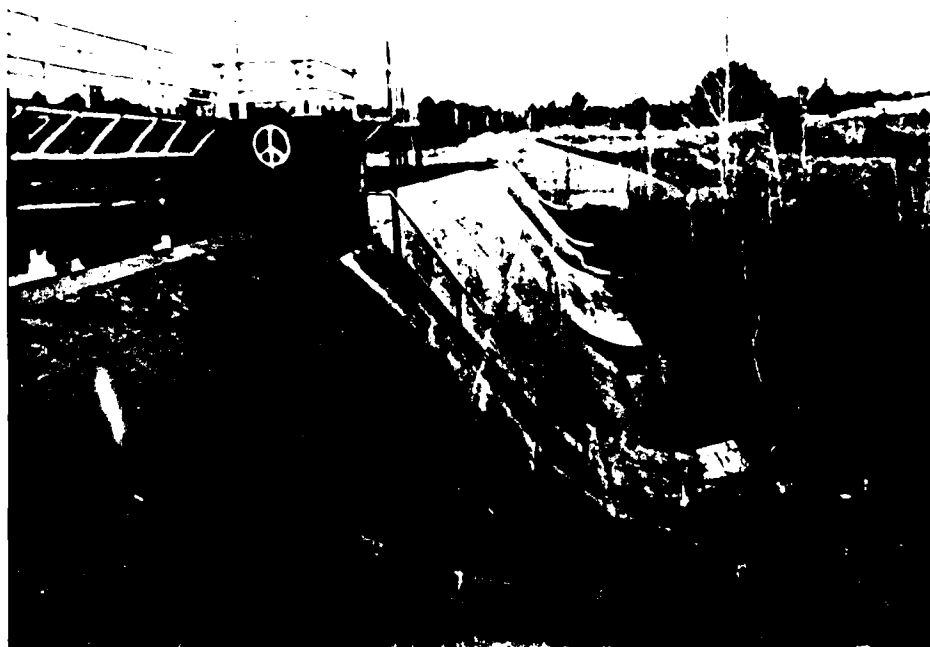
The spillway structure, shown in Photos 7, 8 and 10, consists of fourteen massive concrete segments, each 23 feet long, and two training walls. The concrete spillway surface is in good condition. There are, however, some surface cracks and efflorescence deposits, mostly concentrated around the construction joints, as can be seen in Photos 12, 13, 17 and 18. Field inspection of the training walls revealed concrete surface cracks and heavy efflorescence deposit on the left training wall (Photos 13, 14 and 15). Photo 14 indicates some spalling of the concrete surface.

PHOTO NO. 7 - Downstream face of spillway from right abutment.

PHOTO NO. 8 - Downstream face of spillway  
from left side of dam.

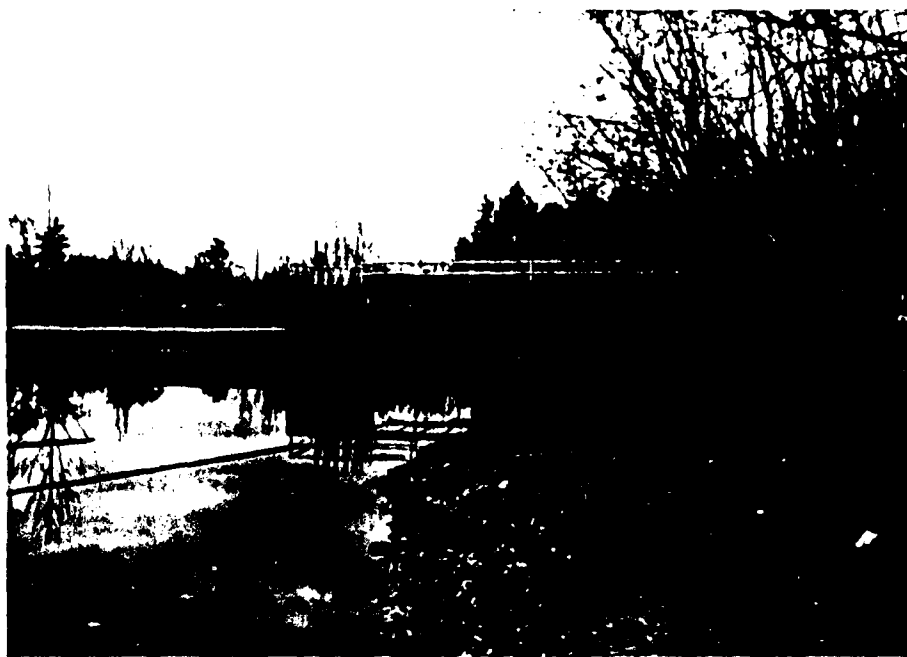
The service bridge to the gate chamber is a simple span truss structure consisting of WT4 standard shapes as the truss cords and 1½ angles as the truss diagonals. The floor consists of metal gratings, some sections of which are missing. The main carrying members, bearing plates, connections, roofing and floor are generally in good condition. The top and bottom truss cords, however, are rusted at the right abutment. The bridge is supported by the right training wall and the gate chamber. The concrete in both supporting areas is in good condition.

| AREA EVALUATED | CONDITION |
|---|---|
| Deck | Grating, good condition; some sections are missing. |
| Paint | Good (top and bottom truss cords rusted at right abutment). |

PHOTO NO. 19 - Outlet works structure with service bridges  
from right bank of reservoir.

(c) The top and bottom truss cords of the service bridge at the right abutment should be refurbished and missing floor grating should be replaced.

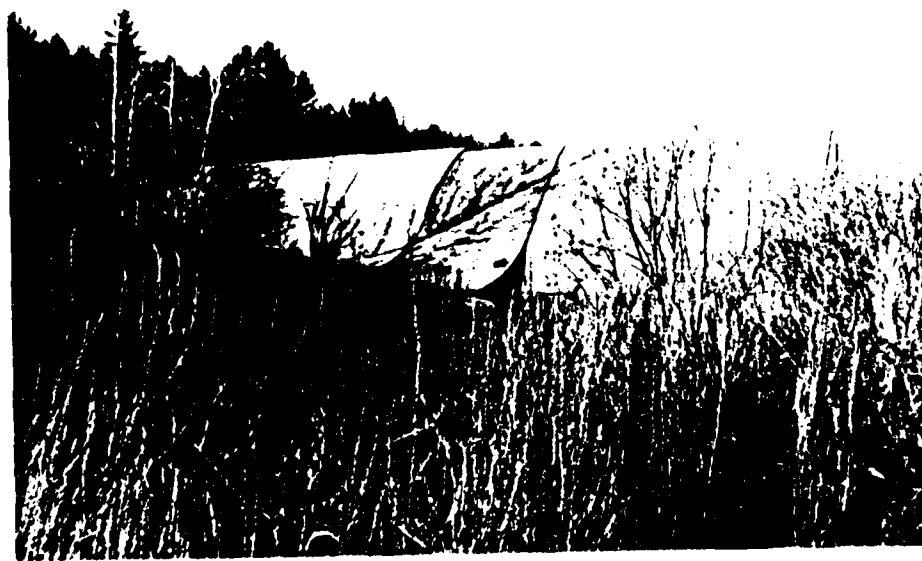
The spillway discharge channel is the original Bellamy River bed. Visual inspection of the discharge channel showed it to be in generally good condition. There were several fallen trees and light brush growth along the sides of the channel. The bed of the discharge channel could not be totally inspected as it was below water (caused by the small four foot high dam immediately downstream).

PHOTO NO. 20 - General view of discharge channel.

PHOTO NO. 21 - Discharge channel at left training area.
