PACKERS FALLS DAM

NH 00441

PHASE I INSPECTION REPORT
NATIONAL DAM INSPECTION PROGRAM

DECEMBER 1980

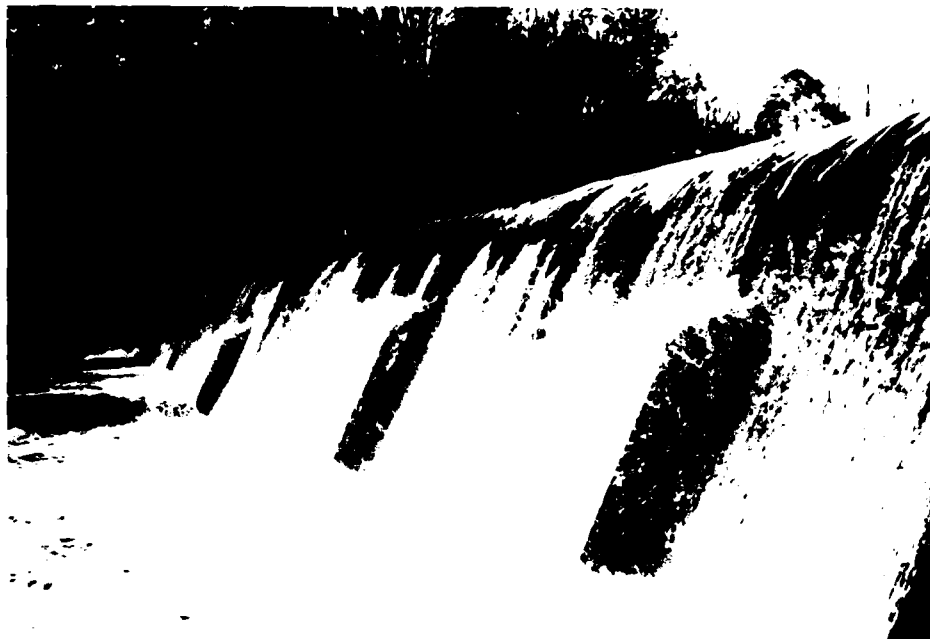
The spillway was inspected under high flow conditions. It is a concrete structure founded on bedrock which was repaired with an application of pneumatic mortar. There are two continuous horizontal construction joints in the mortar application which have been subjected to spalling. These horizontal joints are located approximately 1 foot and 10 feet below the crest of the spillway. A considerable amount of pneumatic mortar has been eroded from the downstream face of the spillway. The deterioration can be attributed to ice damage.

1. Principal Spillway - Note Buttresses on Downstream Face.

(c) Inspect the spillway under low flow conditions and evaluate the effect on the structural stability if flashboards were used.

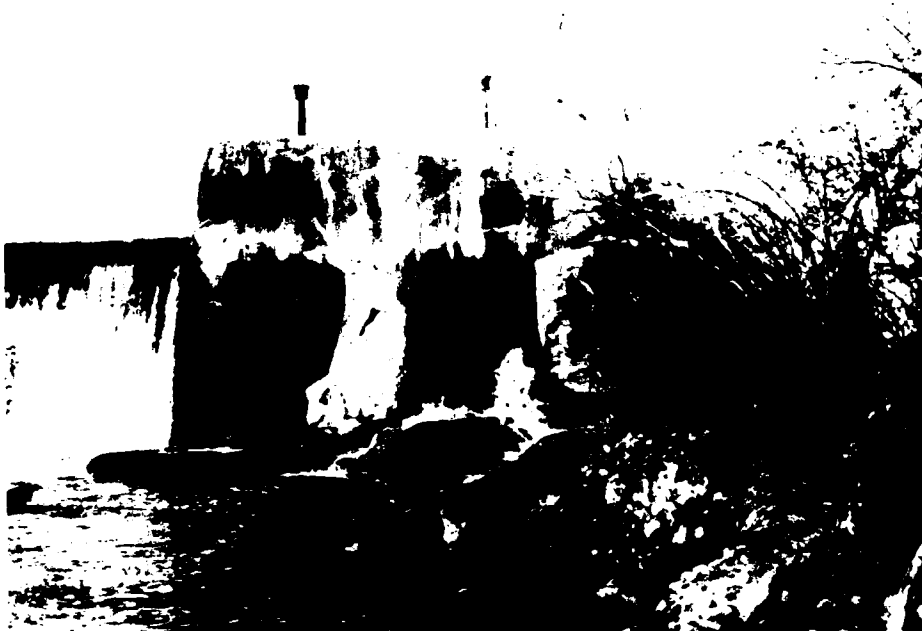
Observations of the bench stands revealed that the left stand is misaligned and tilting downstream. The misalignment has caused binding in the gate which precludes complete seating. Seepage is approximately 1 cfs of clear flow. Observations of the gates from the downstream tunnels revealed that they are in good condition, but appear to be inoperable. The gate operating wheels are stored off-site in order to prevent unauthorized use.

6. Waste Gate Structure Near Left Abutment - Note Seepage Through Gates.

(e) Evaluate the misaligned steel sluice gates and make recommendations for repair.
