WEBSTER DAM

NH 00378

PHASE I INSPECTION REPORT  
NATIONAL DAM INSPECTION PROGRAM

MARCH 1979

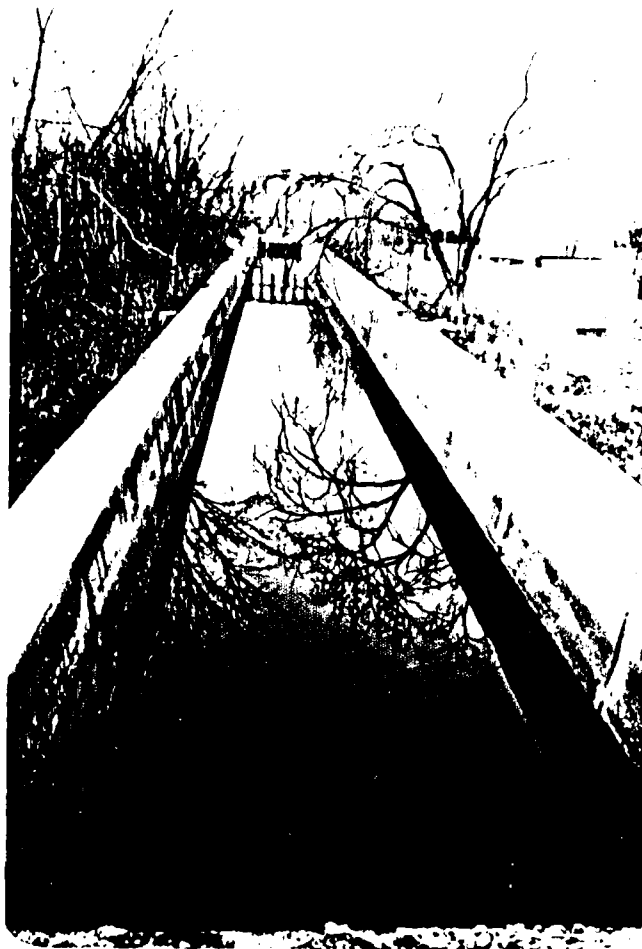
1. View of old diversion channel from gatehouse

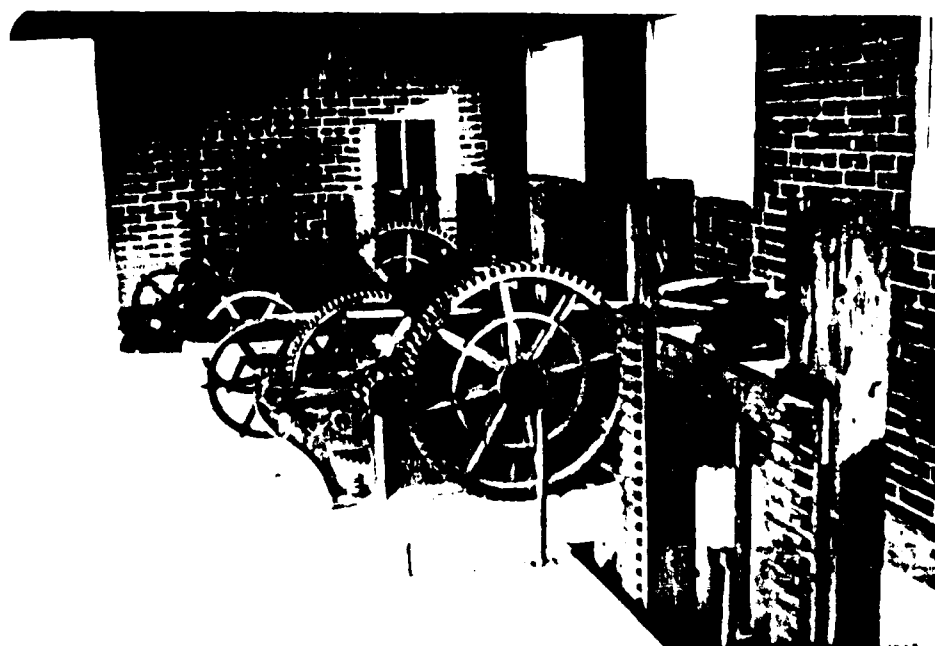
All four gates which are housed in the headworks are in extremely poor condition. The operating mechanisms for the two left gates are dismantled at the present time. Furthermore, the stems of these gates are broken and are inoperable. The operating mechanisms of the two remaining gates are intact but have not been maintained. The timber frames of these two gates are in poor condition because of deterioration at the bottom part of the frame about 3 feet above the water level. The access stairway, located outside the building, is in fair condition. Portions of the operating mechanisms for the two left gates have been discarded on the left side of the building.

1. View of deteriorated gate operating mechanisms

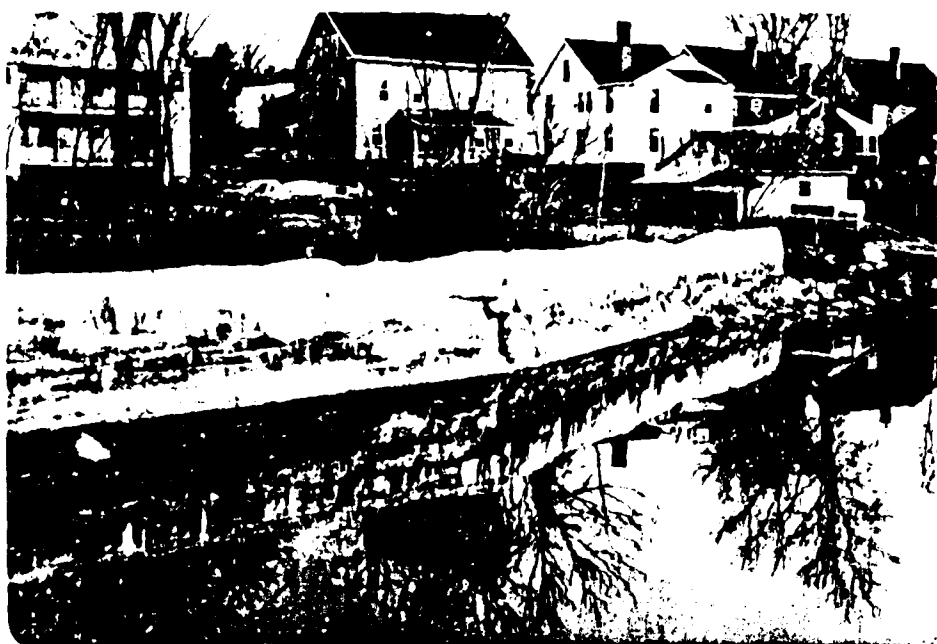
This training wall is in very poor condition. There is severe spalling, cracking and efflorescence over 75 percent of its length and surface area. The top of this wall is completely spalled up to depths of 18 inches and is disintegrating. There are cracks in this wall approximately 4 to 6 inches wide and 12 inches deep. The original wall adjacent to the upstream bend has cracked horizontally over a distance of approximately 10 feet and the top of the wall is leaning outward by approximately 3 inches. This crack is approximately 1-1/2 inches wide. This cracking is attributed to expansion forces generated from the massive wall located immediately downstream. The poor condition of this wall is attributed to poor quality concrete, moisture intrusion, alternate freeze and thaw cycles, and ice damage.

9. View from sluice gate structure showing deterioration of right upstream training wall
