MERRIMACK RIVER BASIN
NEW IPSWICH, NEW HAMPSHIRE

SOUHEGAN RIVER WATERSHED
DAM NO. 13

PHASE I INSPECTION REPORT
NATIONAL DAM INSPECTION PROGRAM

DECEMBER 1979

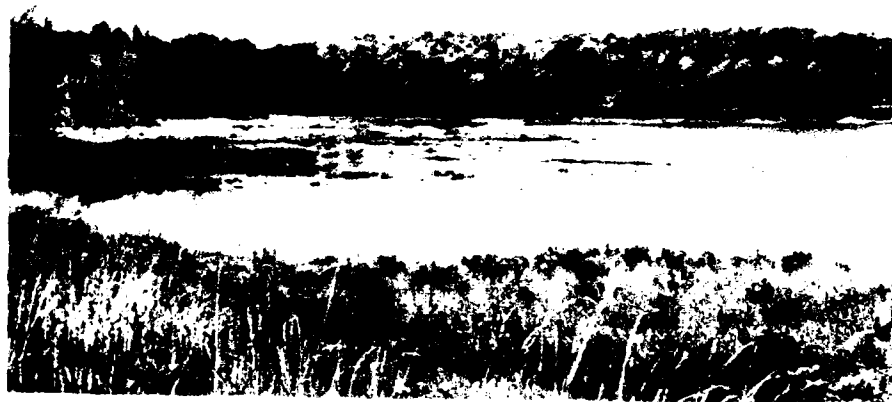
1. Reservoir area from emergency spillway
