UNION LAKE DAM  
NH 00232

PHASE I INSPECTION REPORT  
NATIONAL DAM INSPECTION PROGRAM

DEPARTMENT OF THE ARMY  
NEW ENGLAND DIVISION, CORPS OF ENGINEERS  
WALTHAM, MASS. 02154

AUGUST 1978

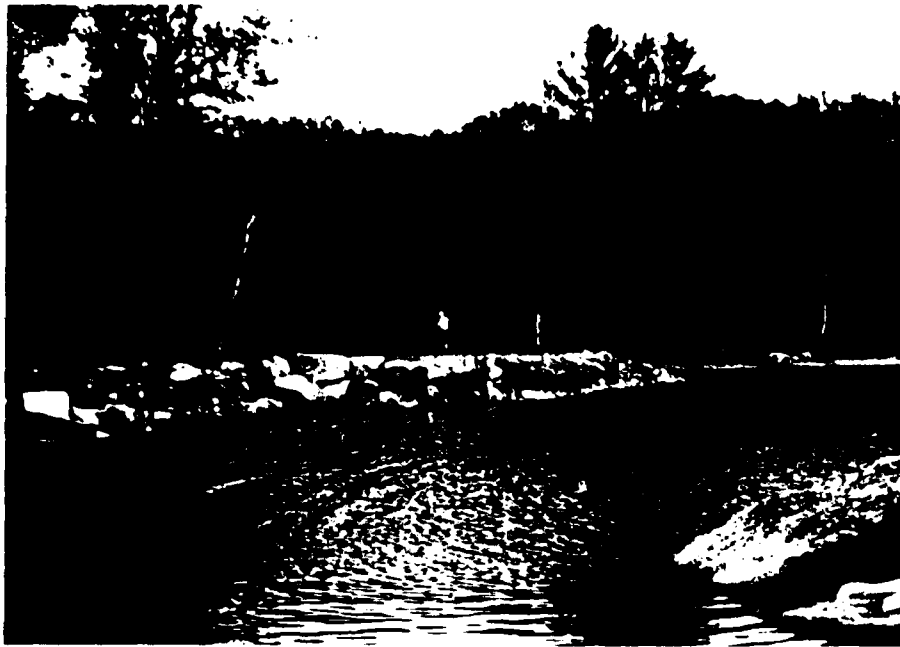
Figure 2 - Looking towards the gatehouse from the north side of the reservoir.

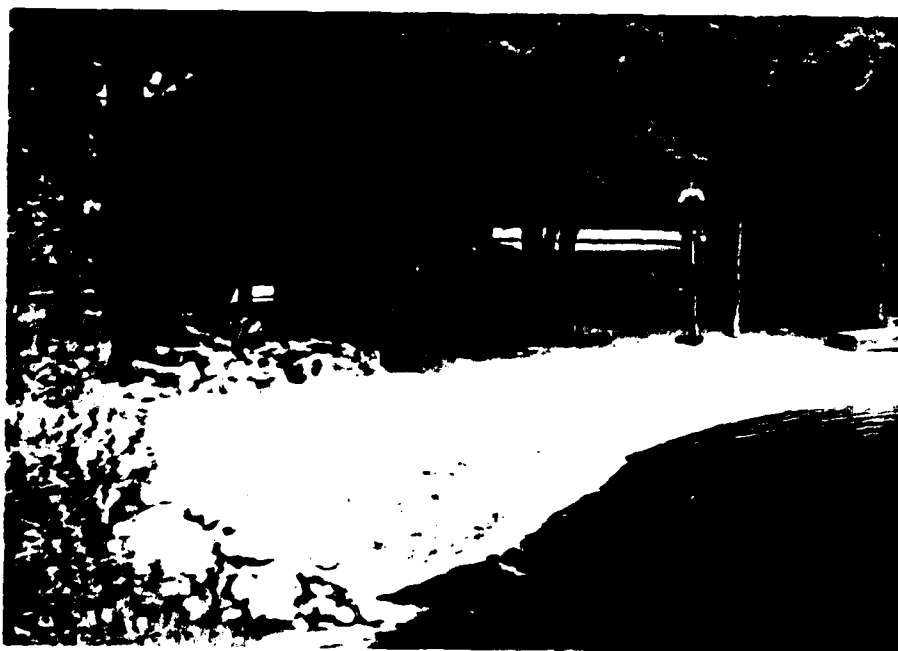
Figure 5 - Looking at the beach which forms the upstream face of the dam near the north abutment.

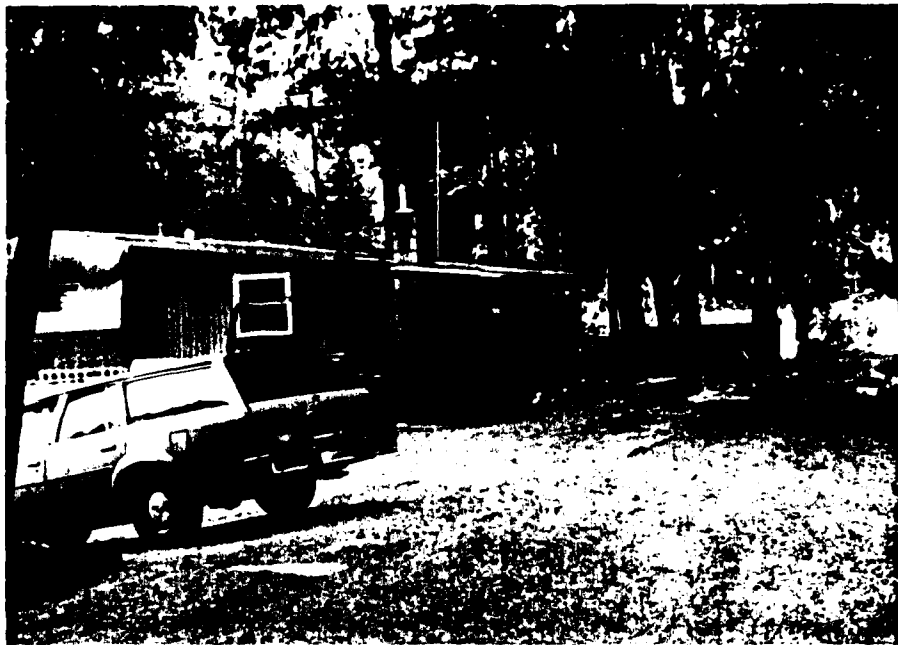
The expanded house trailer is situated on the downstream slope near the north abutment, the privy that was constructed and later abandoned on the downstream slope, and general trespassing on the downstream slope near the north abutment have had unknown effects on the integrity of the dam. Lack of adequate maintenance on the gate house and supporting timbers could lead to collapse of the building into the overflow spillway or to failure of the timber supporting the gate-operating mechanism when a load is imposed during operation of the sluice gate.

Figure 6 - Closeup of house trailer located on north abutment.

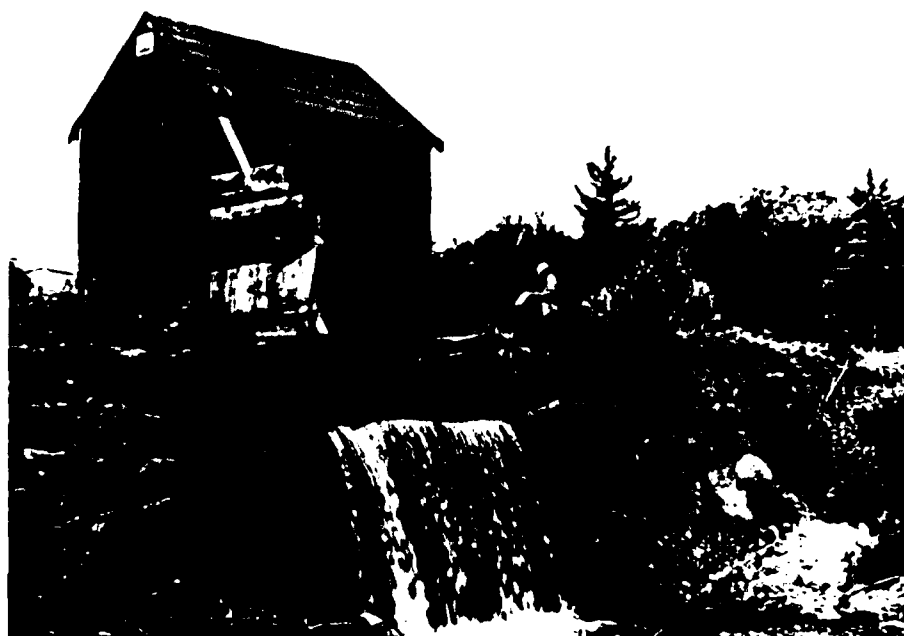
Figure 11 - Looking upstream at the spillway and gatehouse.
