MEGUNTICOOK RIVER BASIN  
CAMDEN, MAINE

KNOX MILL DAM  
ME-00276

PHASE I INSPECTION REPORT  
NATIONAL DAM INSPECTION PROGRAM

AUGUST 1978

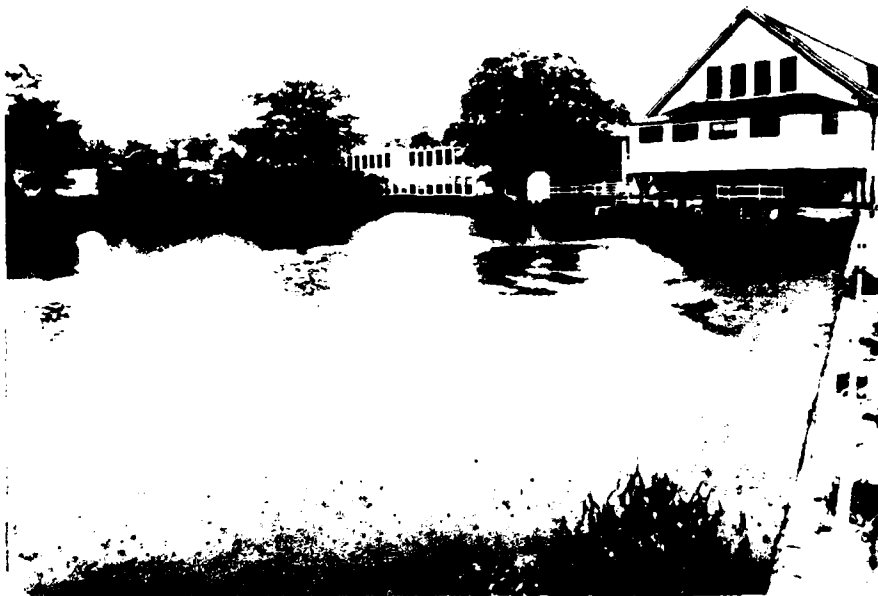
K-1

VIEW OF DAM FROM UPSTREAM

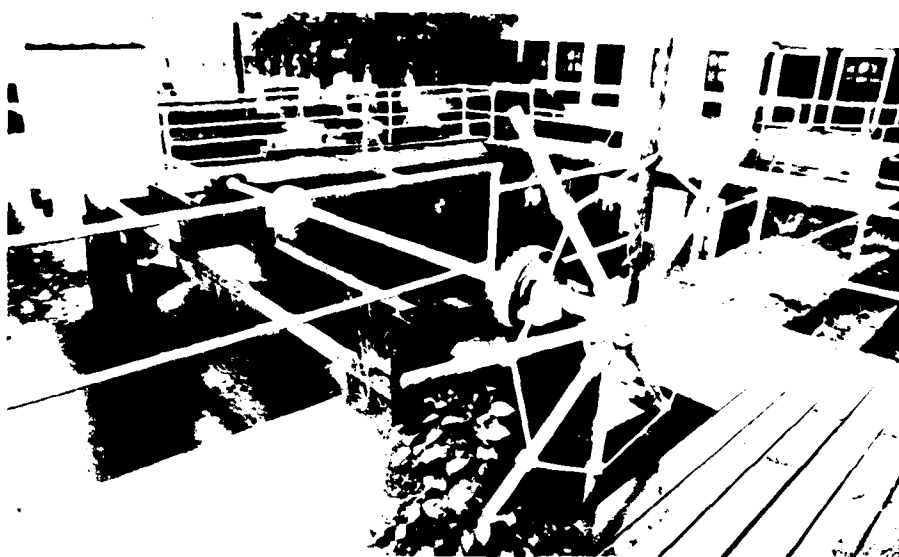
K-3

GATEHOUSE AND CONTROL WHEEL

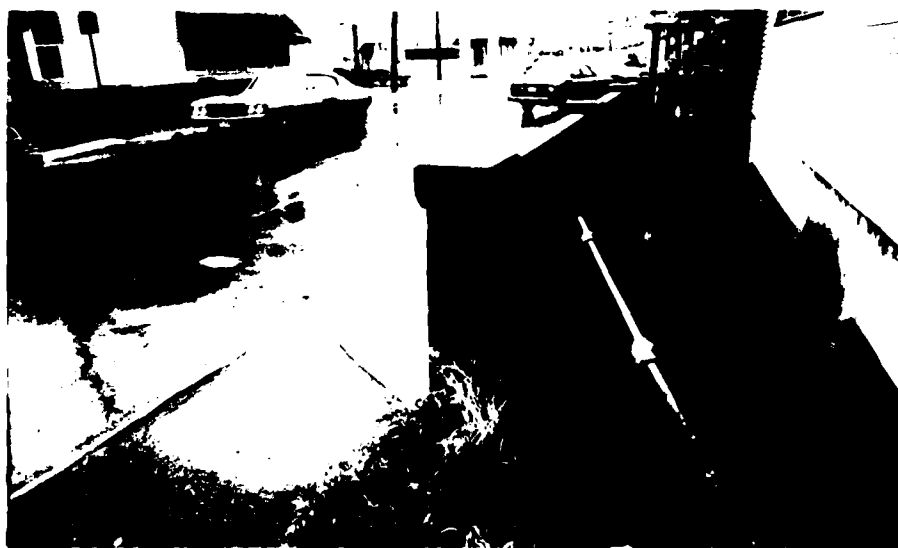
K-4

OUTLET AT DOWNSTREAM SIDE OF KNOX MILL FACTORY BUILDING

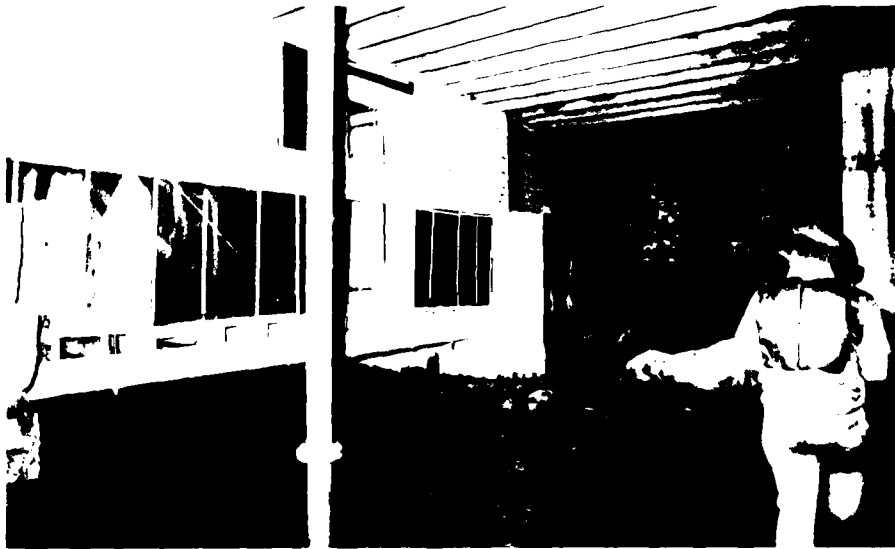
K-5

VIEW OF SHOP OVERHEAD IN NUMBER 1  
SLUICeway UNDER KNOX MILL

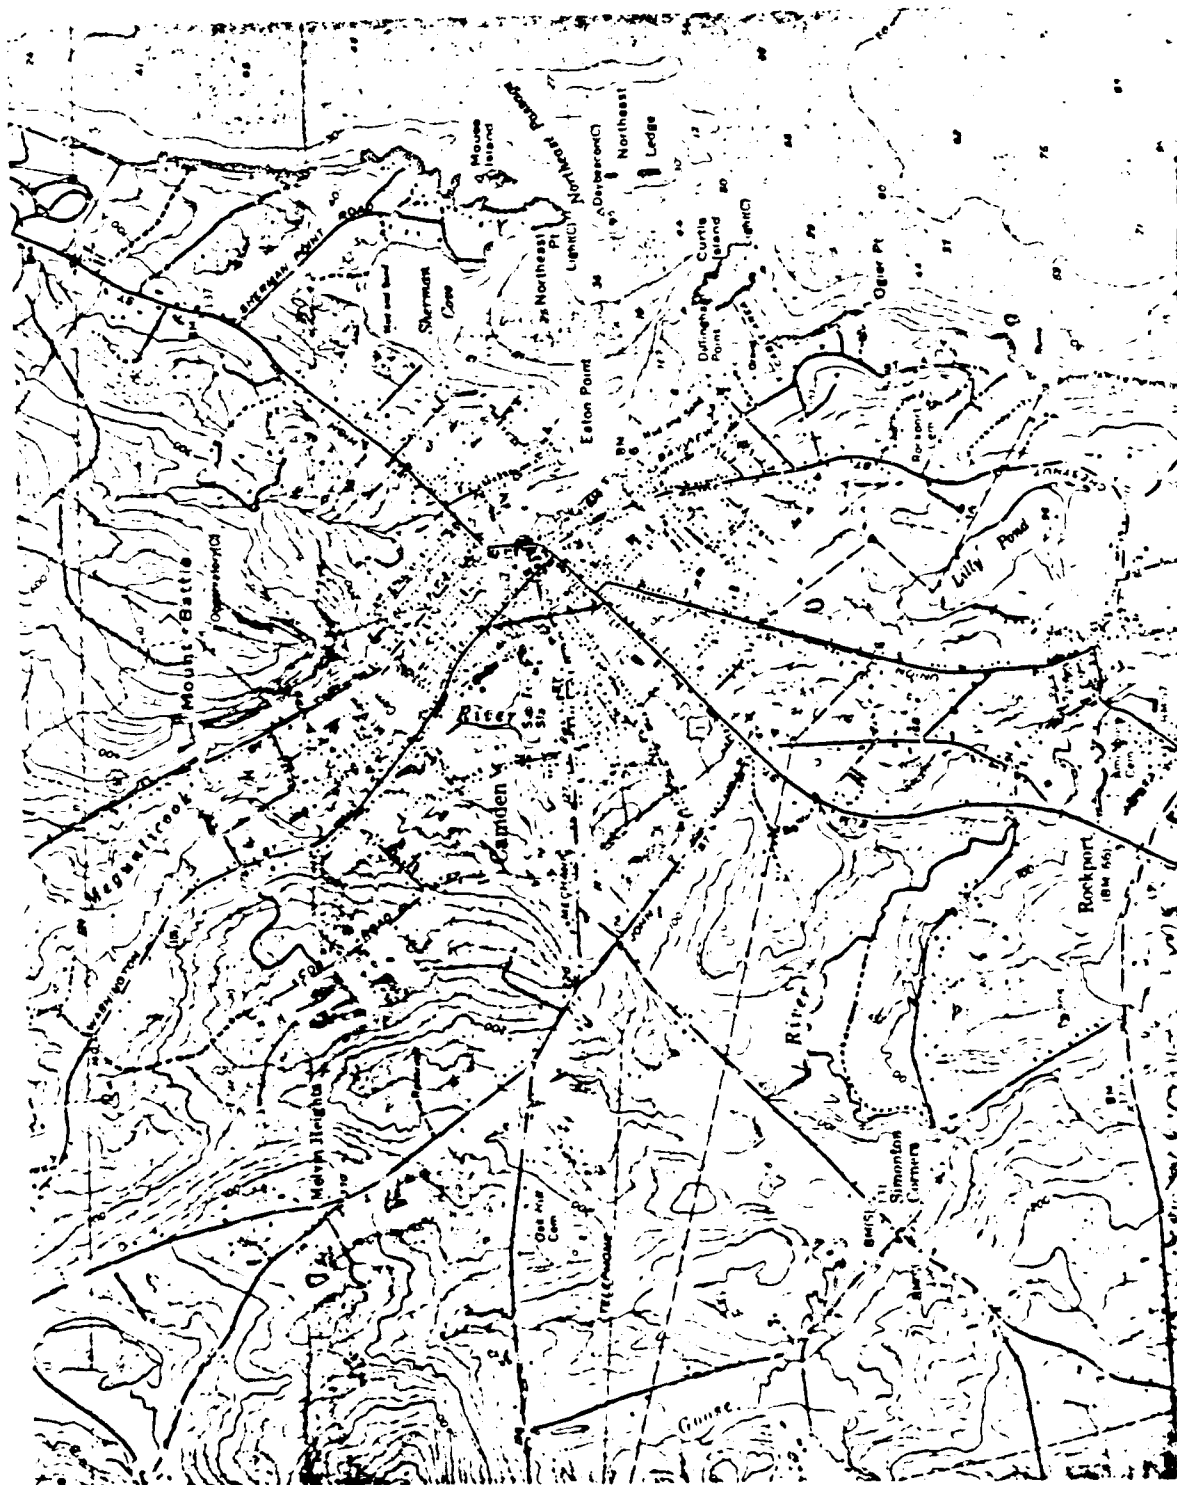
PROJECT FAILURE OF SOUTH  
WING WALL

There is a possibility of failure of the south wing wall of the dam. This possibility was examined according to rule of thumb methods as described in an attachment to ETL 1100-2-234. If the south wing wall failed at a Knox Mill Pond elevation equal to full spillway, there would be sheet flooding of about 1 foot in depth in a 500 foot wide flood plain between Knox Mill and the ocean. Some damage to property would occur. Should the north wing wall be breached by flood flows, these flows would be encompassed by the Knox Mill building complex.

$$Q_{p1} = \frac{8}{27} (59) \sqrt{g} 6^{3/2} = \underline{\underline{1460 \text{ CFS}}}$$

SINCE Qps from a breaching of  
the south wing wall is 1460 CFS  
and 1' of depth of flow will  
conduct a flow of about 3850 CFS,  
it may be concluded that sheet  
flow through the street of London  
to the ocean would occur if  
the south wall were breached.  
There would be damage  
in the flood plain.

1. A system to prevent erosion and provide support during overtopping flows downstream of the south masonry wing wall along the section parallel to Mechanic Street.
2. A designed-to-fail flashboard system should be developed and implemented for the spillway of the Knox Dam. If such a system is used, the spillway capacity will be increased by almost 40 percent during flood flows when the flashboards collapse. This increase in spillway capacity would lessen the frequency of overtopping of the wing walls of the dam.
3. Enlargement or alteration of the spillway to improve the discharge capacity at the dam.
