LOWER POND DAM

VT 00059

PHASE I INSPECTION REPORT
NATIONAL DAM INSPECTION PROGRAM

JULY 1979

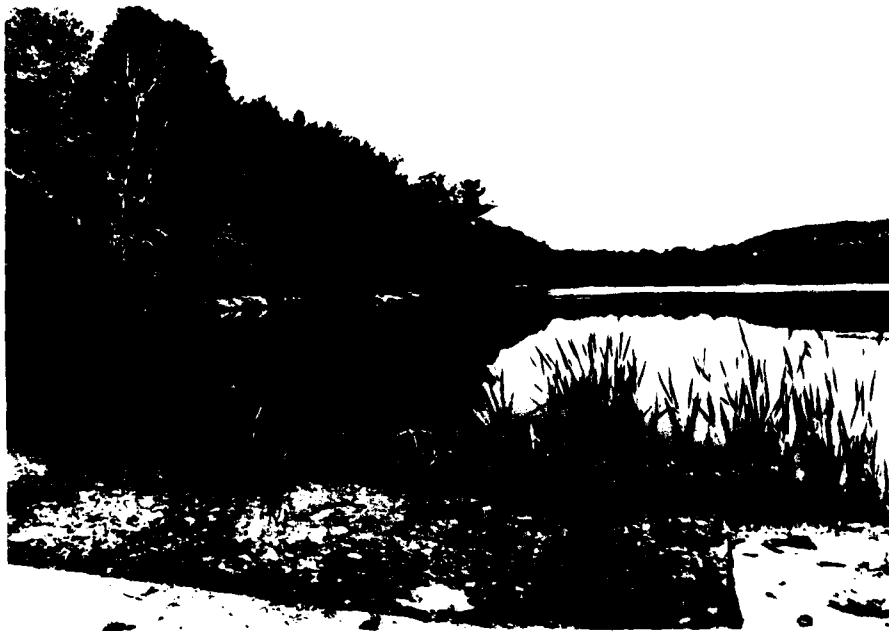
PHOTO NO. 2 - Weed growth immediately upstream of the dam.

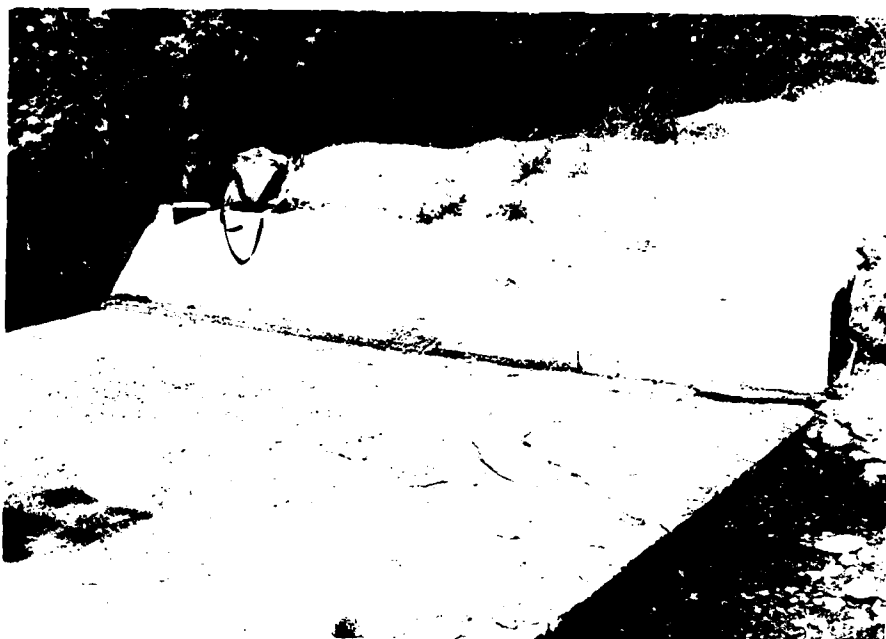
The right training wall and concrete floor slab of the spillway have been cracked due to settlement of the embankment at the upstream end of the spillway.

The spillway section consists of a concrete slab and training walls approximately two feet high, as shown in Photos No. 10 & 11. Inspection of the concrete slab and training walls revealed considerable surface deterioration, including cracks and deep spalling. A deep concrete crack through slab and wall is located at the right upstream corner of the spillway, see Photo Nos. 10 & 11. An earlier inspection indicated that a small amount of water was leaking through the downstream masonry face of the dam under the spillway. This leakage was not noted during the inspection.

PHOTO NO. 11 - Detail view of spillway section.

(6) Repair the spalling and cracks of the spillway slab and training wall.
