NATIONAL PROGRAM FOR INSPECTION OF NON-FEDERAL DAMS
BARDEN RESERVOIR DAM (.. (U) CORPS OF ENGINEERS WALTHAM
MA NEW ENGLAND DIV MAR 80

reads: Phase I Inspection Report, National Dam Inspection Program; official title of the program is: National Program for Inspection of dams; use cover date for date of report.

BARDEN RESERVOIR DAM

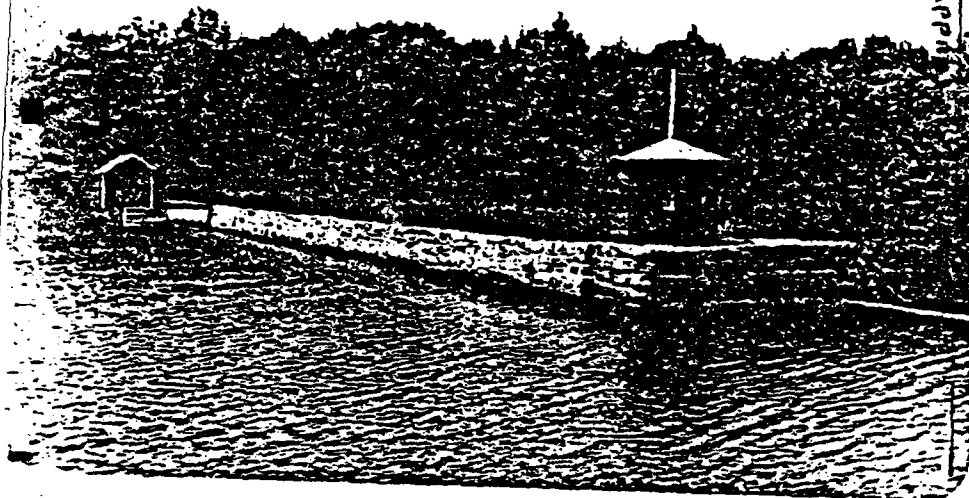
PHOTO #1.

General view of upstream face of dam embankment, showing both gatehouses and mortared masonry wall.

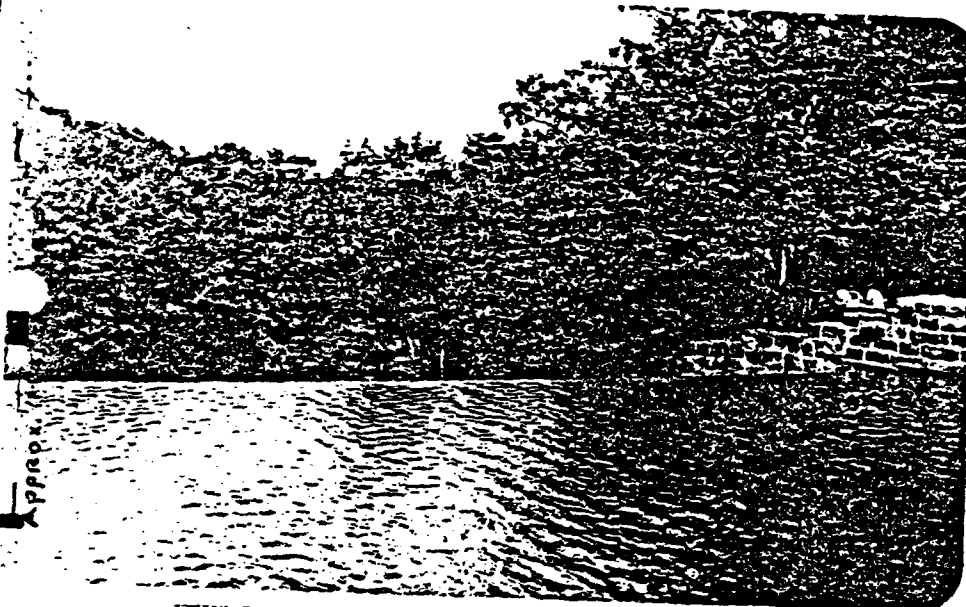
PHOTO #2.

General view across crest of spillway. No significant irregularities noticeable across entire crest.

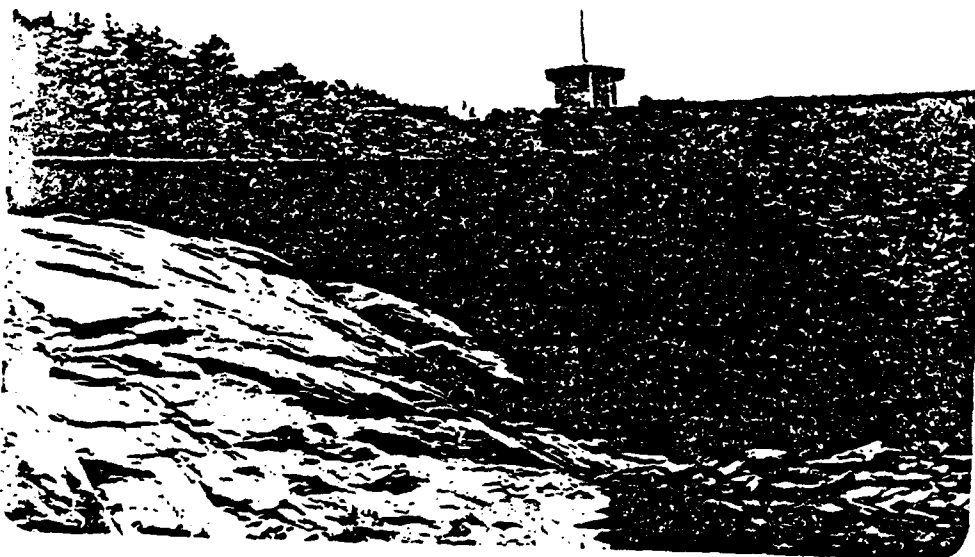
PHOTO #3.

General view of face of spillway, heavy masonry abutment wall & ledge outcropping.

Only a trickle of water passing over spillway this date.

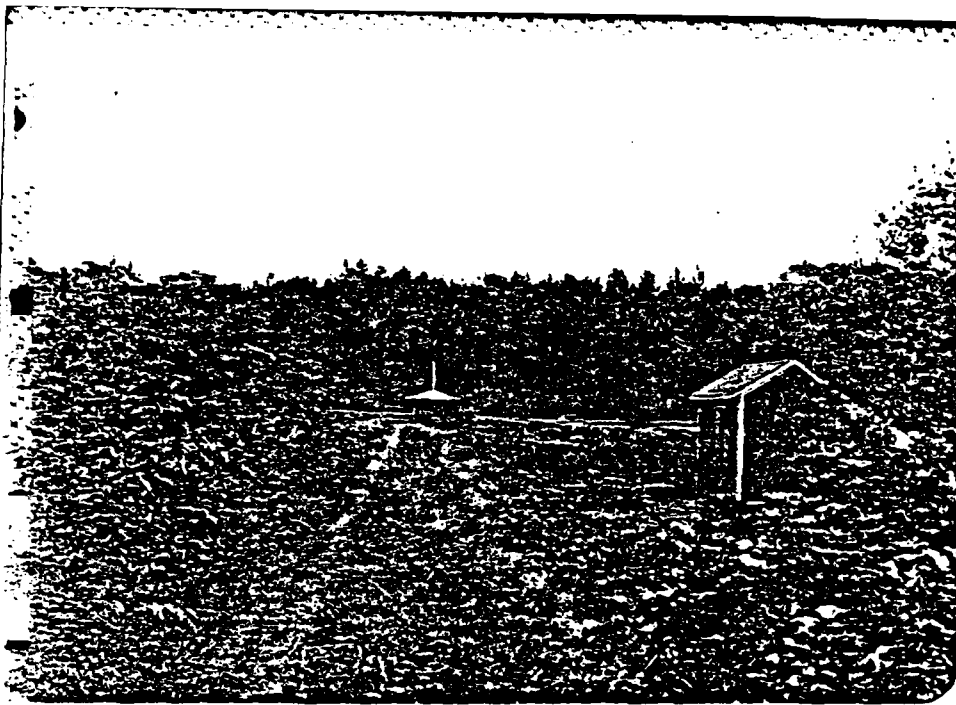
PHOTO #4.

General view of top of dam embankment showing both gatehouses and extent of growth of vegetation. View is toward spillway.

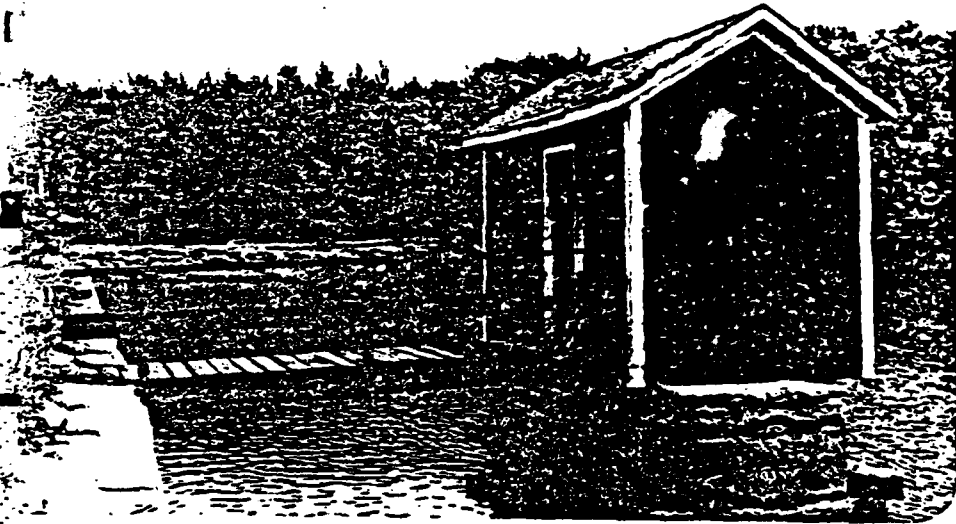
PHOTO #5.

View of gatehouse in center of dam embankment. Access bridge appears to be of recent construction and in good condition.

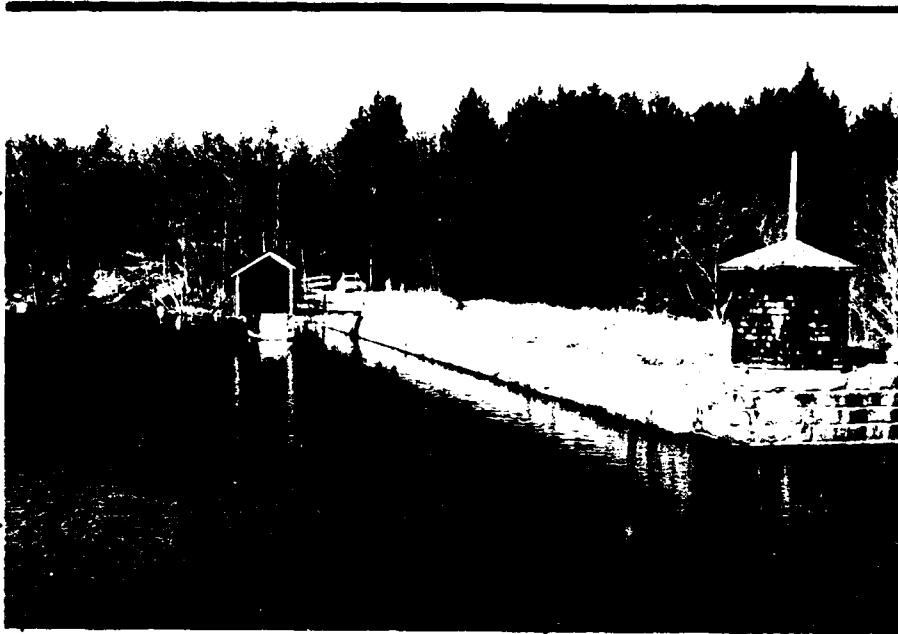
2. Upstream Slope - From Sta 0+00 to Sta 2+49 there is a vertical mortared stone wall above the water level. The wall is in good condition and alignment. The top of the wall is 5 feet above the spillway elevation and about 18 inches below the crest of the dam. A grassed slope extends from the top of the upstream wall to the crest. The upstream slope below the masonry wall was entirely submerged at the time of inspection. Riprap could be observed on the slope to a depth of 2 to 3 feet below the water surface and appeared in good condition. (See photos C-1,2)

PHOTO C-1 - Upstream Face of Dam looking from Right Abutment Area.

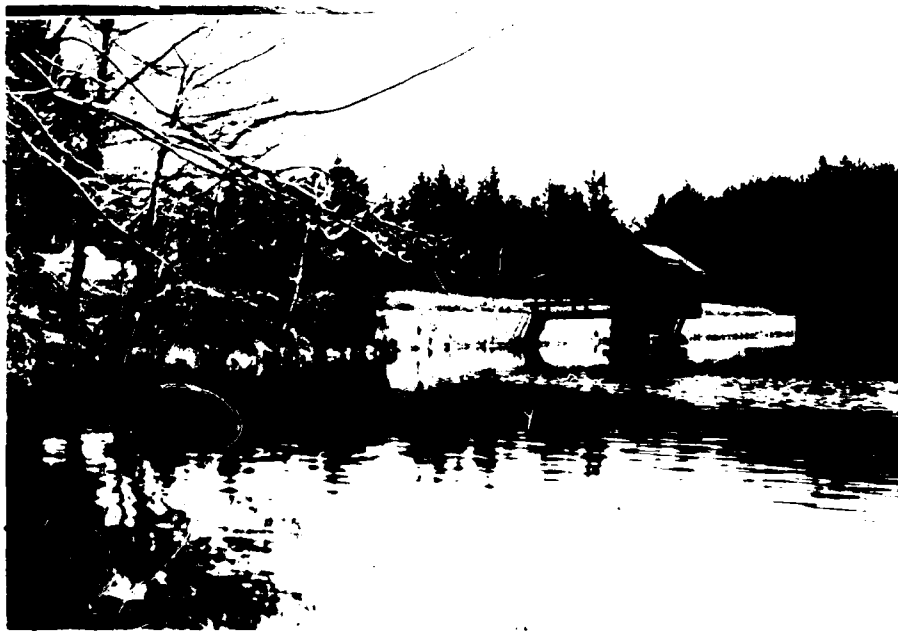
The riprap was missing in several areas above the waterline. Riprap on the upstream slope from Sta 2+49 to Sta 3+00 could be observed below water level to a depth of 2 to 3 feet and appeared to be in good condition.

PHOTO C-2 - Upstream Face of Dam looking from Left Abutment Area.

1. Brush, vines, and trees on the downstream slope should be cleared, and the vegetation on the slope cut annually thereafter.
2. Riprap on the upstream face should be cleared of vines and brush, and missing riprap replaced.

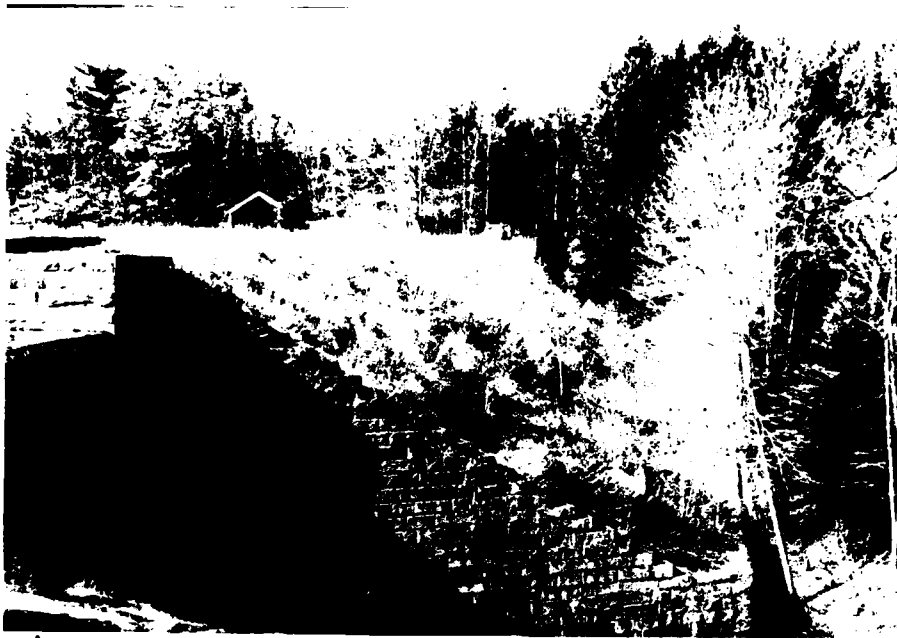
1. Spillway and Training Walls - A stone masonry uncontrolled overflow spillway is located at the right abutment of the dam. The spillway weir is constructed of large granite slabs placed in a slight upstream arc (81.5 feet) that is founded on a large exposed bedrock formation. The approach channel to the spillway is open with the easterly training wall extending upstream approximately 200 feet providing protection against wave action for Hemlock Road. Downstream below the weir crest, the channel is confined within cut stone masonry training walls and the channel bed is the exposed bedrock monolith. (See photos C-3, 4, 5.)

PHOTO C-3 - Downstream Slope of Dam looking from Right Abutment Area.

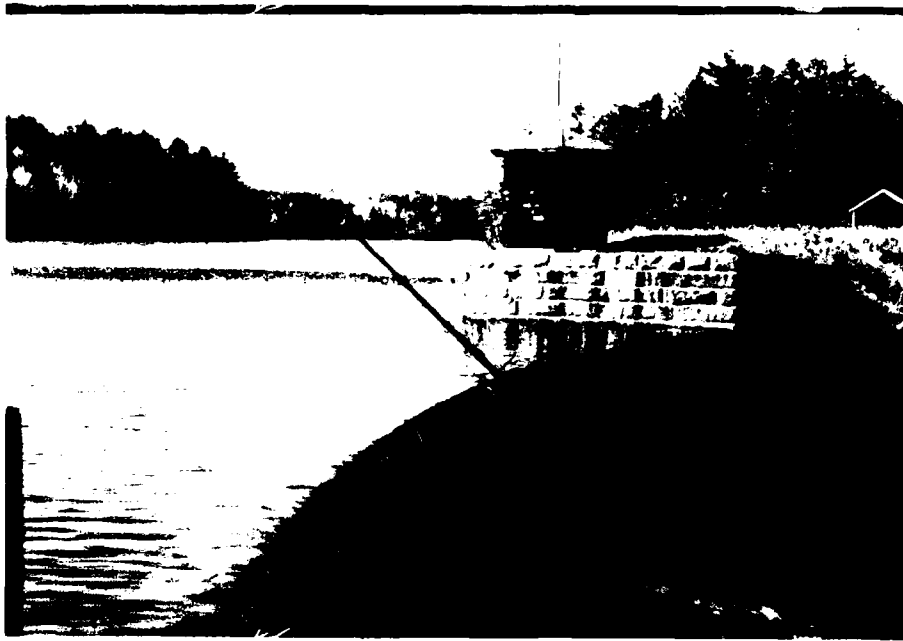
PHOTO C-5 - Overflow Spillway looking from Right Abutment Area.

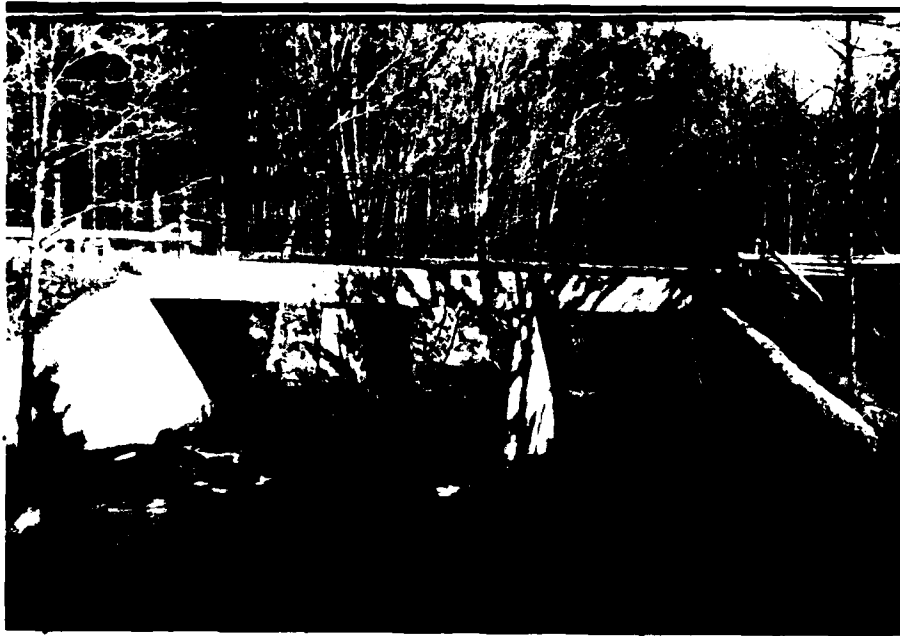
- e. Downstream Channel. The downstream channel below the dam is the natural stream bed of the Ponaganset River which leads to the main Scituate Reservoir impoundment a distance of approximately 2,000 feet. Two stream restrictions were noted immediately below the dam. The first is the dry rubble abutment remains of the former highway bridge. These abutment structures have vertical faces 10 feet high and 41.5 feet apart. The second is the existing Ponaganset Road highway bridge waterway openings. This bridge structure has two center piers that form 3 waterway openings of 12 feet wide by 14 feet high each. (See photos C-10, 11, 12)

PHOTO C-11 - Ponaganset Road Bridge Downstream from Dam.
