WOONASQUATUCKET RIVER BASIN
SMITHFIELD, RHODE ISLAND

SLACK RESERVOIR DAM
RI 03104

PHASE 1 INSPECTION REPORT
NATIONAL DAM INSPECTION PROGRAM

JUNE 1980

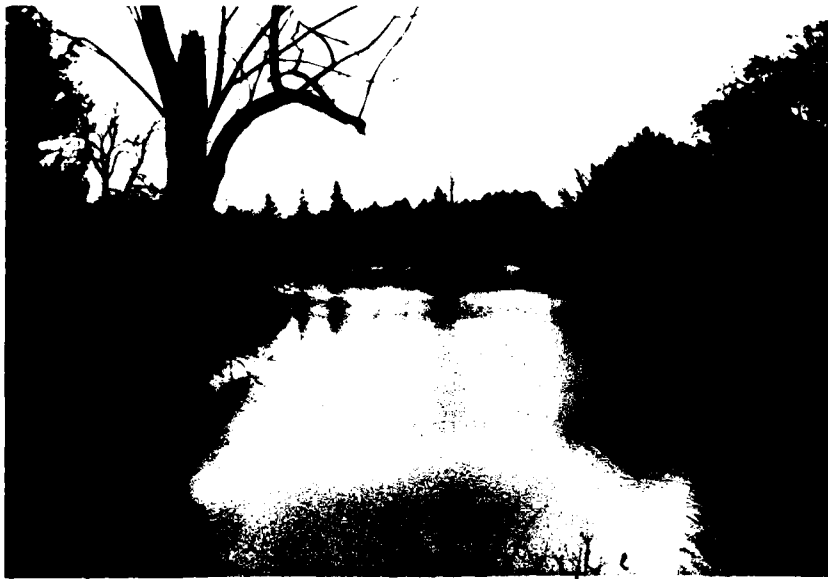
The downstream channel is a tailwater pond. Several trees were observed overhanging the pond (See photo C-9).

PHOTO C-9 Looking downstream from crest of dam.
