**RICHELIEU RIVER BASIN
BELMONT VERMONT**

**STAR LAKE DAM
VT00010**

**PHASE I INSPECTION REPORT
NATIONAL DAM INSPECTION PROGRAM**

AUGUST 1978

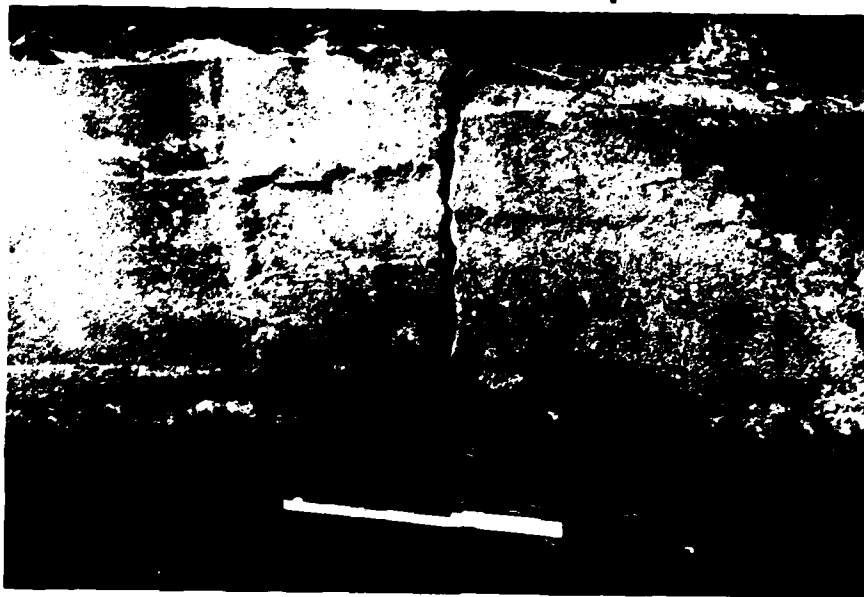
The concrete lined flume which leads from the weir is seriously cracked and misaligned. This in turn allows a substantial flow to enter the body of the dam below, which supports the deepest section of the dam.

#1 CRACK AND MISALIGNMENT IN RIGHT WALL AND SLAB OF FLUME

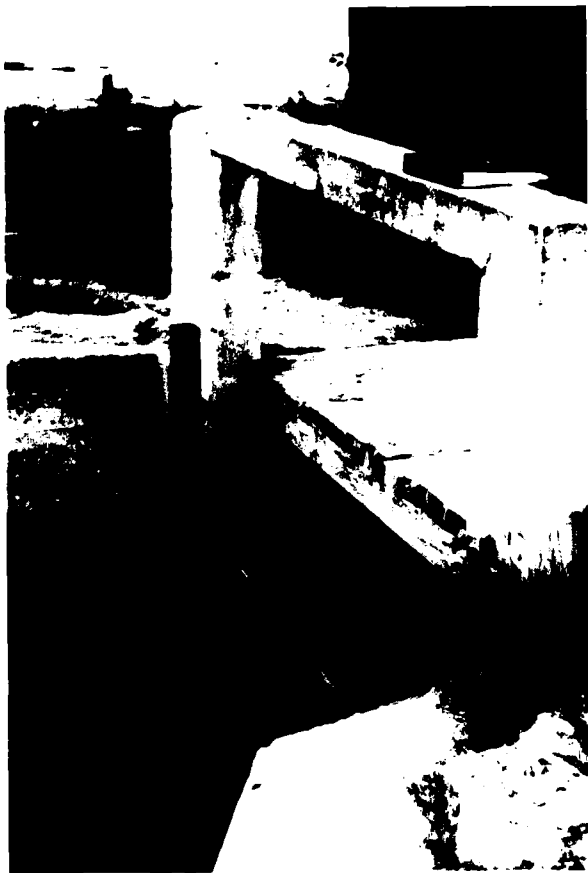
#3

In addition, spalling has taken place on the right support for the stop board angle (see photo #3) and also the railing at the bridge. Both have the minimal reinforcing (bolts and scrap metal) exposed.

RIGHT ABUTMENT FOR FOOT BRIDGE
AND SUPPORT FOR STOP BOARD
ANGLES

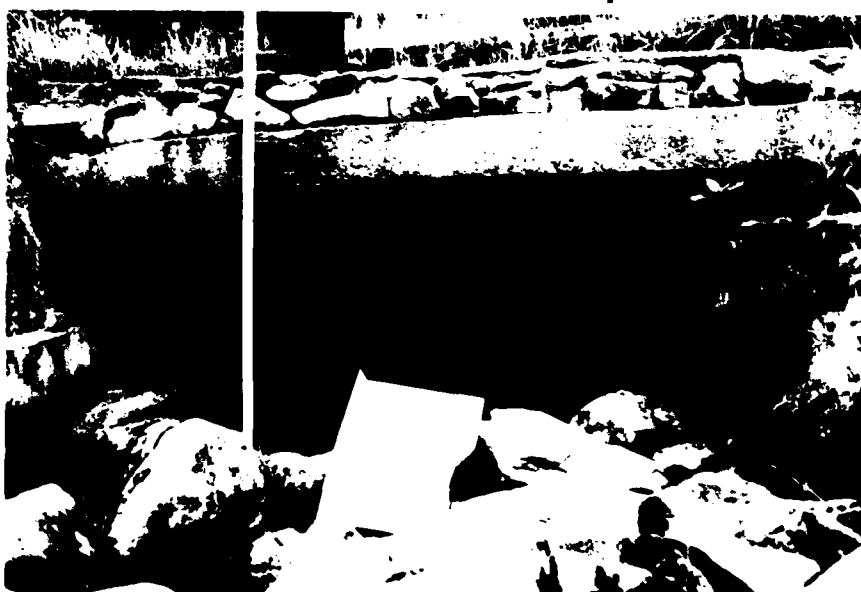
bed. There is an accumulation of debris in this portion of the channel which may accumulate at downstream culverts during high flows and reduce the flow-carrying capacity of these structures. The stream enters a 4.5 x 5.0-foot concrete box culvert near the side of a house and proceeds diagonally under the Belmont-Mt. Holly Road. After passing under the front corner of another house, the stream exits the culvert and flows against the foundation of another house approximately 30 feet downstream. After this point the stream flows through a rather wide, uninhabited flood plain area (see photos #6 and #7).

BOX CULVERT UNDER ROAD NOTE CONSTRUCTION

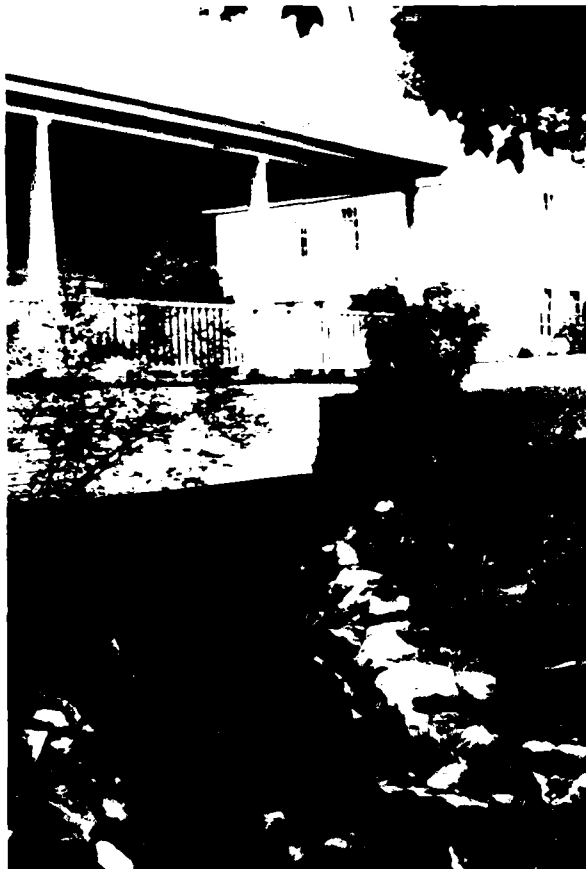
#7

DOWNSTREAM CHANNEL WHERE
BASEMENT WALL OF HOUSE
FORMS A PORTION OF BOX
CULVERT. LOOKING UPSTREAM

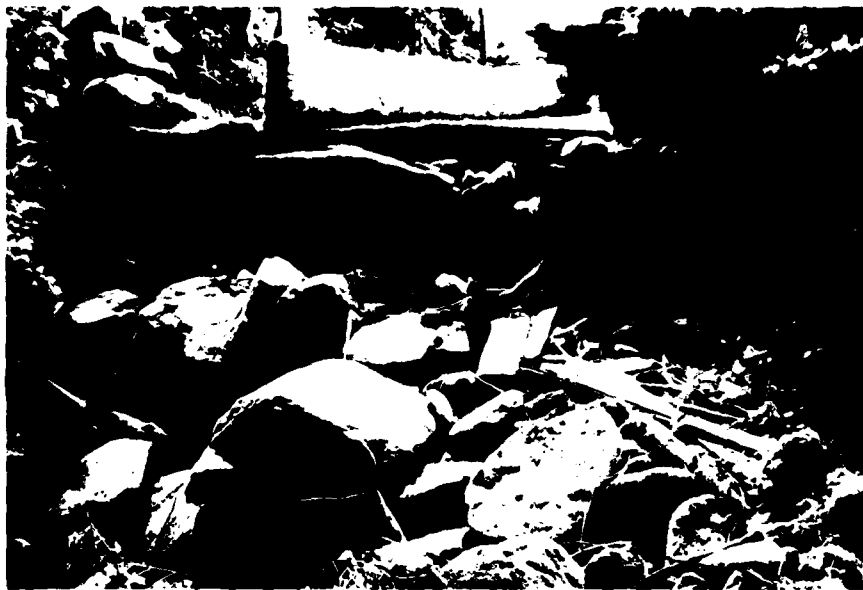
#9 RUBBLE AND DEBRIS AT END OF SPILLWAY NOTE 2" DIAMETER OUTLET PIPE
