SLATERSVILLE RESERVOIR UPPER DAM

RI 02501

PHASE I INSPECTION REPORT  
NATIONAL DAM INSPECTION PROGRAM

SEPTEMBER 1979

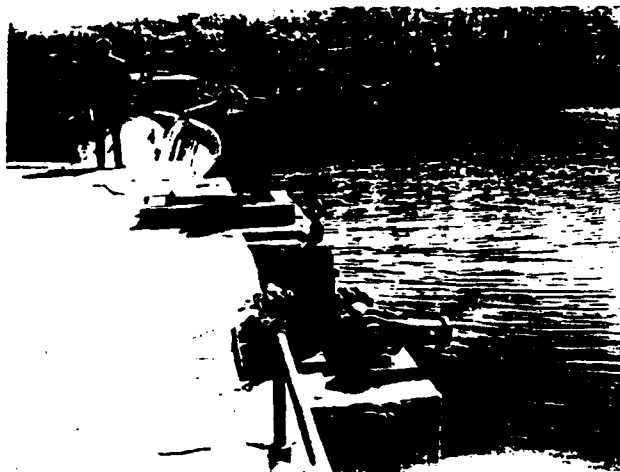
PHOTO #1

Draw-off gates closed--both gates appear to be inoperable because of condition of gate mechanisms. Bracket missing on gate nearest bank and entire mechanism missing on gate nearest spillway. See photo #1

LOOKING FROM WEST SIDE OF SPILLWAY. BOTH  
GATE MECHANISMS APPARENTLY INOPERABLE DUE  
TO MISSING PARTS OF GEARS, ETC

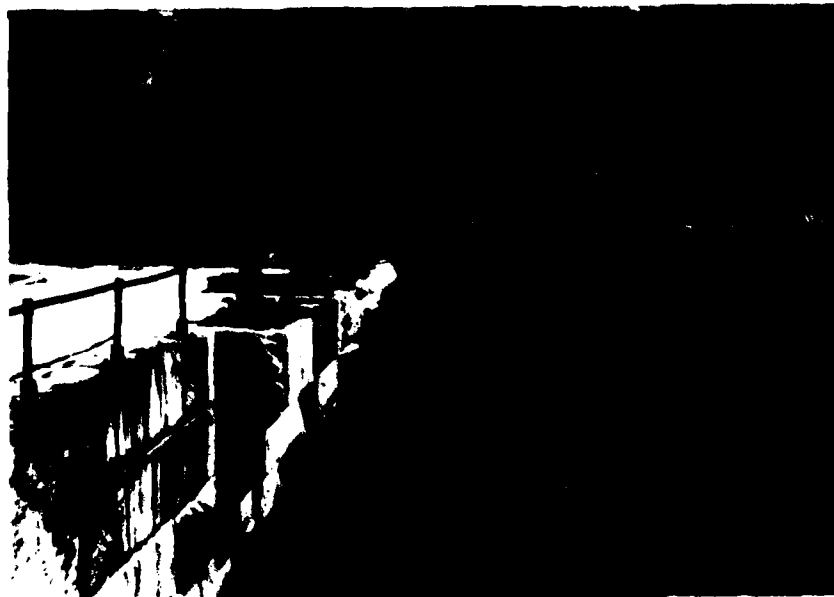
(1) Outlet Works Conduit. Low level discharge from Slatersville Reservoir Upper Dam is provided by two 6 ft. high x 3.5 ft. wide sluiceways controlled by hand operated wooden slide gates. At the present time the gates are not in an operating condition because of missing parts. However, if the gates were operational they would be capable of discharging about 1,200 cfs when wide open and the reservoir water surface level was at test flood level. With the water level at top of dam the discharge capacity would be about 1,170 cfs with both gates wide open.

6. Abandoned sluiceway operating mechanisms

(3) Study the feasibility of putting the sluice gates back into an operating condition and using them as a means to safely drain the reservoir.
