PAWTUXET RIVER BASIN
GLOCESTER, RHODE ISLAND

ONAGANSET RESERVOIR DAM
RI 01304

PHASE 1 INSPECTION REPORT
NATIONAL DAM INSPECTION PROGRAM

MARCH 1980

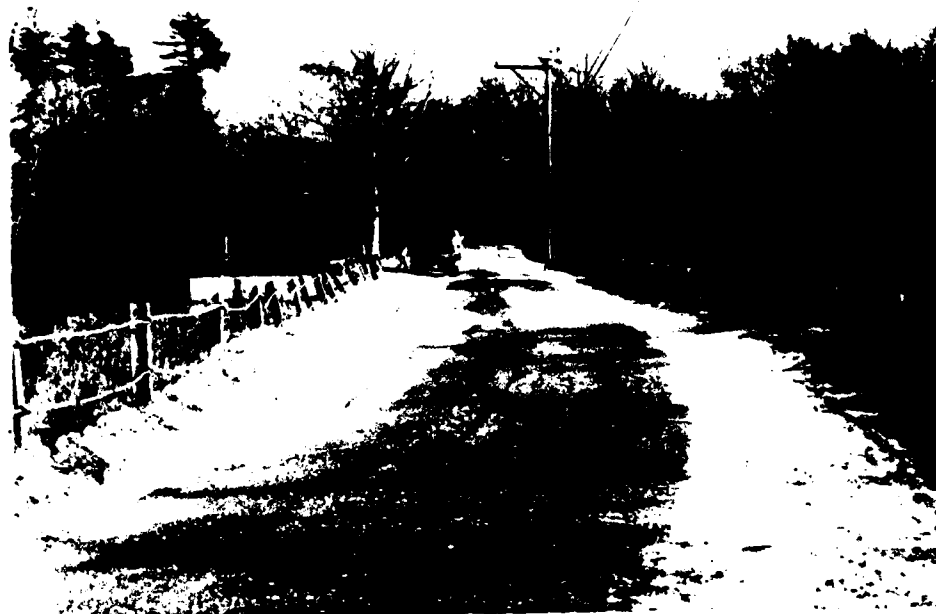
1. Crest - The crest of the dam is approximately 24 feet wide and supports George Allen Road. The pavement of George Allen Road is in need of repair and some erosion of the crest at the edges of pavement has occurred. The guard-rail system which consists of steel post and strung cable is also in need of repair and appears inadequate for present day conditions. Presently the Water Supply Board has added a new catch basin at the edge of the road near the outlet works gate mechanism. In addition, the Providence Water Supply Board has designed, but not constructed, an asphalt berm drainage ditch for George Allen Road to reduce the amount of erosion to the crest of the dam from roadway runoff. (See Photo C-4)

PHOTO C-4 - Crest of Dam looking from Right Abutment.

9. Complete the improvement to George Allen Road.
10. Resolve the differing elevations used by the Providence Water Supply Board on the reservoir documents and the published topography of the U.S. Coast and Geodetic Survey, as used on the Chepachet and Clayville Quadrangles. After resolvment of the discrepancy, re-evaluate the impact to downstream areas from a potential dam failure discharge by developing a downstream profile that will reflect the natural storage areas, flow restrictions and detailed topography.

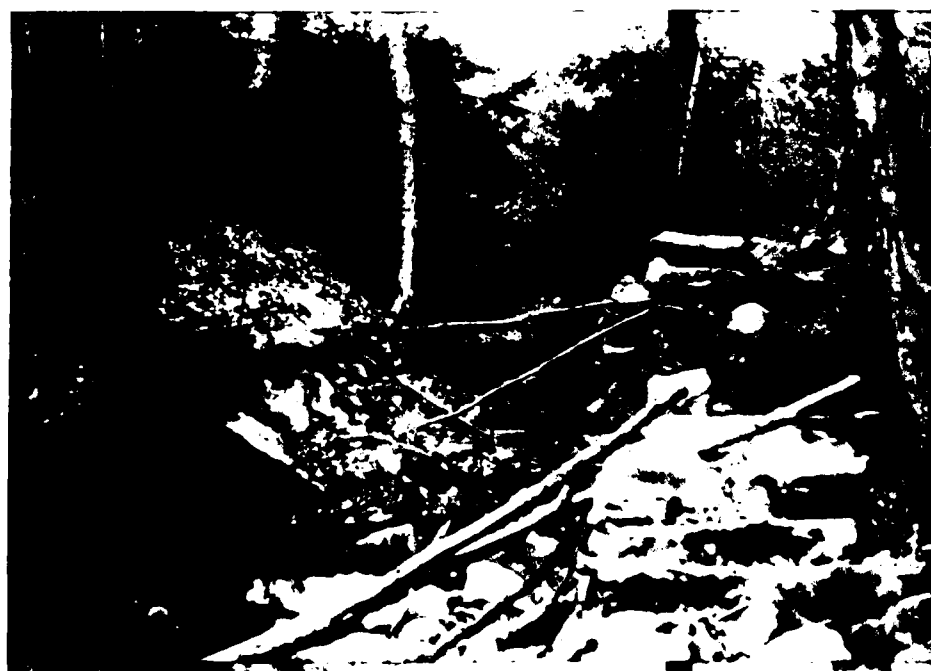
PHOTO C-10 - Downstream channel.
