NATIONAL PROGRAM FOR INSPECTION OF NON-FEDERAL DAMS
FLAT RIVER RESERVOIR..(U) CORPS OF ENGINEERS WALTHAM MA
NEW ENGLAND DIV FEB 81

4. TITLE (and Subtitle) Flat River Reservoir Dam NATIONAL PROGRAM FOR INSPECTION OF NON-FEDERAL DAMS		5. TYPE OF REPORT & PERIOD COVERED INSPECTION REPORT

Based on a visual inspection of the site, the main dam embankment and appurtenances are considered to be in FAIR condition. The earth dike comprising the right portion of the dam, however, is considered to be in VERY POOR condition due to serious seepage problems which could lead to a piping failure.

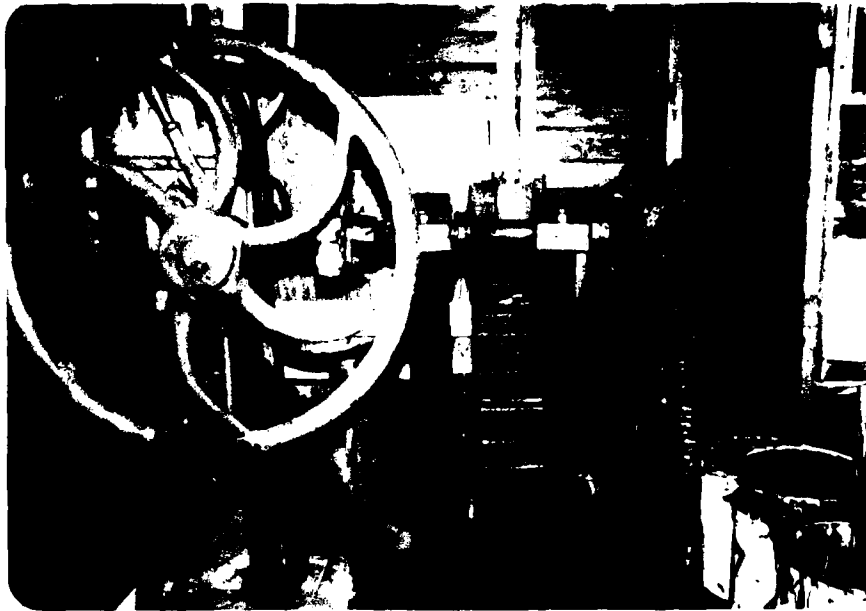
PHOTO C-13: Control mechanism for middle gate of intake structure.

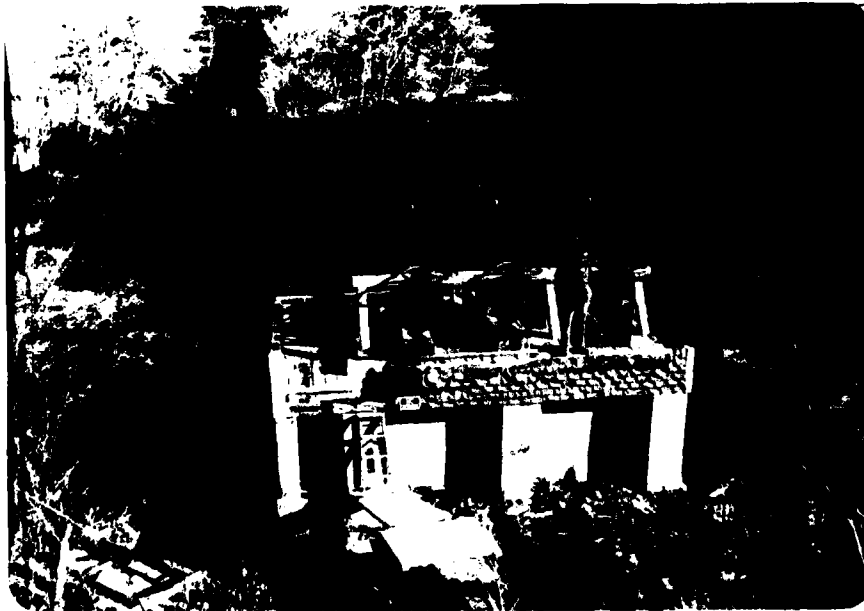
4. Outlet Structure and Gates. The outlet gate structure is located at the downstream toe of the dam (Photo C-14) and is in poor condition. Only the floor remains of the original wooden superstructure that housed the controls for the outlet gates. The wooden floor boards are rotted and unsupported on the right downstream side. Concrete on the downstream face of the outlet structure is spalled up to 3 inches into the face, and several cracks were observed in construction joints at the bottom of the structure. Access to the outlet structure is difficult. Loose plywood planking forms a crude bridge to the elevated structure and is in poor condition. An unanchored wooden step-ladder provides the only access to the control mechanisms for the outlet gates which are located at the downstream end of the outlet pipes. The left gate is inoperable. Just above the outlet gatehouse, each conduit has a short 48" diameter surge tank with a rotten wooden cover. Should the outlet gates be closed with the inlets open, the tank covers would be washed away by flow out of the top of the surge tanks. The outlet gatehouse cannot control outflow from the reservoir because of the condition of the surge tank covers.

PHOTO C-14: Outlet structure and downstream channel from crest of dam.

6. Further investigate the poor condition of the outlet gate structure and design the repairs or replacement necessary to restore it to an operable condition, if required.
