COMMANDANT'S INTERNATIONAL TECHNICAL SERIES

Fire Aboard the M.S. SCANDINAVIAN SEA
on March 9, 1984
Technical Assessment

USCG CITS-85-1-1

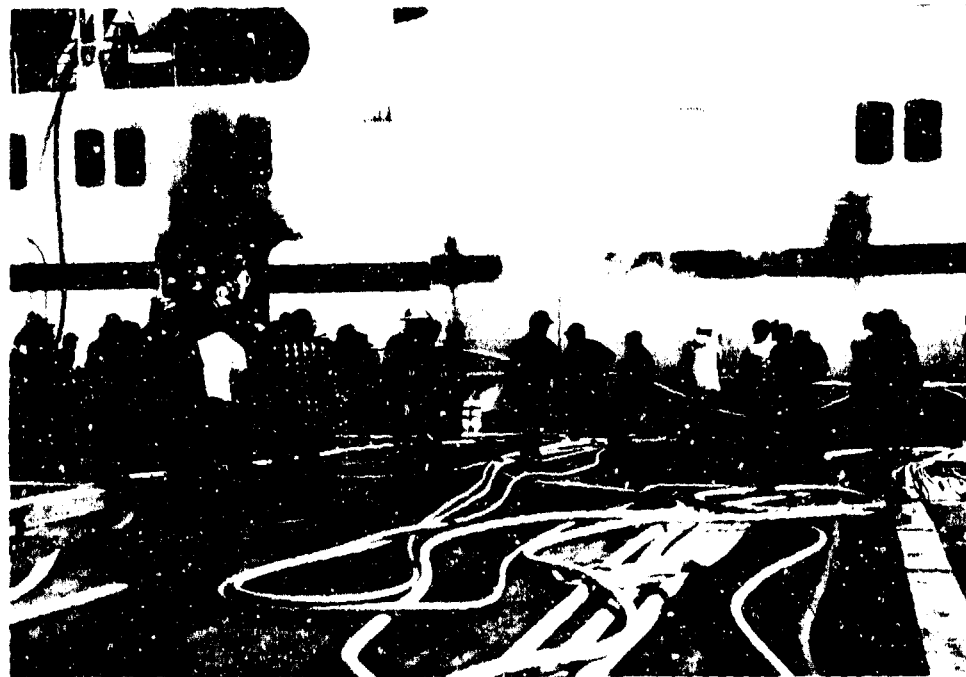
Photo 3 - Firefighting Operations

Main entry into the vessel for firefighting operations was provided through the door shown in Photograph 3 that led to the upper deck. This door provided entrance to the vessel two decks above where the fire was reported to have originated.

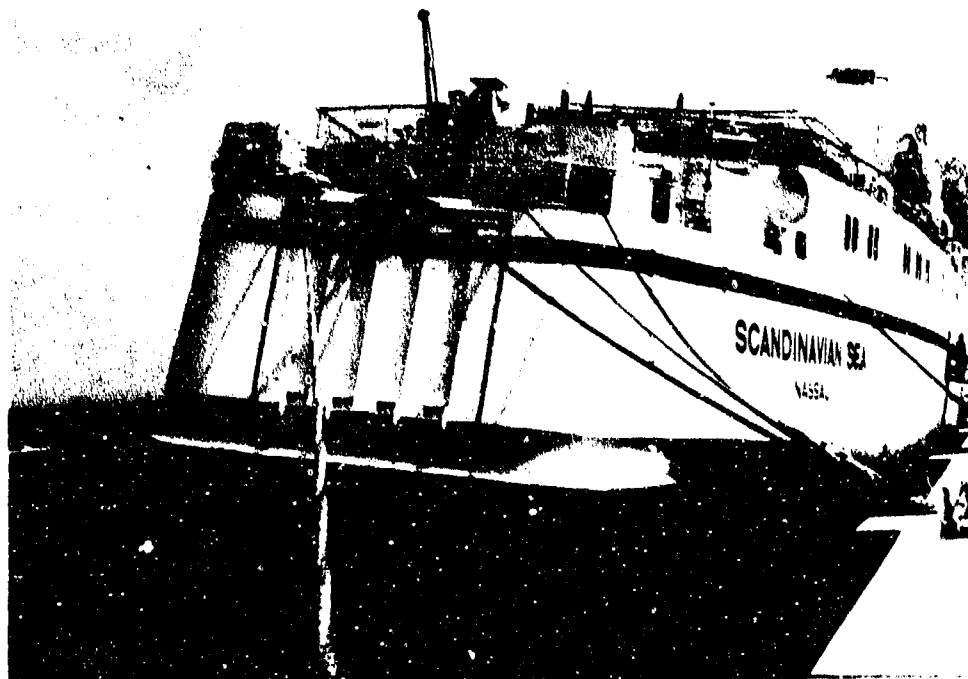
Photo 4 - SCANDINAVIAN SEA listing to starboard

Firefighting operations were delayed at various times as a result of a list that developed as large quantities of water were pumped into the vessel to extinguish the fire and to cool decks above "A" deck. Photograph 4 is a view from the stern showing the list.

5. Shipboard fires should be fought so as to minimize the degradation of stability as the effort progresses. When a choice exists, fight the fire as low in the vessel as possible and dewater as high as possible. This has the effect of lowering the center of gravity or at least minimizing the rise. The extent of longitudinal flooding should be limited as much as practicable. The degradation of stability due to free water depends on several factors. Among them are the length of the flooded compartments, the angle of heel of the vessel, the height of the compartment above baseline and the percentage to which the compartment is full (i.e. 10%, 20%, etc.). This percentage affects the equilibrium heel but not the free surface correction. In general, limiting the longitudinal extent of the flooding is most readily accomplished and is very effective.

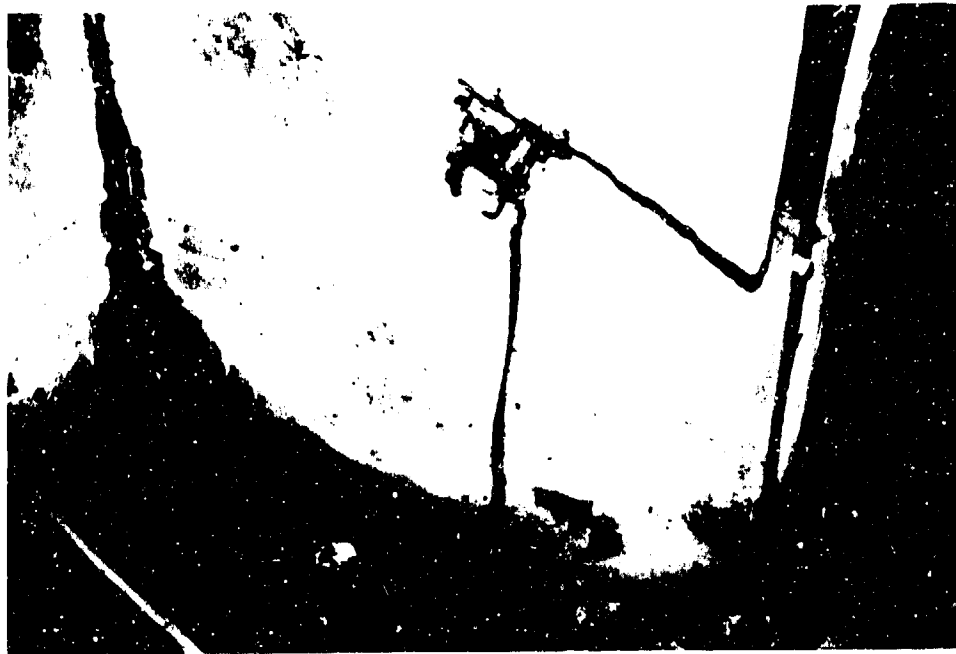
Photo 11 - Electrical cutlet

Since electrical problems had been reported in cabin 414, particular attention was directed to detecting evidence of arcing. Photograph 11 is the remains of the outlet near the desk area where the radio was reported to be plugged in and did not work. This outlet was located about three feet above the deck and about two feet around the corner from the desk alcove. Photograph 11 shows the remains of the electrical wiring that leads to this receptacle. The wires had the appearance of having melted through with no signs of arcing.
