REPORT
MRL-R-956

WELD REPAIR OF CRACKED DEFA
CANNON MOUNT FRAMES

J.C. Ritter, R.H. Phillips and B.F. Dixon

C Commonwealth of Australia
FEBRUARY, 1985

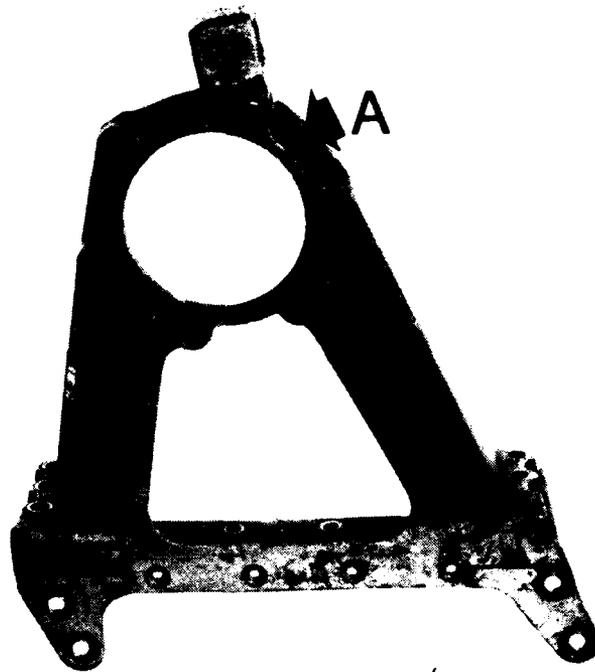
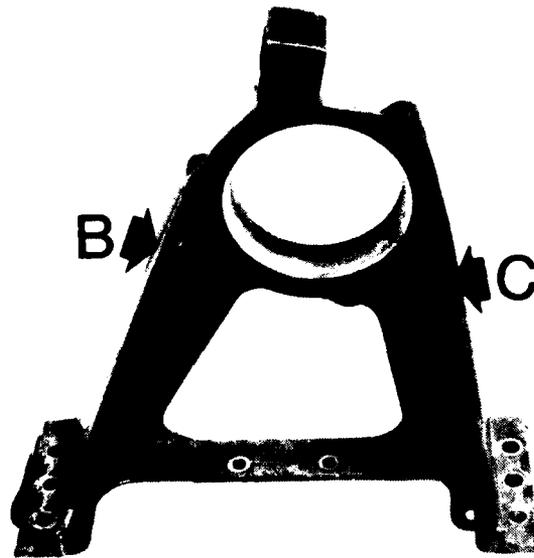
FIGURE 1

Previous inspection of cracked frames at MRL had shown that even the most severe cracks were repairable. All cracks in positions A, B and C (Fig. 1) were therefore weld repaired, regardless of size. Cracks were ground out using specially shaped tungsten carbide cutting burrs in a pneumatic rotary grinding tool. In this crack removal operation a 'U' shaped groove with tapering sides was required as the most suitable repair preparation. This geometry was chosen to minimize the possibility of lack of side wall fusion during subsequent welding.

- (i) Cracks were totally removed where they had not propagated through a complete section. This situation commonly arose at position A, Fig. 1. During the process of crack removal it was frequently necessary to check for complete elimination of the crack using the fluorescent magnetic particle technique.
- (ii) Where crack had propagated through a section, as could occur in position B (Fig. 1), 0.5 mm of metal was left to help support the subsequent weld root run. The aim here was to completely fuse out the remaining crack in the first root pass. The weld preparation to achieve this is shown diagrammatically in Figs 3. A grooved copper backing strip, especially manufactured for this operation, was used for additional support during welding (Fig. 4).

Location of cracks in Defa front mount frames. Cracking was most common in sites A and B.

In the case where cracking had occurred at only one or two of the identified recurrent sites, preventative action was taken to delay fatigue crack initiation at the remaining sites (Fig. 1), by coarse polishing over an area about 30 mm across using a pneumatic rotary polishing wheel, followed by fine hand polishing. A final fluorescent magnetic particle inspection was then applied.

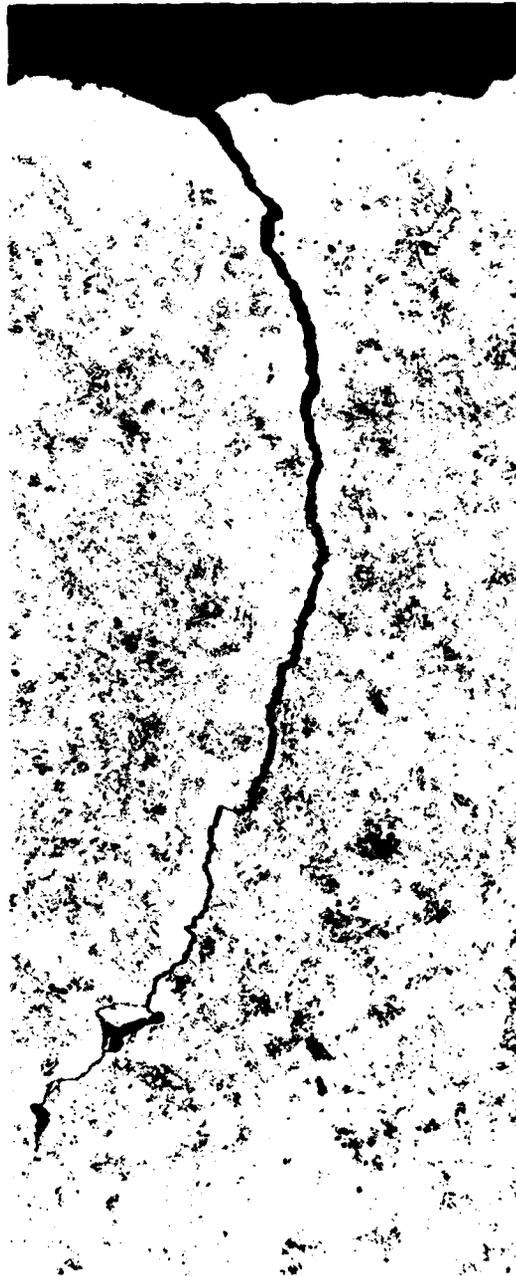
FIGURE 2

1. The upsurge in the incidence of cracking in these front mount frames has been identified as fatigue cracking caused by the harmful effect of a decarburized layer on the surface of the heat-treated steel castings.

Initiation of a fatigue crack in the decarburized surface layer of a frame.

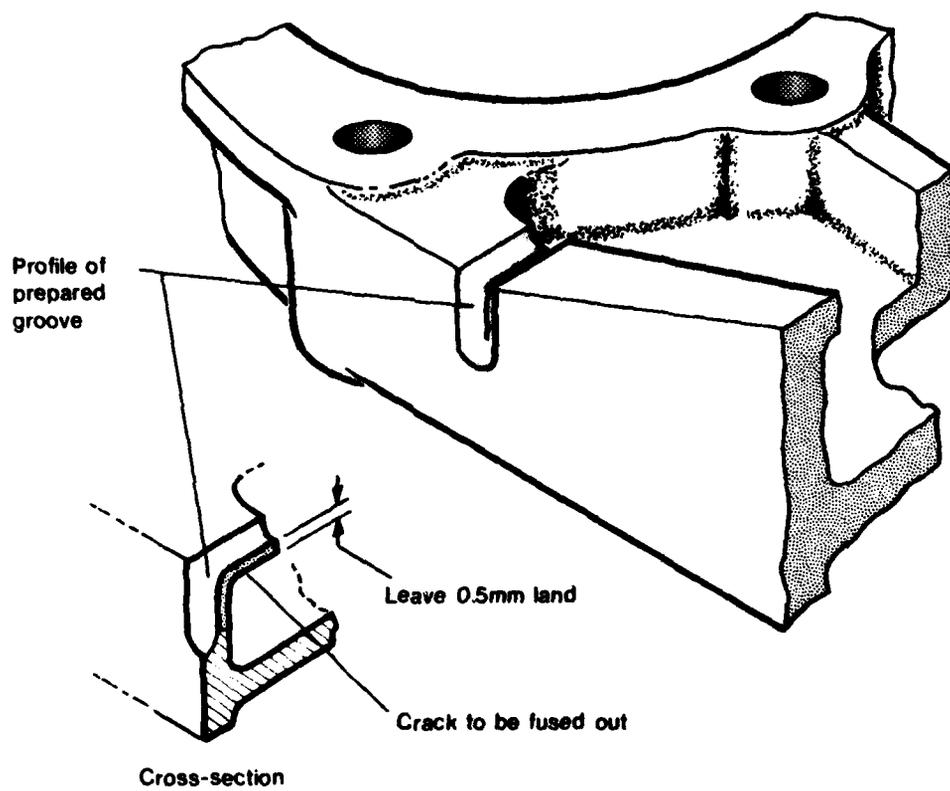
FIGURE 3

Recommended weld preparation for through-thickness cracks in position B, shown in Fig. 1.

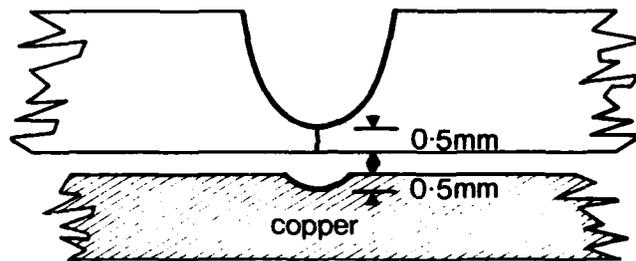
FIGURE 4 Schematic diagram of weld preparation and copper backing strip for through-section cracks.

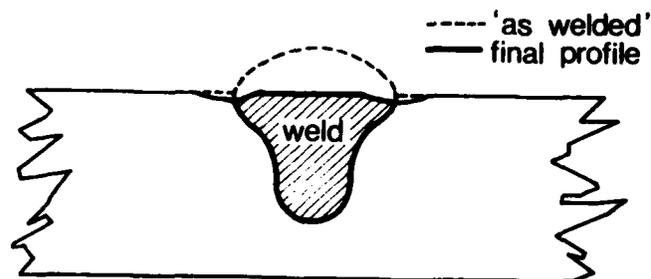
FIGURE 5 Schematic diagram showing blending out in weld toe areas.

The weld reinforcement was then ground off using tungsten carbide cutting burrs and the weld toe areas carefully blended out as shown in Fig. 5. A pneumatic rotary polishing wheel was used in the final blending-out operation. This polishing was done to minimize the propensity for crack initiation in the region of the weld toe, a common site for fatigue cracking, where the geometric notch effect of machining grooves and fusion boundary is compounded by the metallurgical notch effect of the weld.

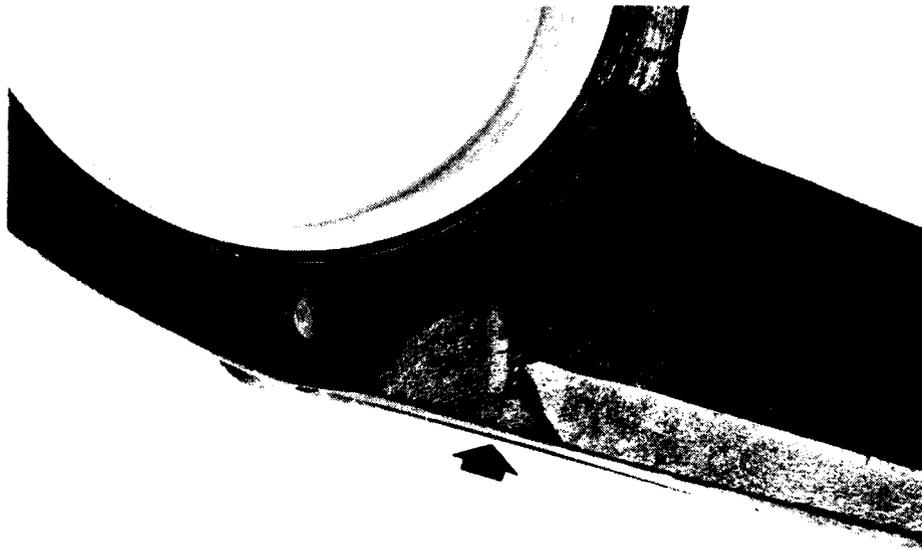
FIGURE 6

Analysis was undertaken on one crack, labelled B in Fig. 1, and shown more clearly in Fig. 6.

When broken open, the crack was found to extend some 8 mm into the section. It exhibited features characteristic of fatigue: at low magnification a generally flat, slightly fragmented surface (Fig. 7) with a few prominent progression markings. Scanning electron microscopy (SEM) at high magnification revealed many areas of striation markings relatively free from mechanical damage, and of noticeably uniform spacing (Fig. 8 (a)). A single origin at the surface of the section permitted reliable crack length measurement to any point.

Detail of the crack shown at B in Fig. 1. The section shown had been subjected to bending stresses across the crack (arrowed), causing flexure convex to the plane of the page. The crack initiated at a machining groove, at the periphery of the machined surface.

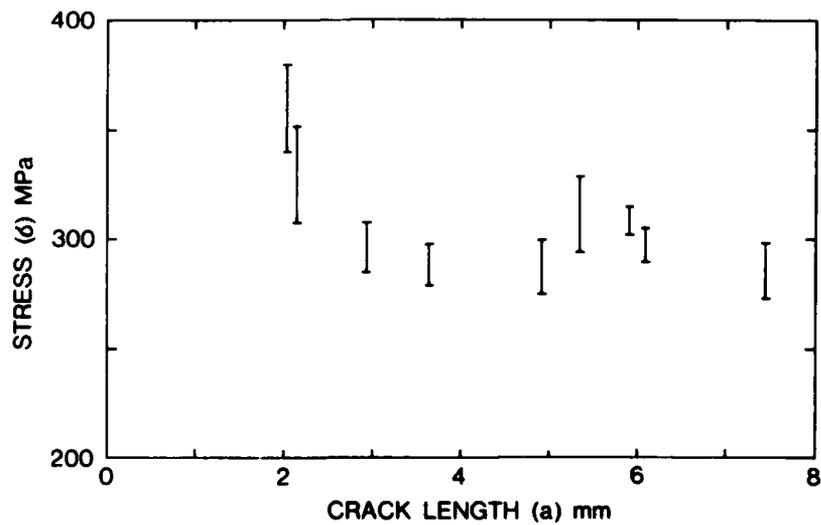
FIGURE 11

The results in Table 3 are presented graphically in Fig. 11. Despite considerable scatter in fractographic measurements, a reasonably confident estimate of 300 ± 30 MPa for crack driving stress is obtained provided that two values from measurement at $a = 2$ mm (where measurement was more difficult) are given less weighting. The scatter bars in fact reflect

Estimates of the fatigue crack driving stress in the cast frame based on measurements of the crack shown in Figs. 7 and 8.
