MISCELLANEOUS PAPER CERC-85-9

# SIDE-SCAN SONAR OF BAILEY'S DAM, RED RIVER, ALEXANDRIA, LOUISIANA

Joan Pope

September 1985

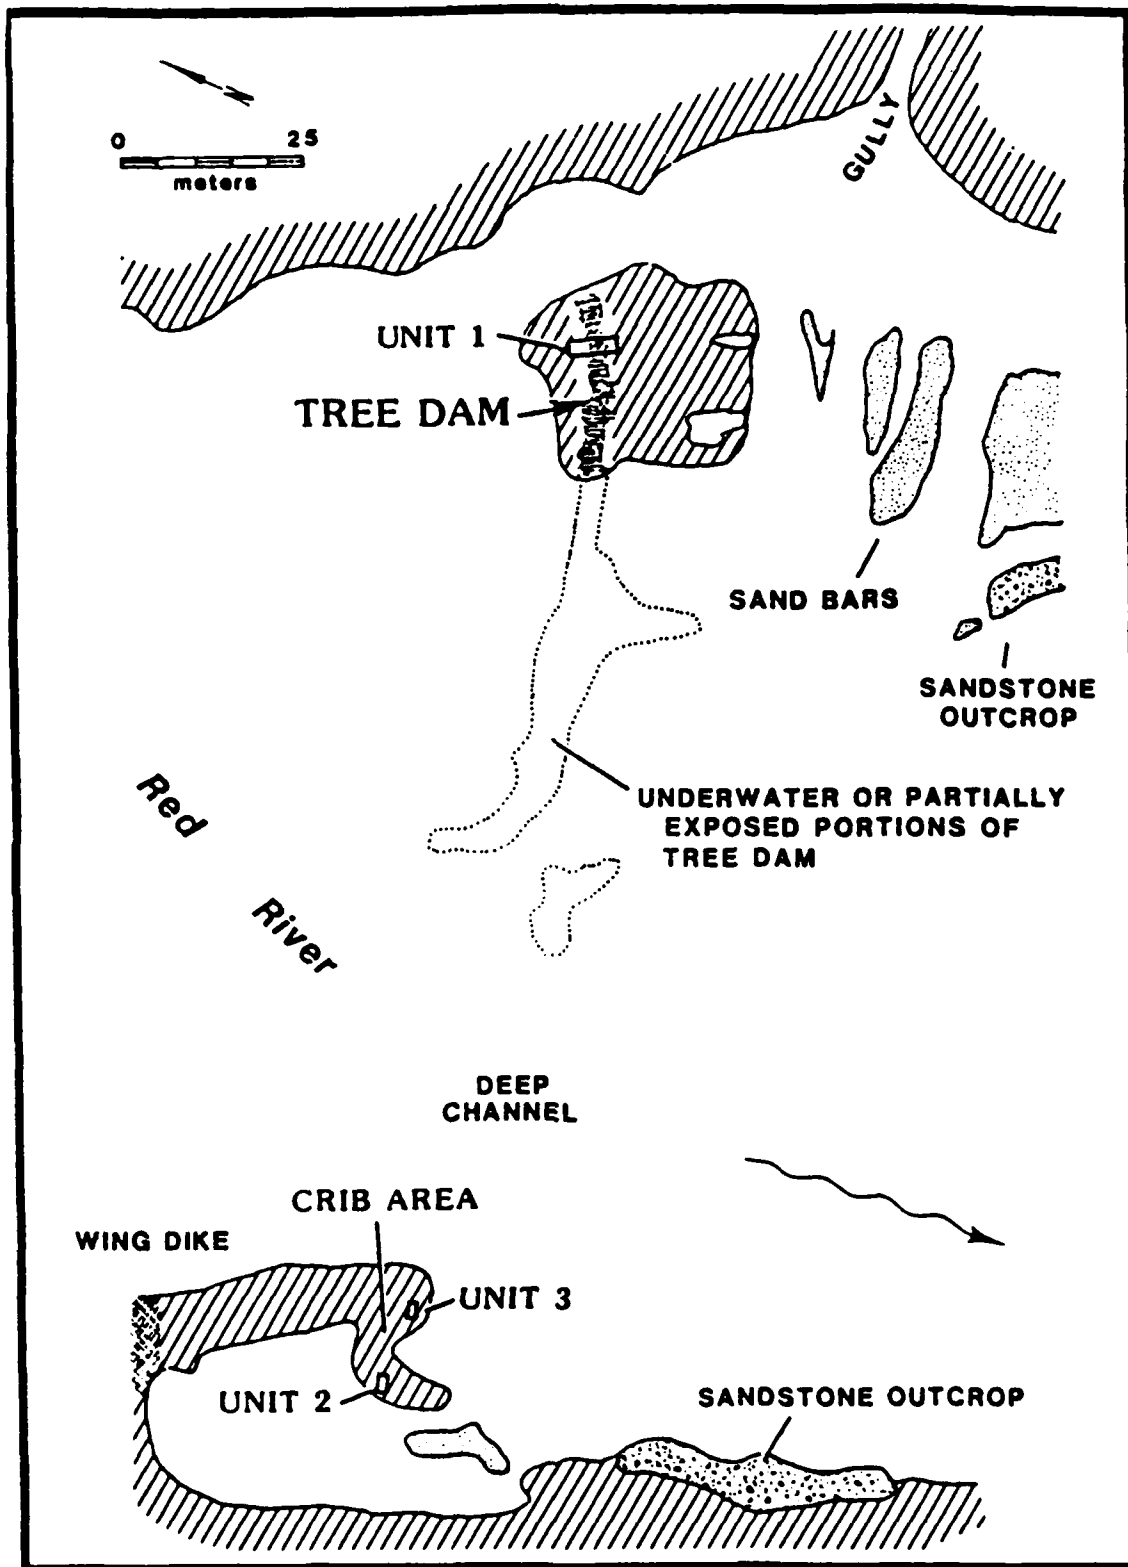
2. Although the lower dam is accessible during very low water, both structures were completely submerged at the time of this survey and navigation of the Red River was not impeded by the presence of these structures. Figure 2 is a stylized drawing of the original Civil War project. A large portion of the lower dam was constructed of layers of cut timber fashioned into a "Tree Dam" which extended across approximately half the channel from the north bank, a deep channel or "chute" across a third of the channel, and a few standard timber cribs along the south bank (Figure 3). Originally the upper dam consisted of a line of timber cribs built halfway across the channel from the south bank, a chute, and an arrowhead arrangement of a Tree Dam and a "Bracket Dam" built out from the north bank (Figure 2). Figures 1 and 4 may be used to illustrate the approximate location of these structures relative to modern features.

Figure 3. Plan of present condition of Lower Bailey's Dam  
 (Coastal Environments, Inc. 1984)

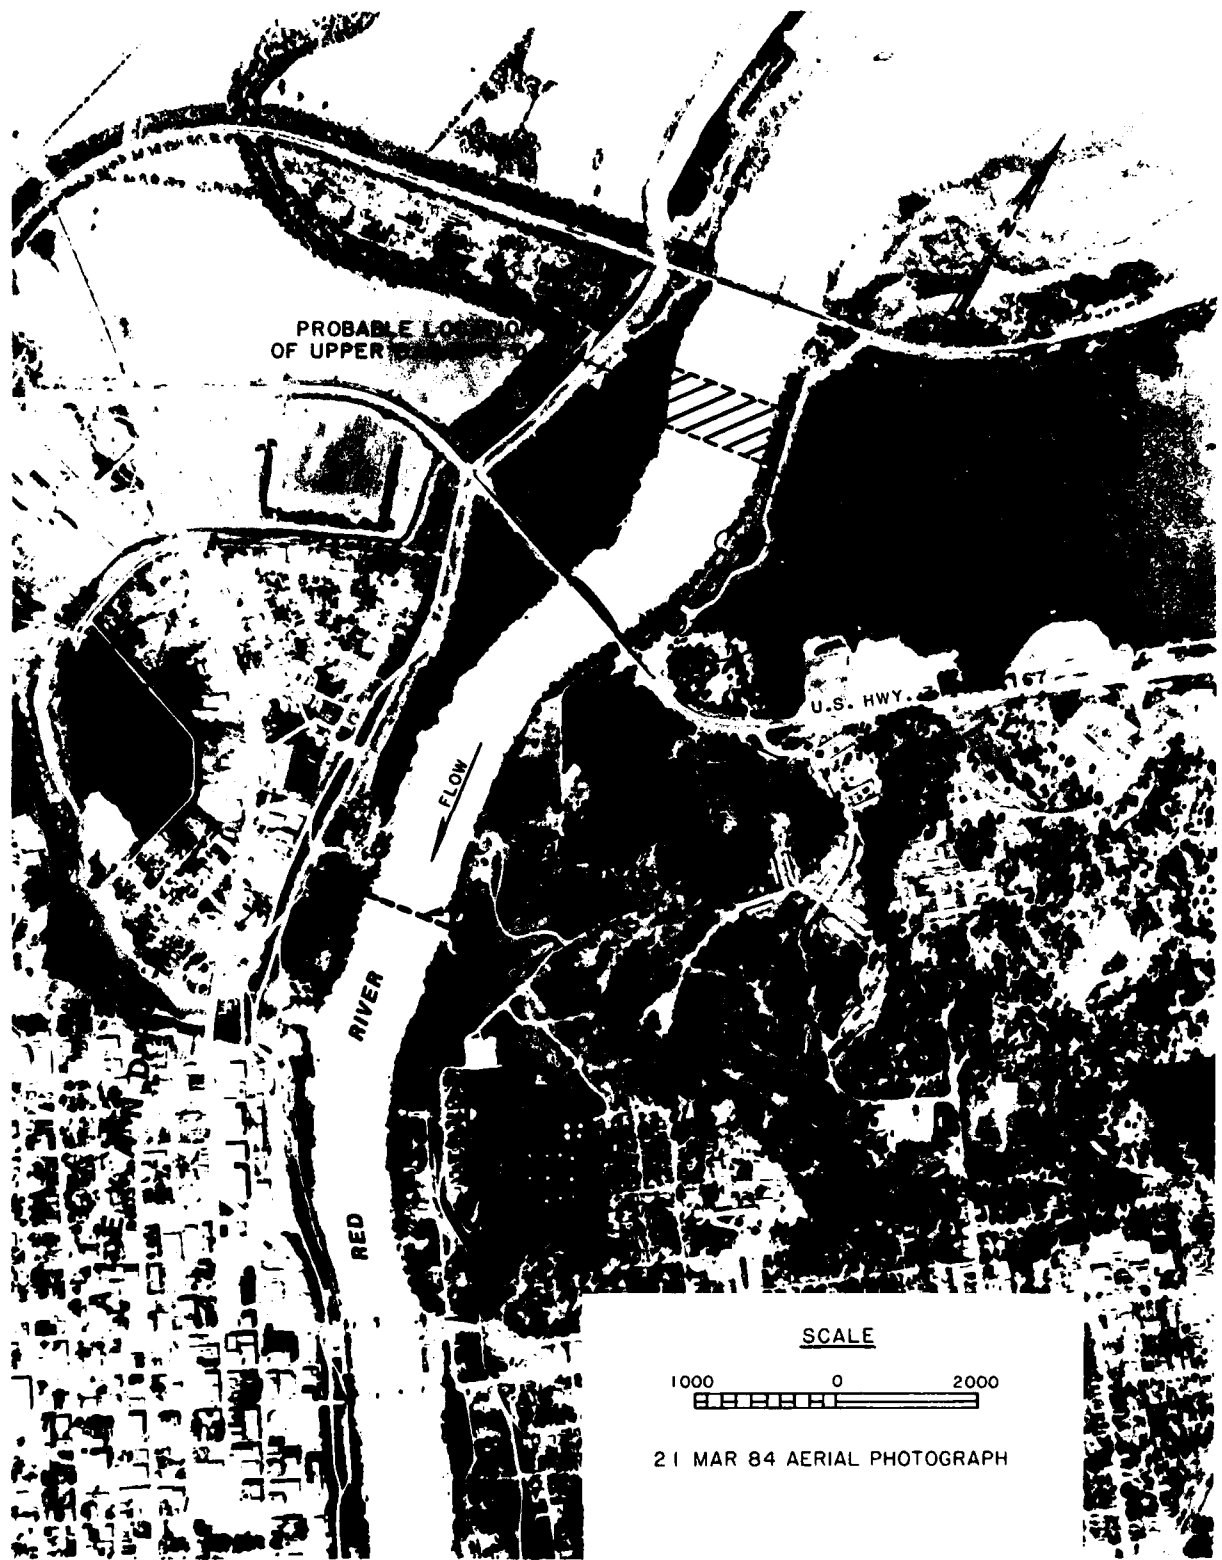
6. A series of runs was conducted from the Highways 71, 165, 167 Bridge under the Missouri-Pacific railroad bridge, to the new boat launching ramp just downstream of Bayou Rigoleta. As a result of this survey reasonable location for Upper Bailey's Dam has been identified. The survey continued to identify a cross-channel lineation or masking and even the suggestion of crib-like features in the midchannel area at a location approximately midway between the first and second reference poles downstream of the railroad bridge, labeled "C" and "D" in Figure 4 and the example sonographs (Figures 10-13).

Figure 4. 21 Mar 84 aerial photograph
