AGARDograph No. 278

AGARD Corrosion Handbook Volume 1 Aircraft Corrosion: Causes and Case Histories

AIRCRAFT CORROSION: CAUSES AND CASE HISTORIES

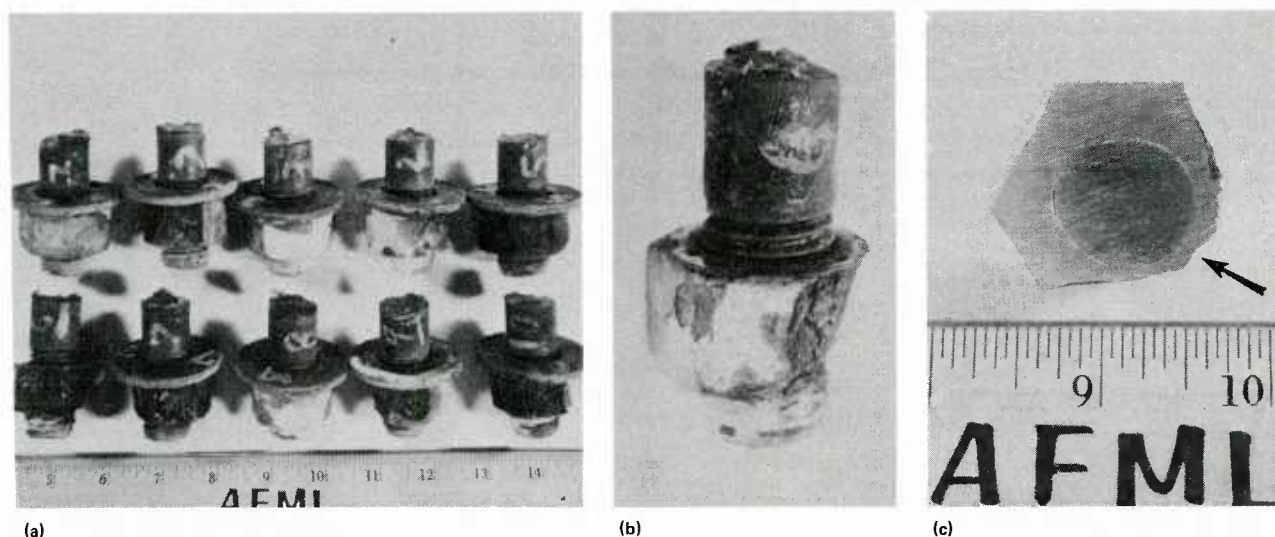
Visual and optical examination verified that considerable corrosion existed on all part surfaces. However, the most severely affected areas were found to be on the surfaces of the nuts, as shown in Figure 7-10(b). Cross-sections through the nuts and bolts revealed the severity of corrosion, and showed that nearly one-third of the cross-sectional area on all ten nuts had been lost to corrosion. The depth of corrosion, in some areas, extended almost to the bolt surface, as shown in Figure 7-10(c).

Fig. 7-10 Corrosion of structural steel fasteners

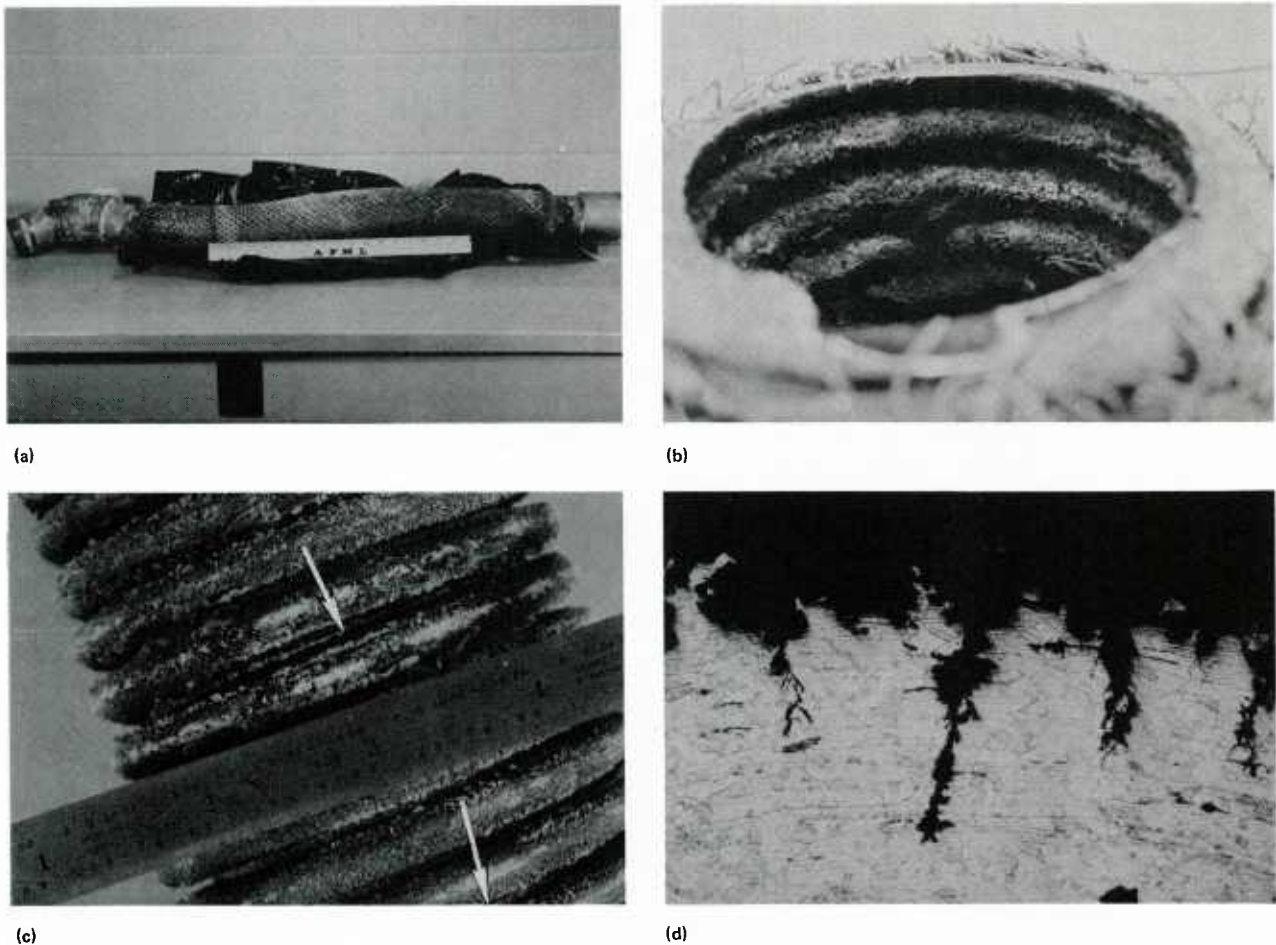
Visual examination of the flexible stainless steel pipe, Figure 7-11(a), revealed the outside surface to be covered with a light tan powdery residue or corrosion product. A dark brown residue was found on the inside surface when the pipe was sectioned (Fig. 7-11(b)). The wire mesh was stripped from the convoluted flexible pipe and large cracks were found running circumferentially around the inside or small radius bends of the convolutes (Fig. 7-11(c)).

Fig. 7-11 Hydrofluoric acid corrosion of an austenitic (316) stainless steel pipe

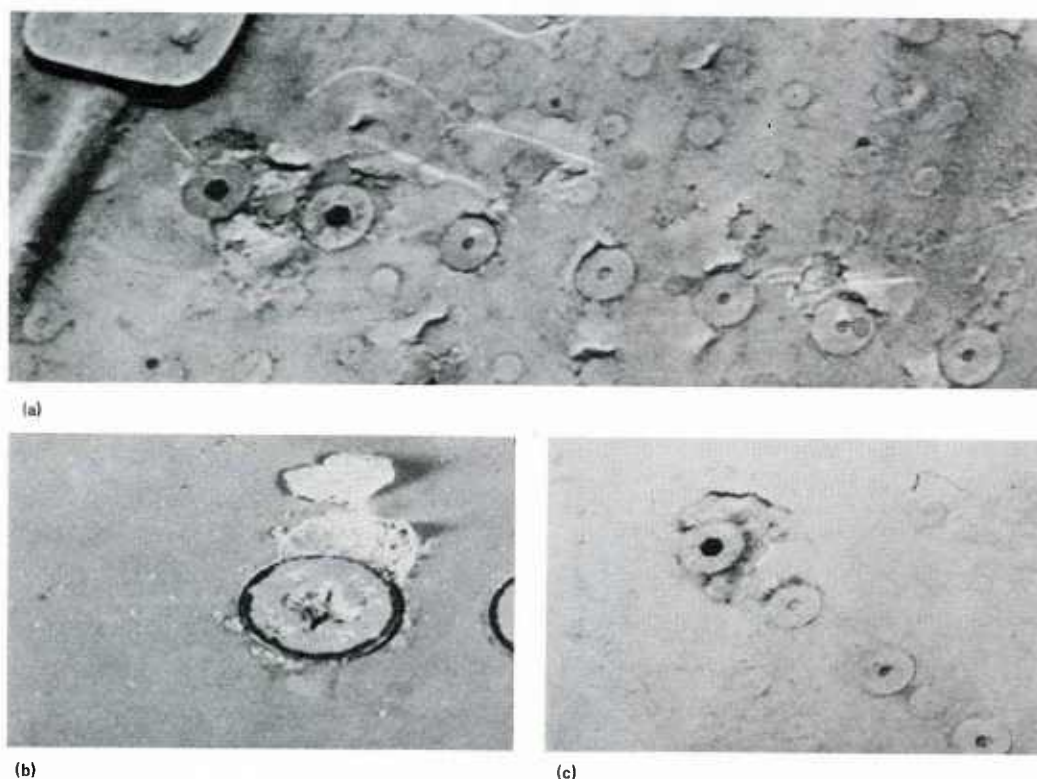
Fig. 8-1 Galvanic corrosion occurring around cadmium plated steel fasteners in a 7075-T6 aluminium skin

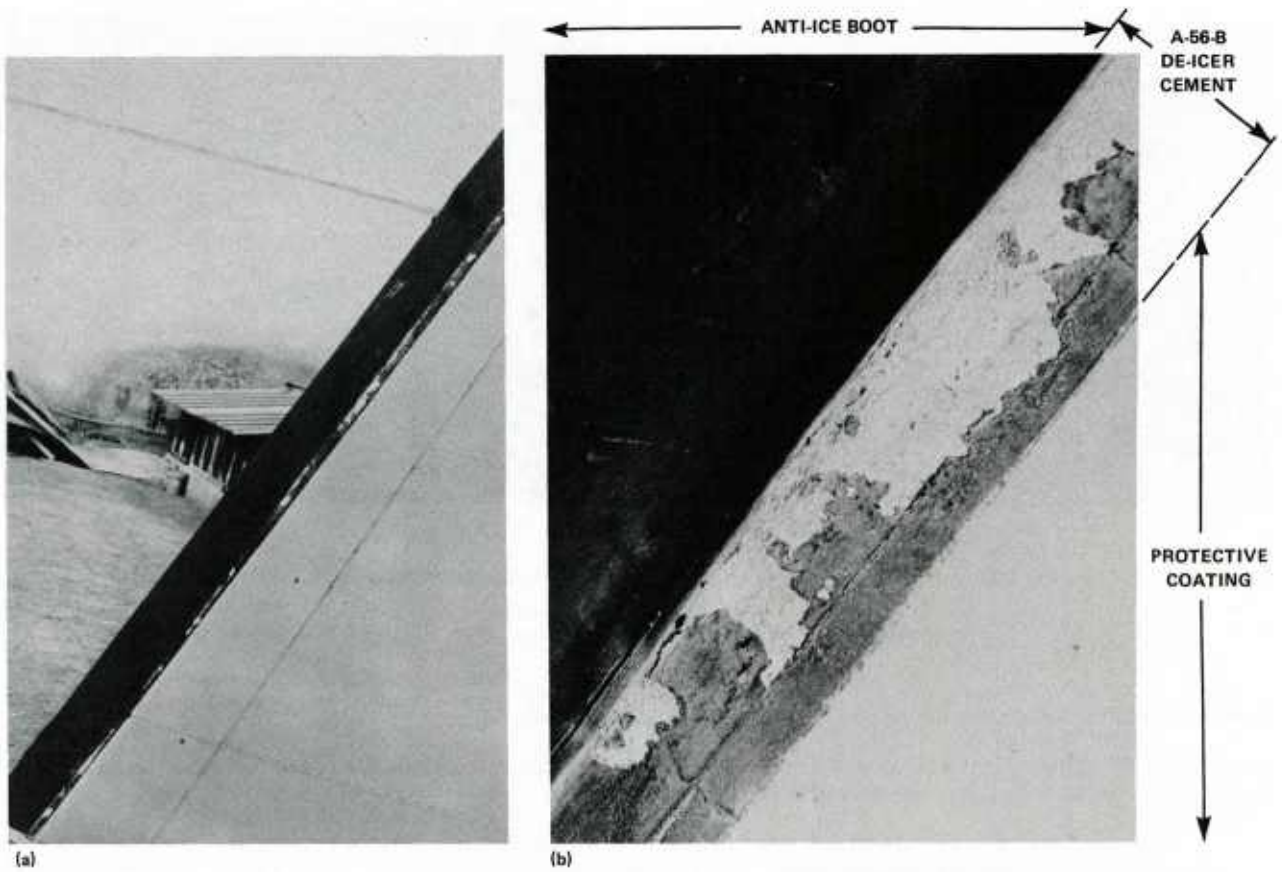
Fig. 8-4 Galvanic corrosion in an aluminium alloy skin due to contact with a conductive cement

The personnel involved in the repair and overhaul of this aircraft recommended the use of a rain erosion resistant anti-static coating system (MIL-C-7439) to replace the conductive de-icer cement. The important requirement is to avoid the use of a conductive cement in exposed contact with the aluminium. In the example cited, corrosion damage to the 2024 aluminium would have been much reduced had the bare cement been covered by a protective coating to prevent mechanical damage to the cement and to prevent the intrusion of water.

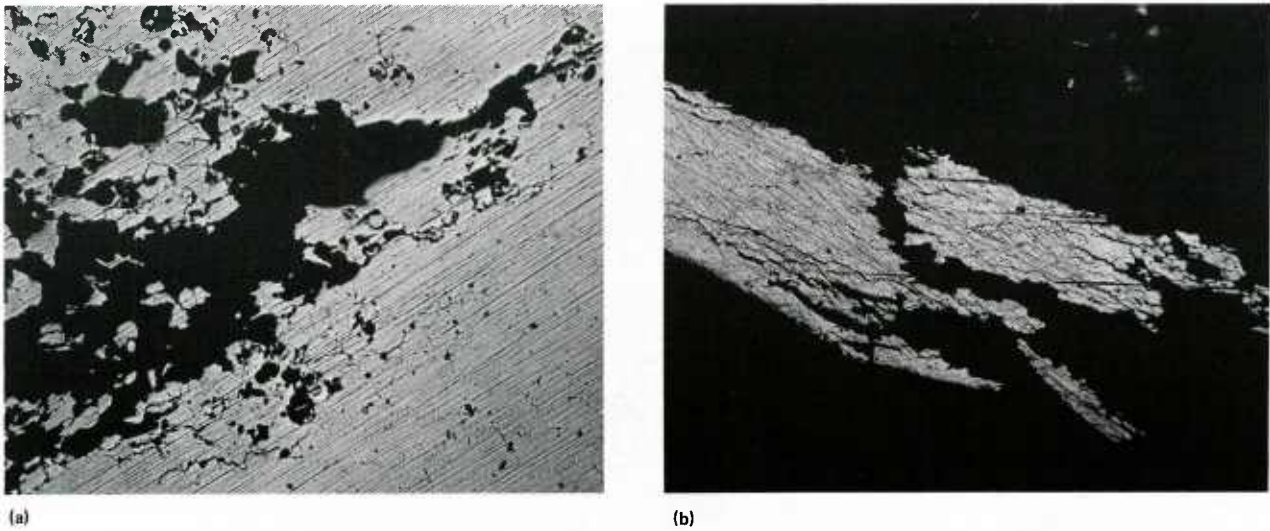
Fig. 8-6 Metallographic sections through the aluminium skin shown in Figures 8-4 and 8-5

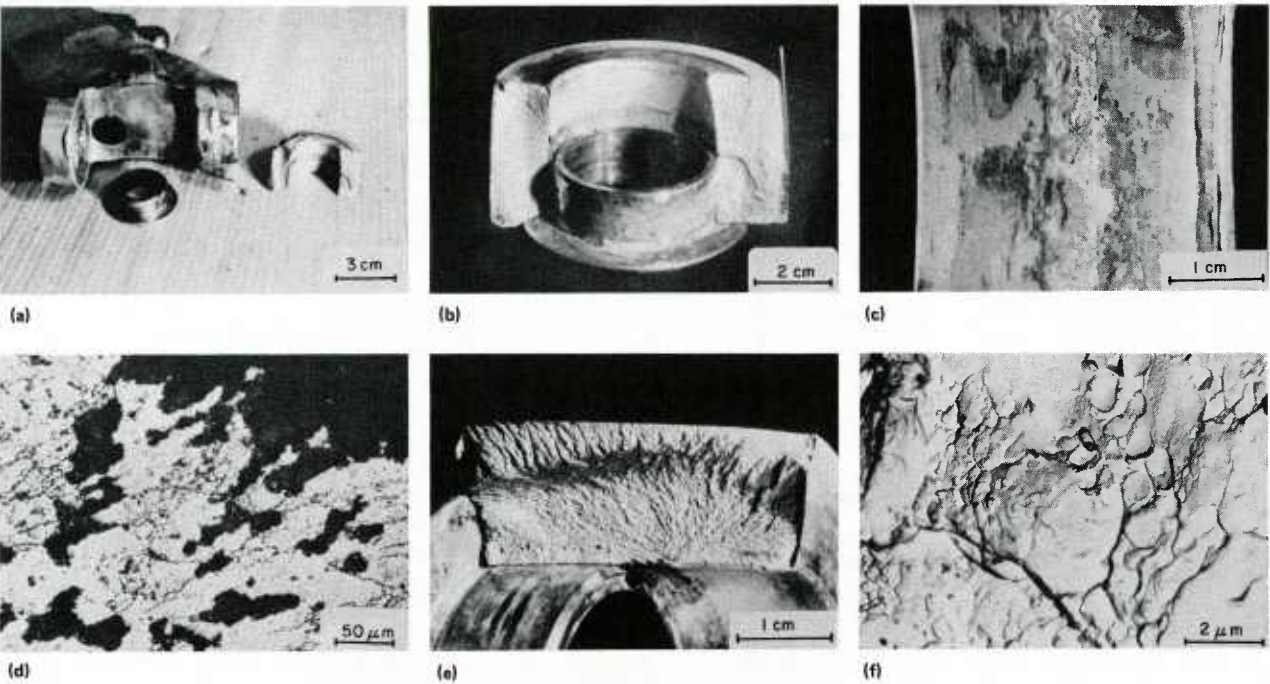
Figures 8-7(e) and 8-7(f) show one of the fracture surfaces produced by the failure. Figure 8-7(e) shows that the fracture originated at the site of the corrosion damage. Electron fractography of the same fracture surface (Fig. 8-7(f)) revealed mainly ductile dimples indicative of ductile failure.

Fig. 8-7 Galvanic corrosion in a 7075-T6 king pin lug of a fighter aircraft main leg

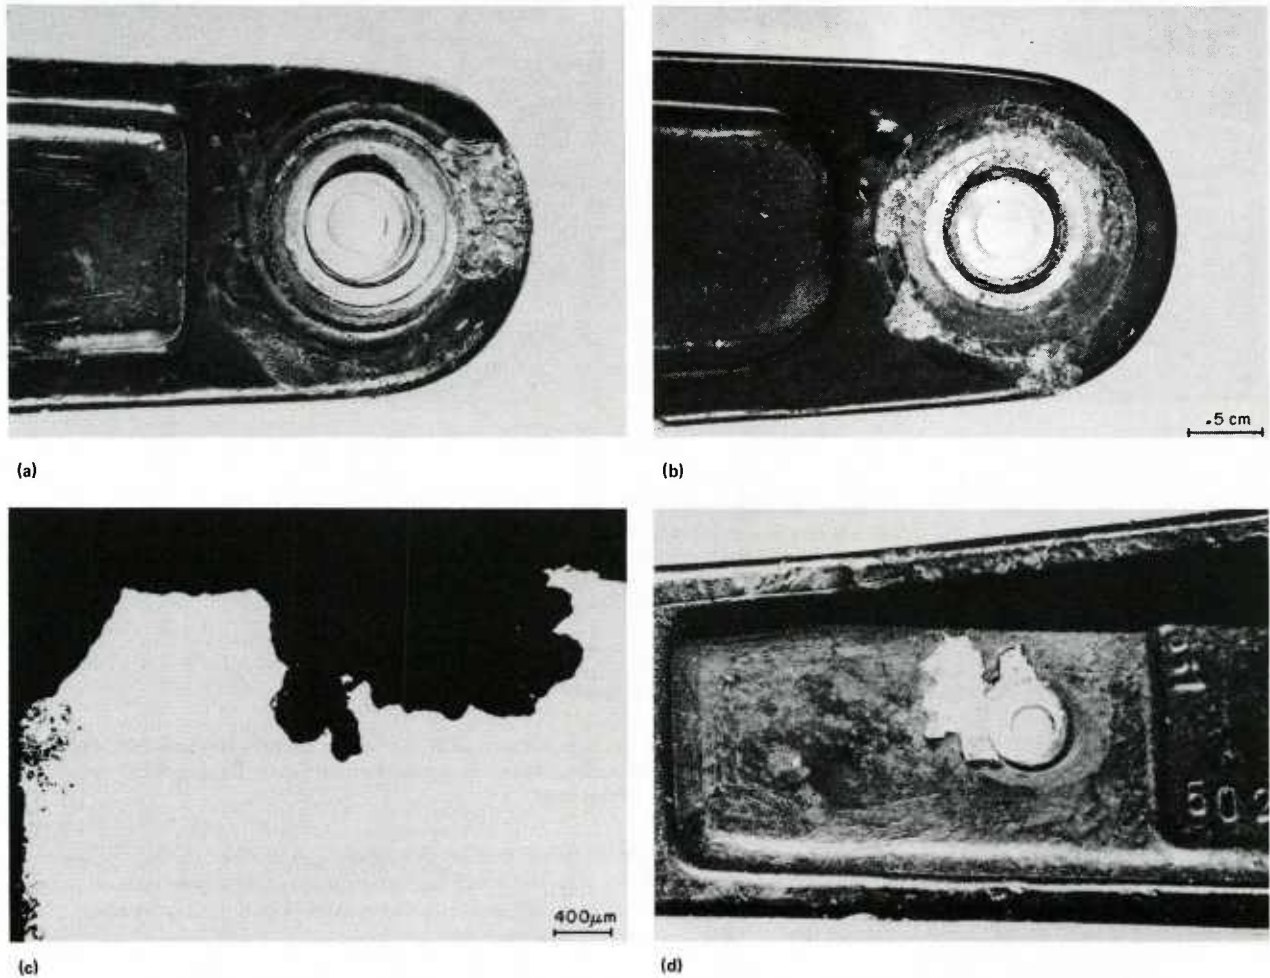
The control levers of a flap deflection mechanism of an aircraft were made from a magnesium casting alloy with a nominal composition Mg - 6%, Zn - 2%, Th - 0.75 Zr, similar to ZH62A. The levers were protected with a zinc-chromate primer and an epoxy top-coat. Galvanic corrosion was found in the levers in a socket where steel balls had been located. The ends of the lever arms are shown in Figures 8-10(a) and 8-10(b), which also show the corrosion damage. Figure 8-10(c) shows a cross-section through the lever arm in the corroded area and shows deep cavities due to this galvanic corrosion.

Fig. 8-10 Galvanic corrosion in a cast magnesium alloy flap control lever arm
(a) and (b) End of the magnesium lever showing ball socket and corrosion. (Mag. × 2)
(c) Cross-section through the corroded region of Figure 8-10(a), showing deep pitting. (Mag. × 25)
(d) Galvanic corrosion in the magnesium lever around a press-fit aluminium bushing.

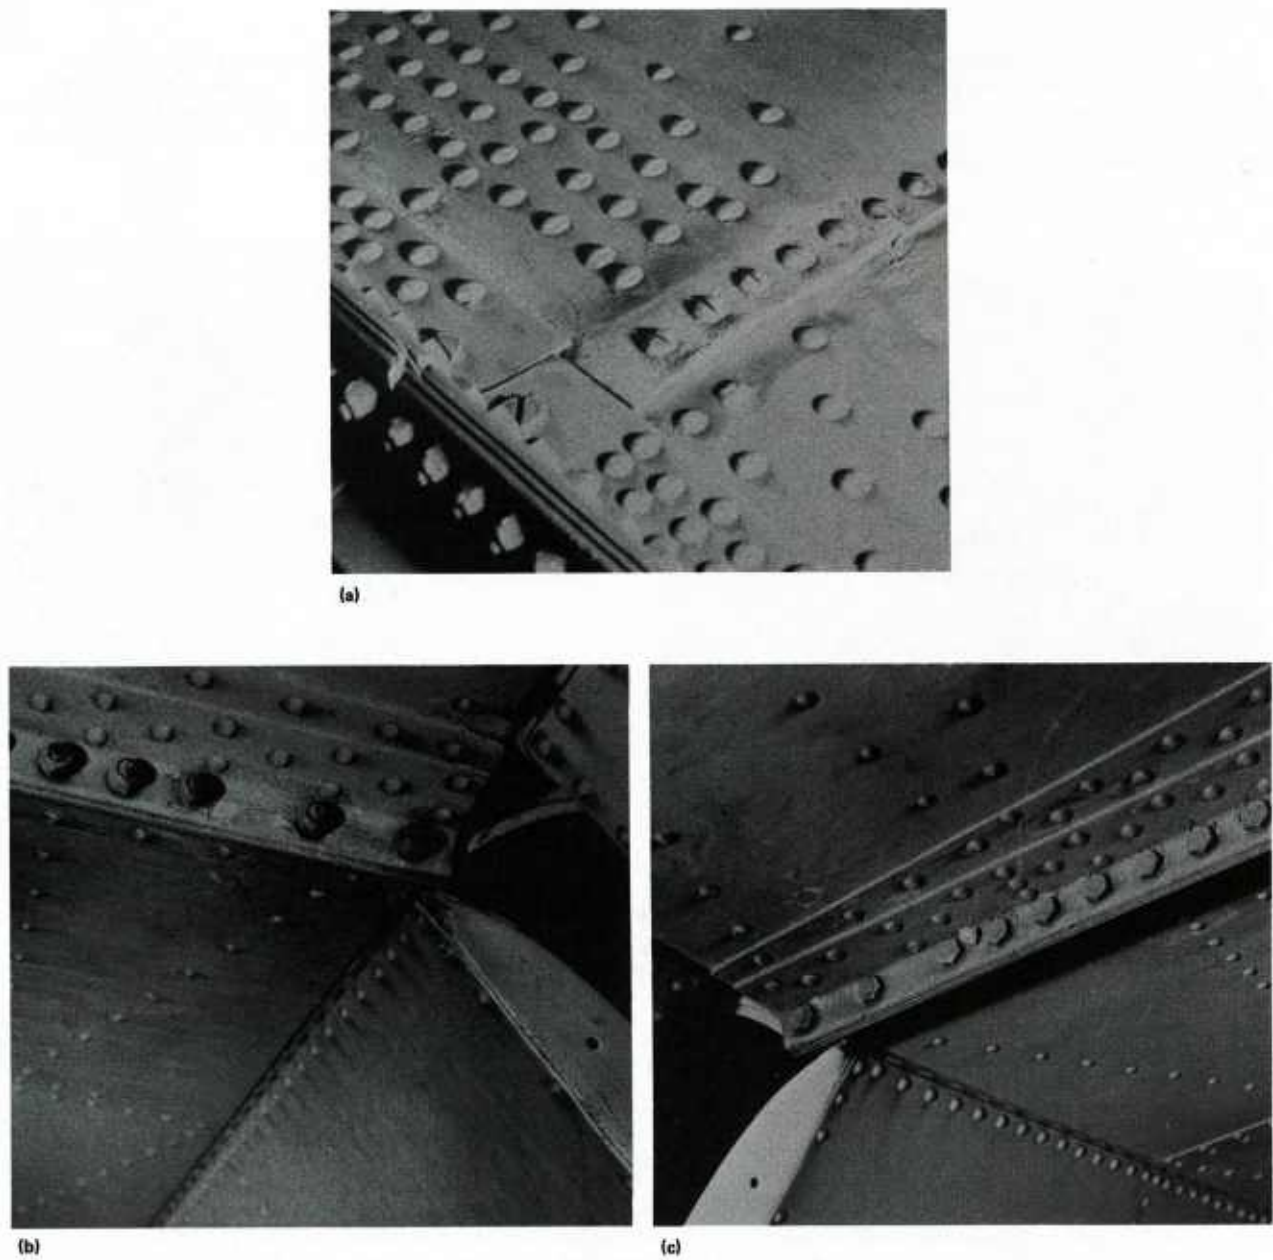
Fig. 9-3 Crevice corrosion in the outer wing coupling flange of a transport aircraft

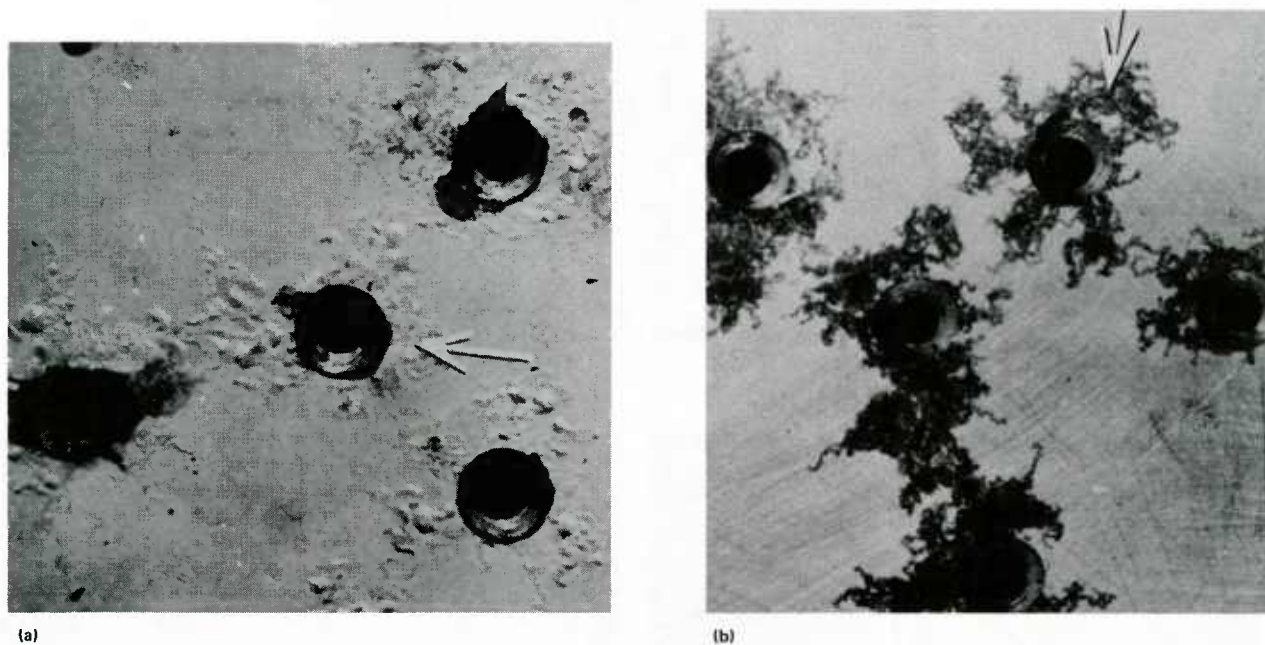
Fig. 9-4 Filiform corrosion in an aluminium alloy sheet structure

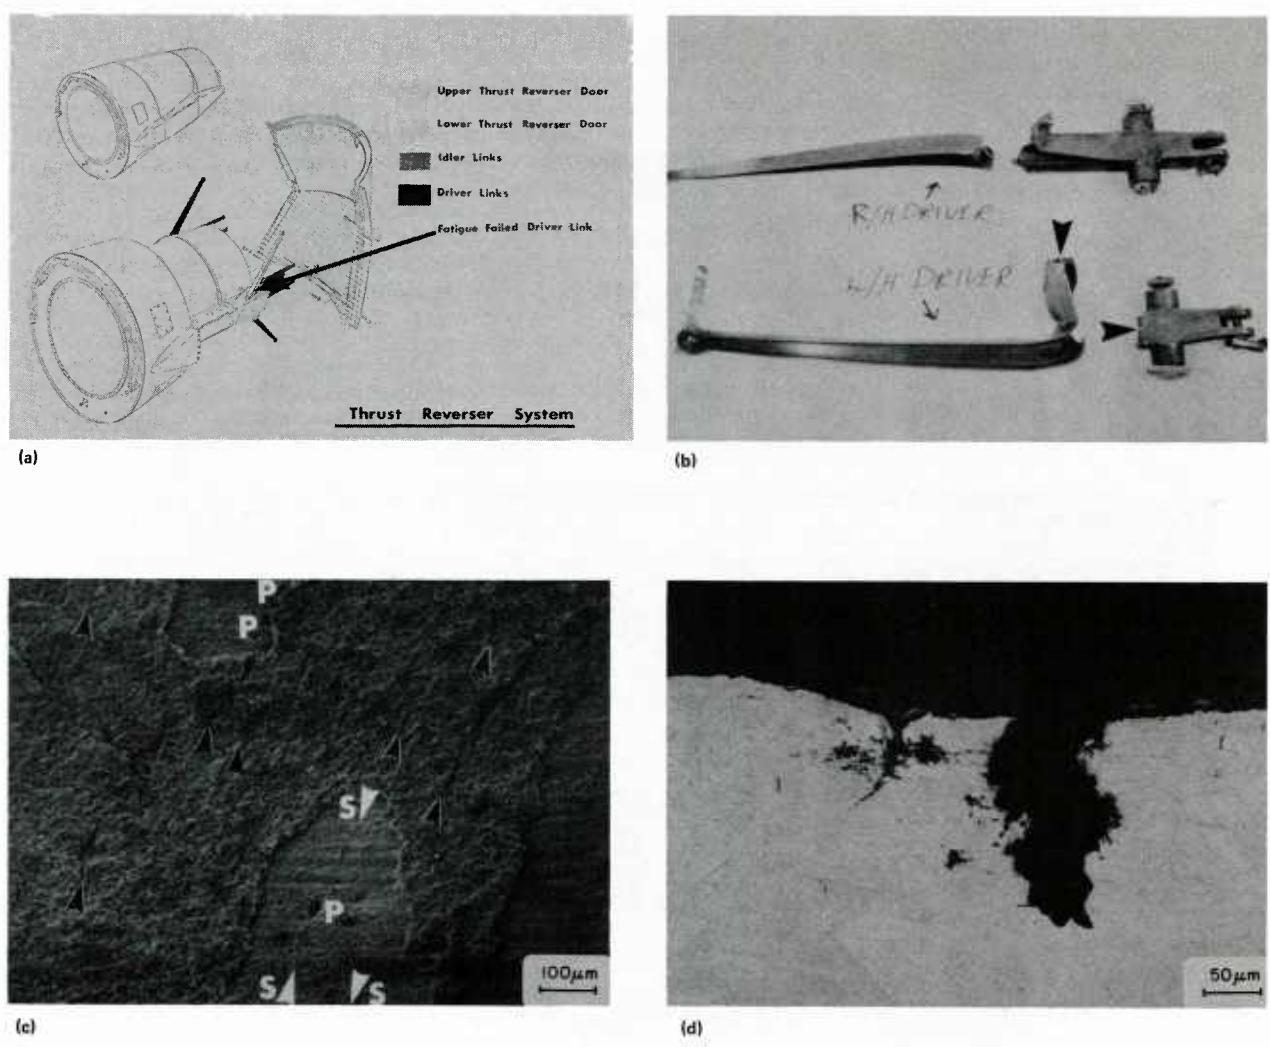
A large commercial jet lost the thrust reverser doors from one of its engines in cruise flight, but nevertheless landed safely. Subsequent investigation showed one thrust reverser door driver link had fractured, allowing the leading edge of the door to spring up into the 550 knot airstream. Figure 9-5(a) shows the general arrangement of the thrust reverser system with the failure location indicated by an arrow. The resulting air loads on the thrust reverser had torn the doors away from the aircraft. Closer inspection showed that the link failed in fatigue, but the fatigue crack initiated at pitting corrosion sites in the link surface. The latter was coated by a protective molybdenum disulphide type dry film lubricant. Figure 9-5(b) shows the broken driver links, with the primary fatigue fracture indicated by arrows.

Fig. 9-5 Pitting corrosion and fatigue failure of a thrust reverser driver link

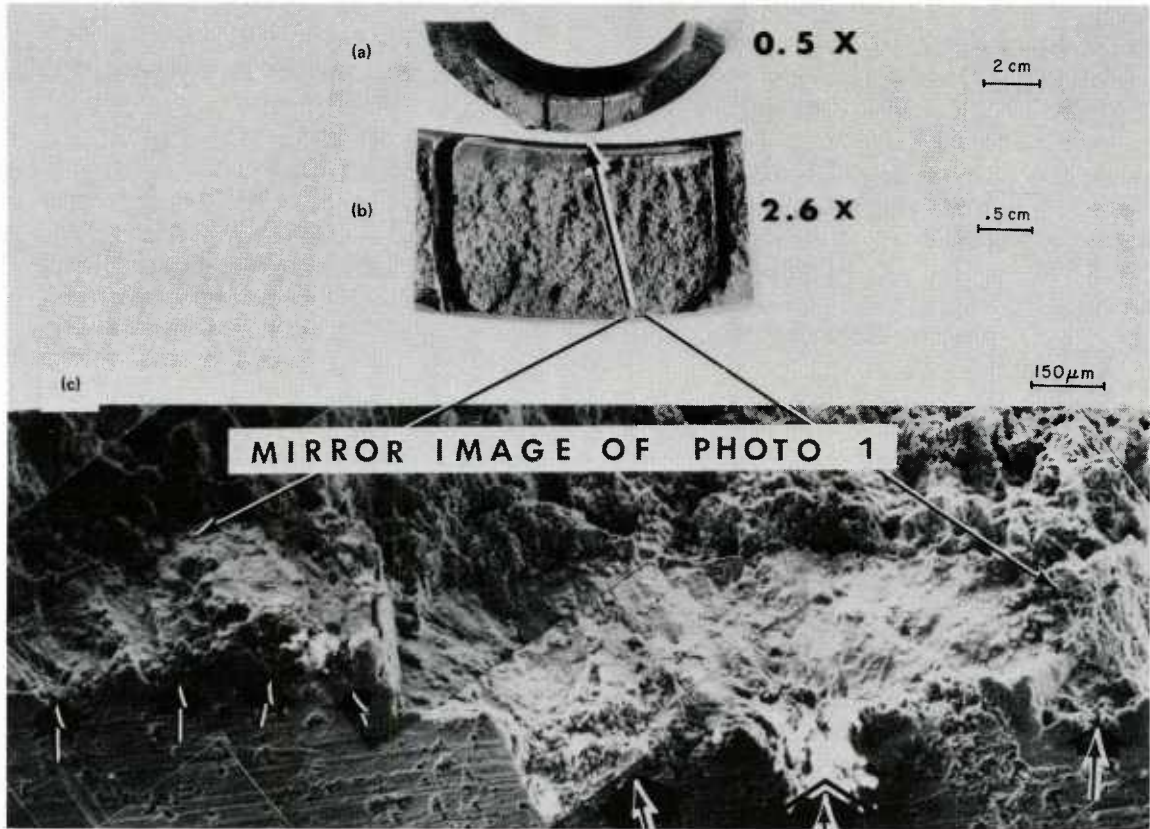
Within a one month period, three naval aircraft were damaged due to failure of their main landing gear struts. The failed struts were submitted for laboratory examination, which showed the strut outer barrel was fabricated from 2014-type aluminium alloy, and all were within the specified dimensional tolerances with respect to wall thicknesses.

Fig. 9-6 Pitting corrosion and fatigue of a 2014 aluminium alloy main landing gear strut

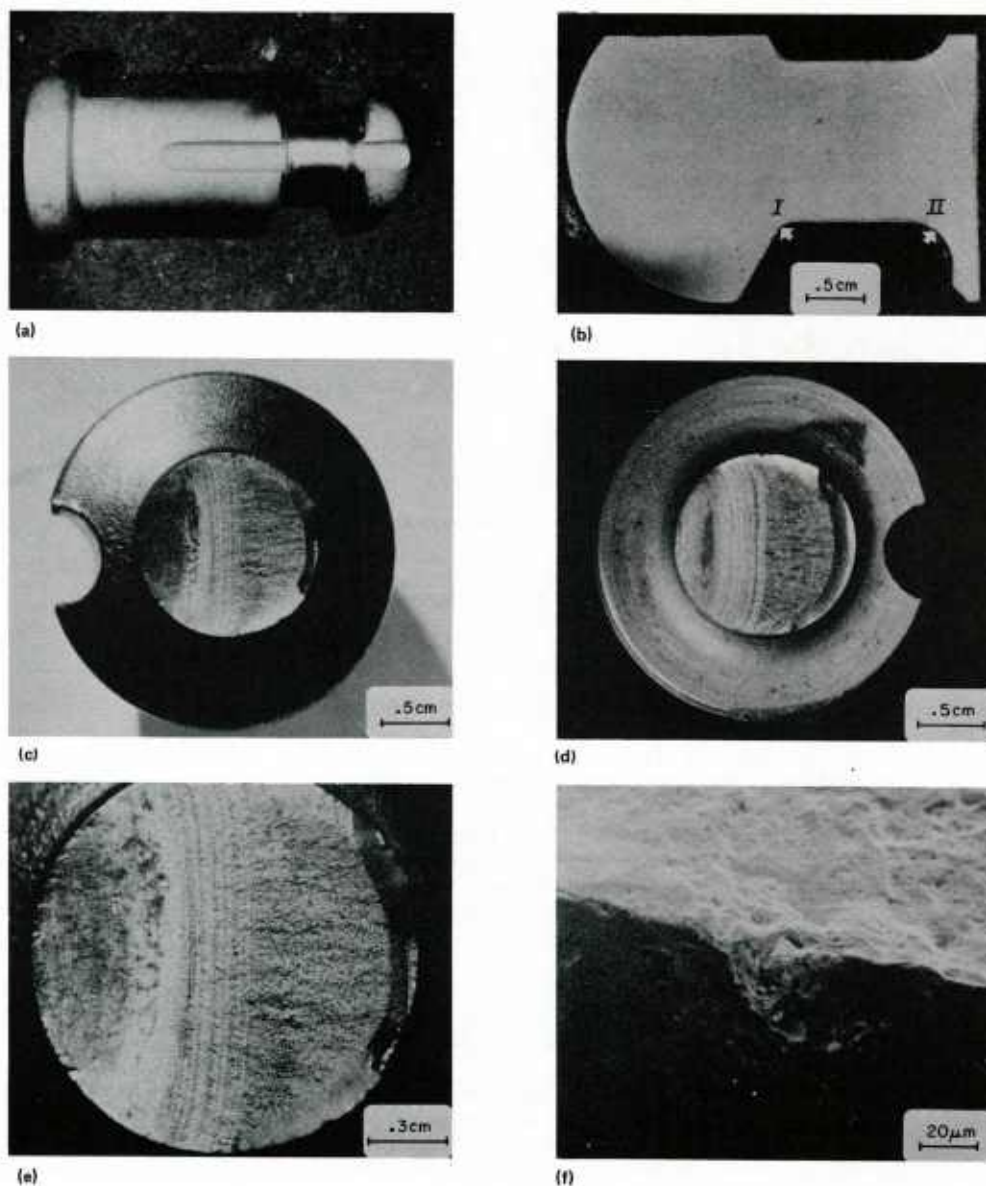
All of the failures initiated at the side of the latch knobs facing towards the wing lower side, and in every failure almost half the cross-section showed a fatigue fracture surface. An investigation with the scanning electron microscope revealed that the failures were initiated by corrosion pits. This is illustrated in Figure 9-7(f), showing a corrosion pit at the origin of one of the fatigue fractures.

Fig. 9-7 Pitting corrosion and fatigue failure of a 4340 steel tip tank latch knob

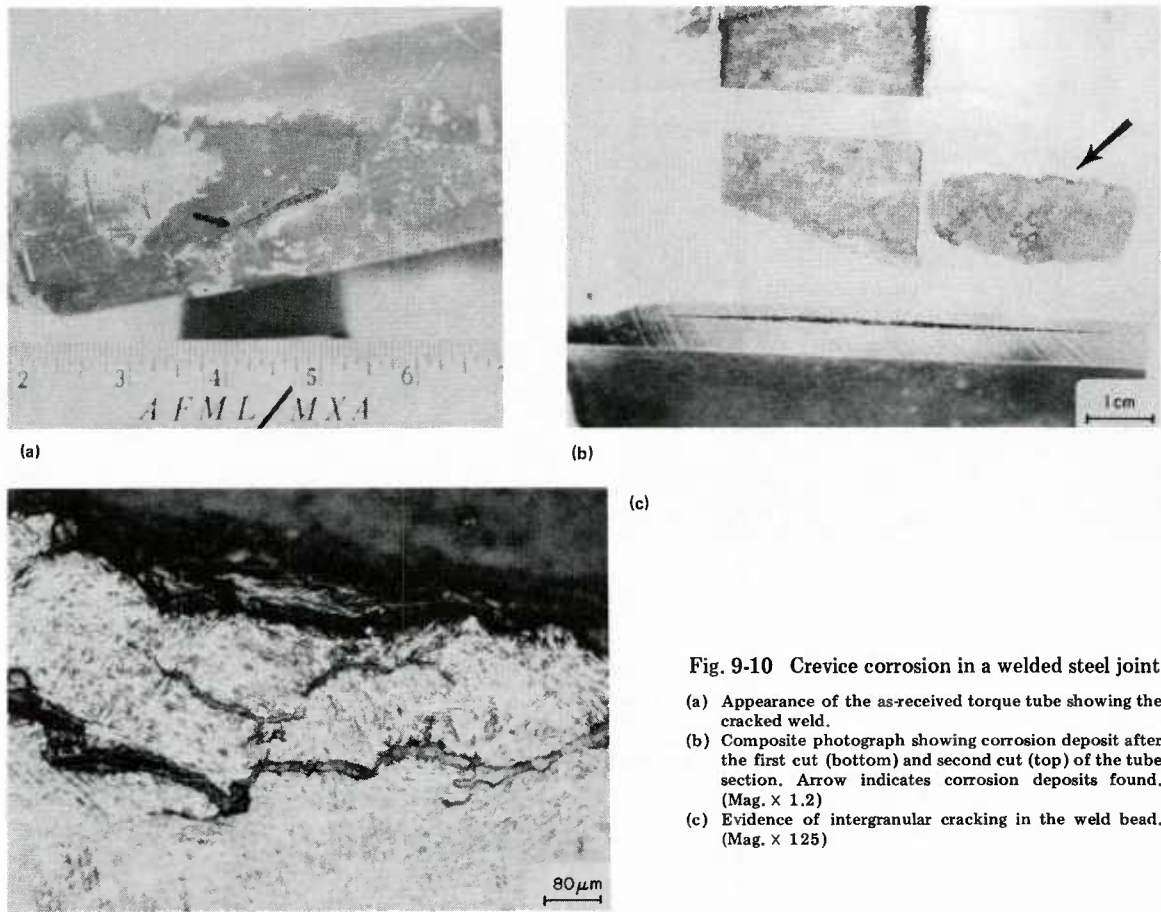
Fig. 9-10 Crevice corrosion in a welded steel joint

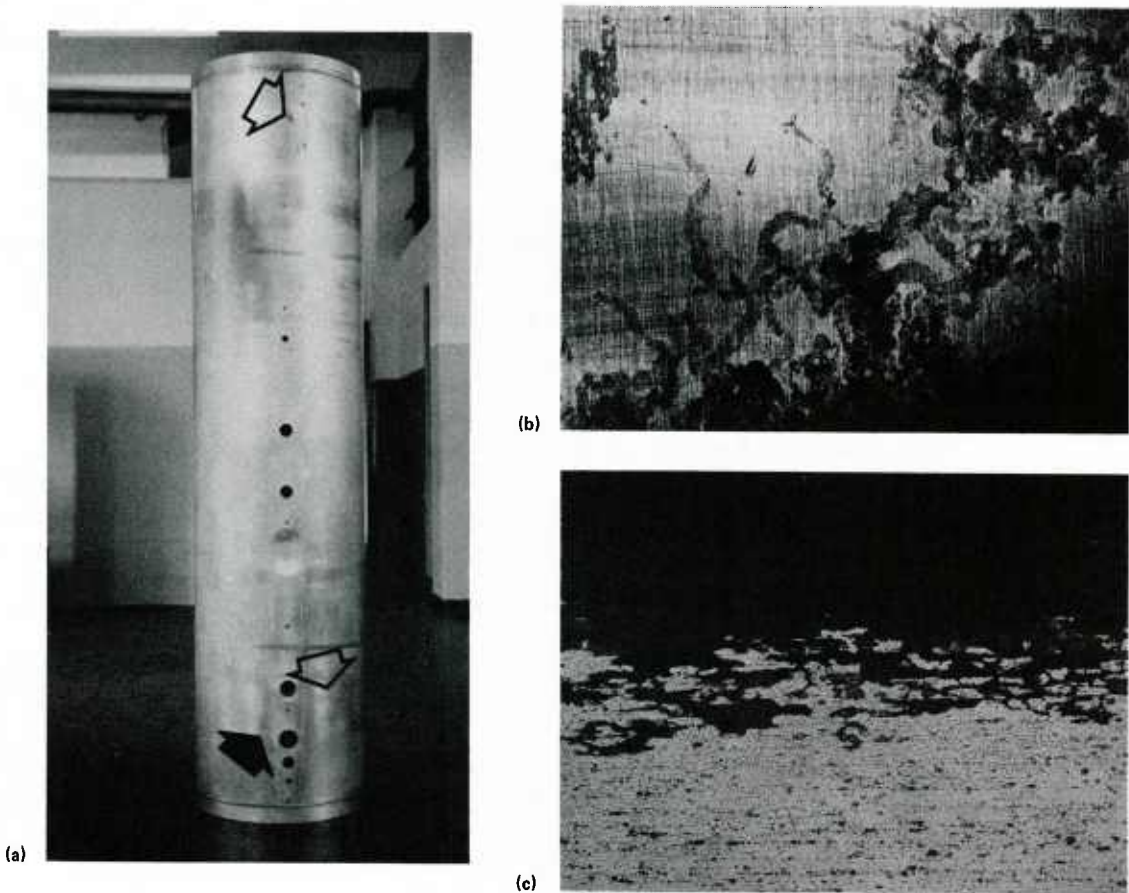
Fig. 9-13 Filiform corrosion in a fighter aircraft pylon tank

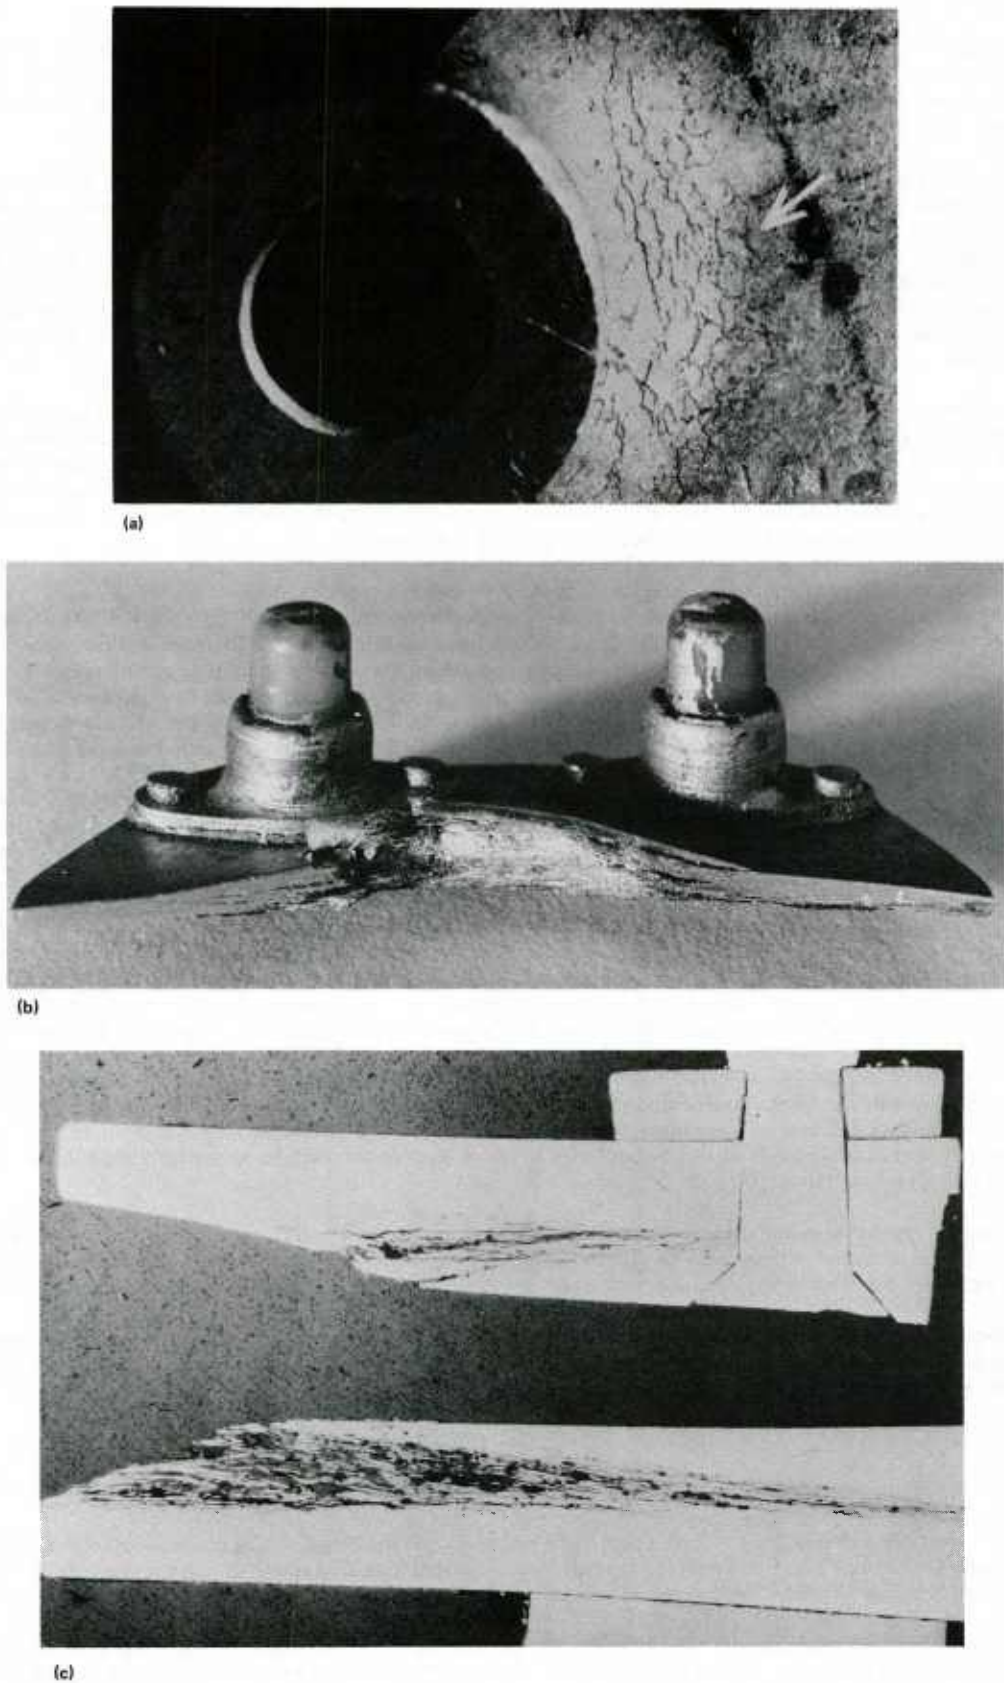
Fig. 10-1 Examples of intergranular and exfoliation corrosion in aircraft structure and components

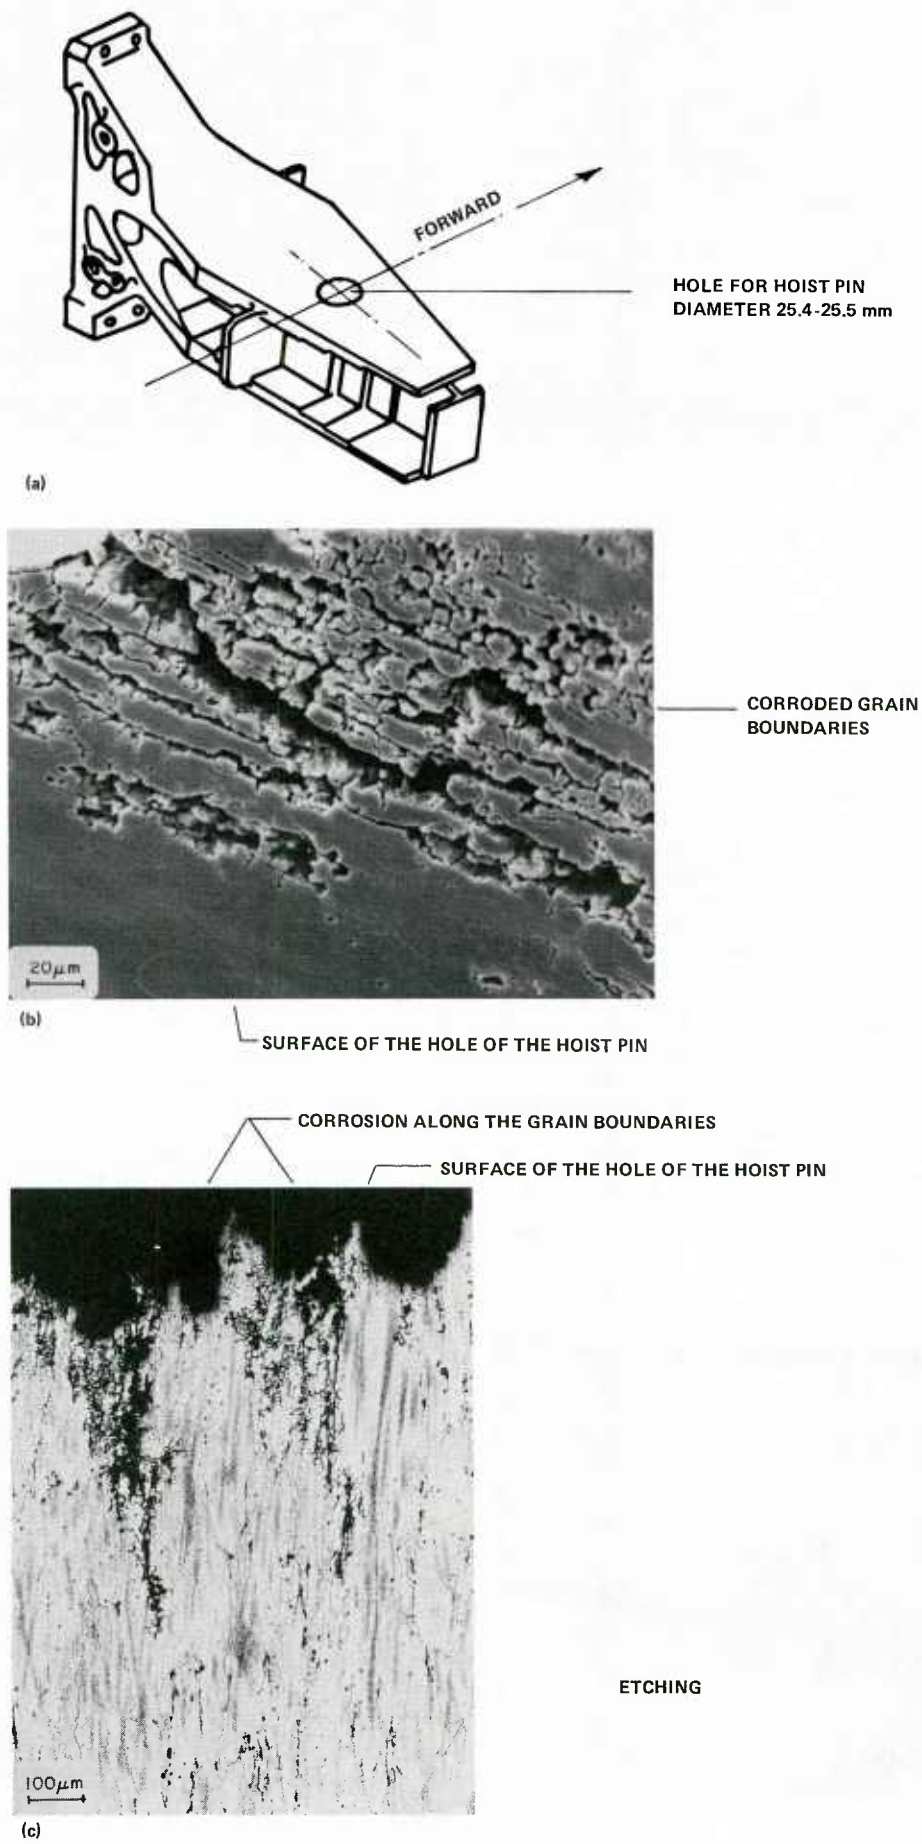
Fig. 10-4 Intergranular corrosion of an Al-Zn-Mg-Cu alloy wing attachment forging

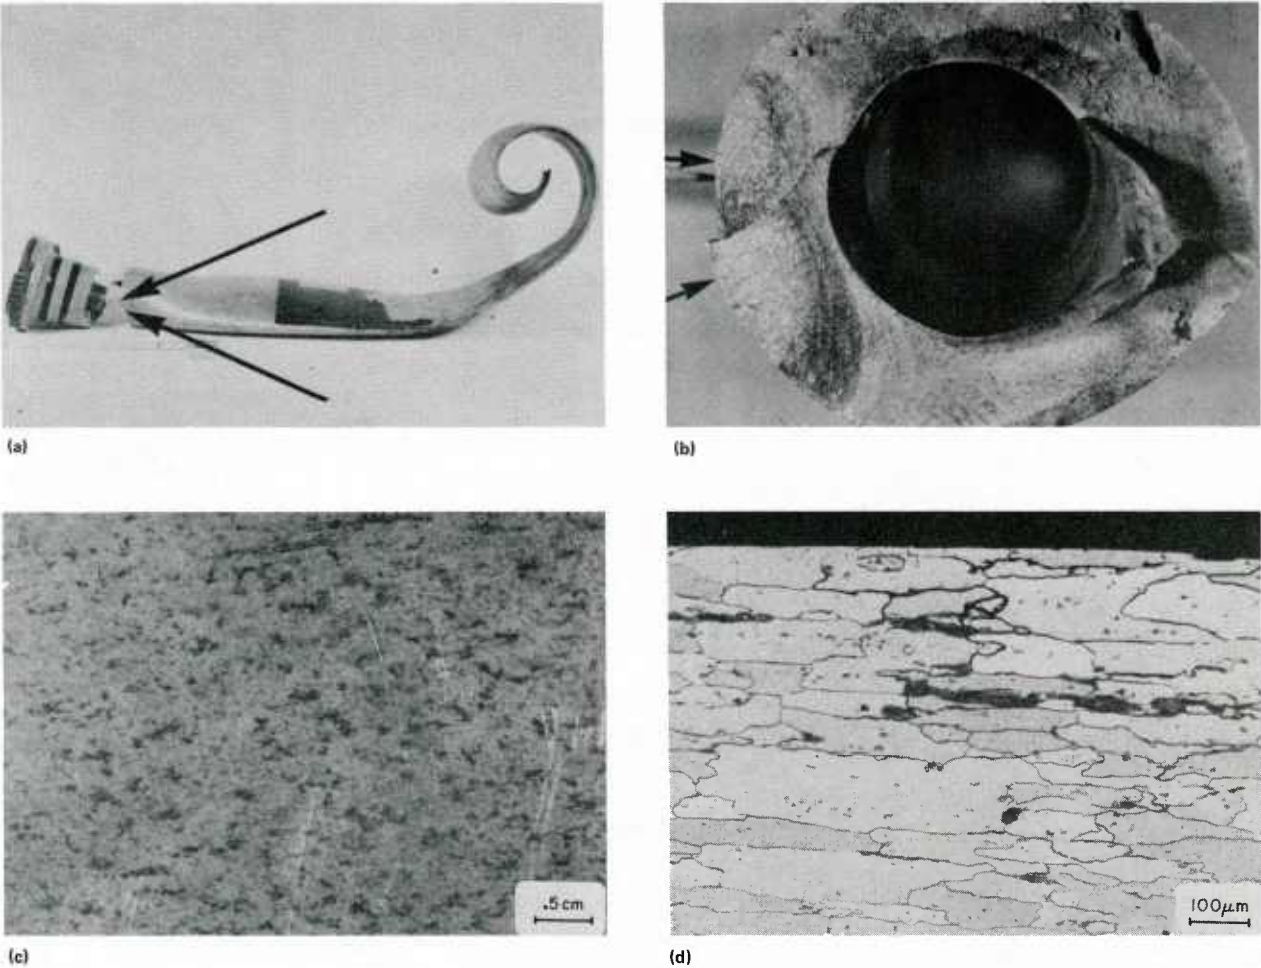
Fig. 10-5 Intergranular corrosion and fatigue of an aluminium alloy propeller
(a) Failed propeller showing the fatigue crack initiation sites near the leading edge root (arrows).
(b) Fracture face showing two major fatigue cracks whose origins correspond to the arrows in Figure 10-5(a).
(c) Surface of the propeller blade near the fatigue initiation sites showing a mottled appearance but no indications of widespread corrosion. (Mag. X 2)
(d) Section through the area seen in Figure 10-5(c) showing severe intergranular corrosion. Keller's etch. (Mag. X 100)

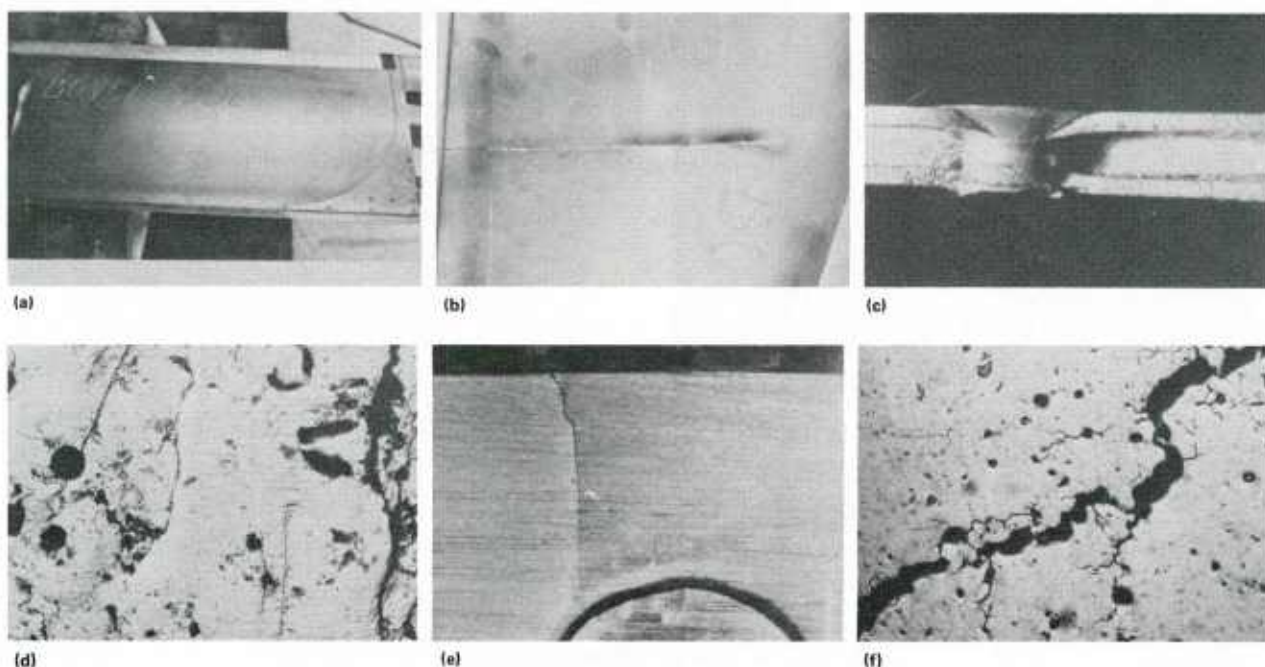
Fig. 10-6 Intergranular corrosion and fatigue in a helicopter main rotor blade
