AGARDograph No. 278

AGARD Corrosion Handbook Volume 1 Aircraft Corrosion: Causes and Case Histories

AIRCRAFT CORROSION: CAUSES AND CASE HISTORIES

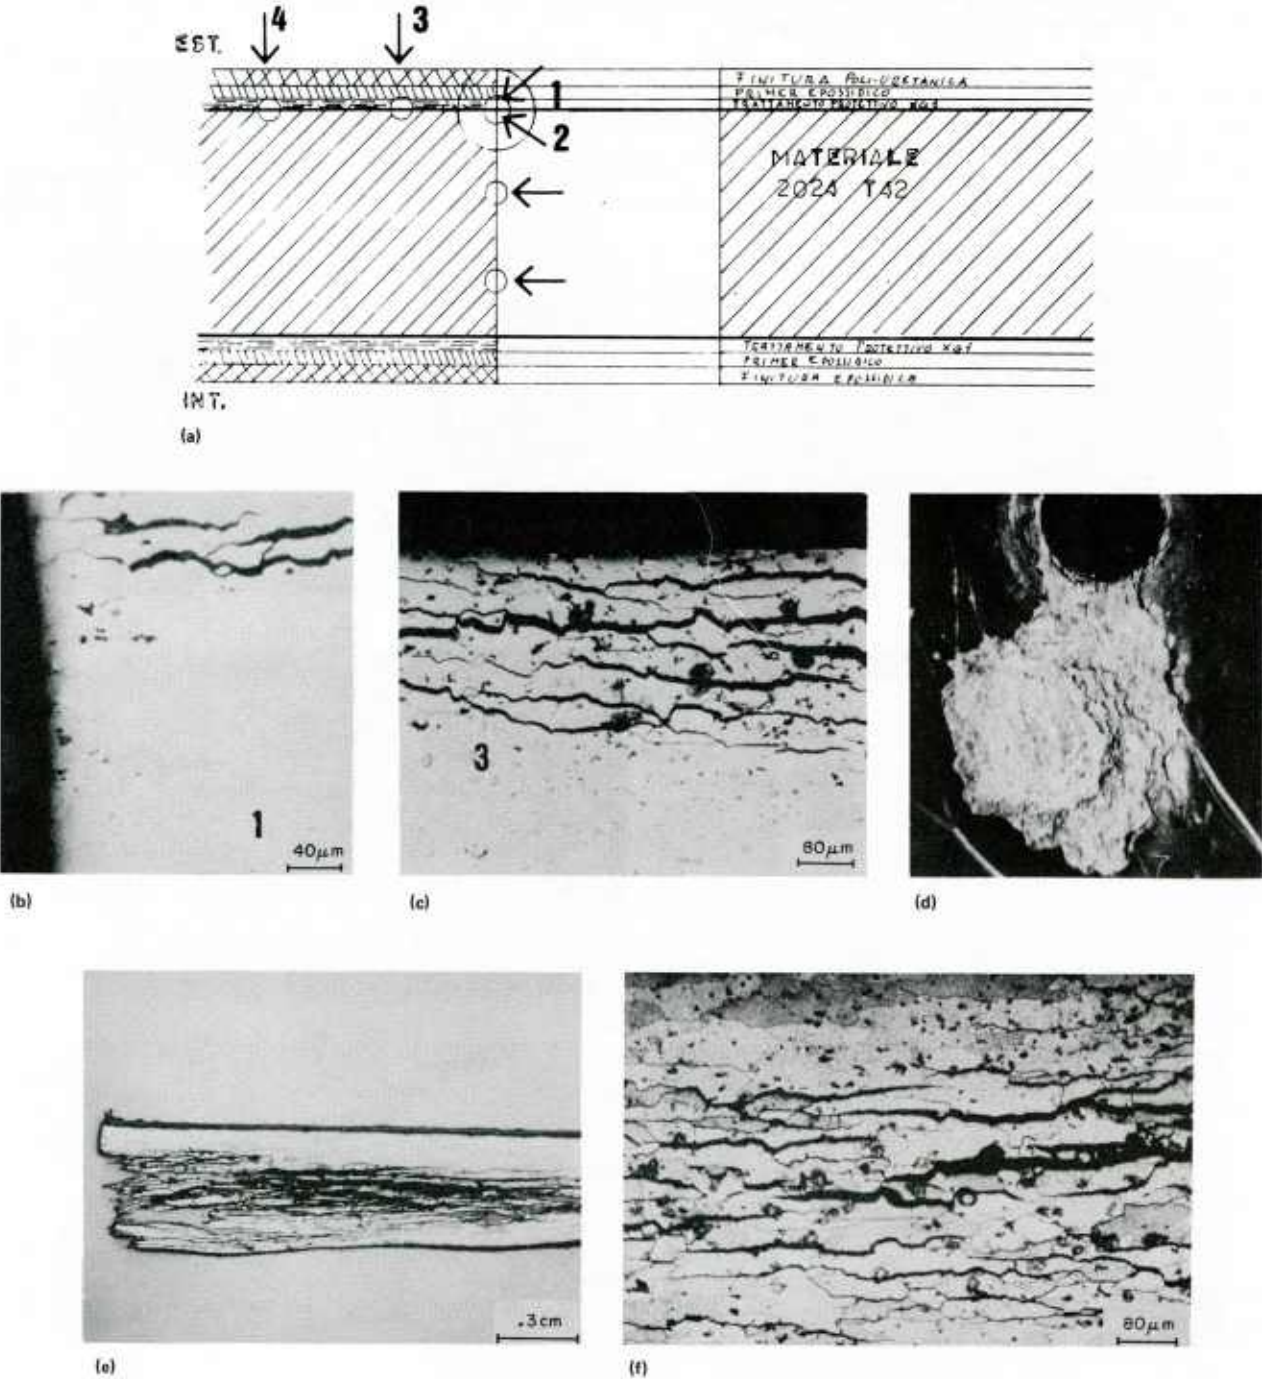
Fig. 10-7 Intergranular corrosion and exfoliation in a 2024-T42 vertical fin and horizontal stabilizer

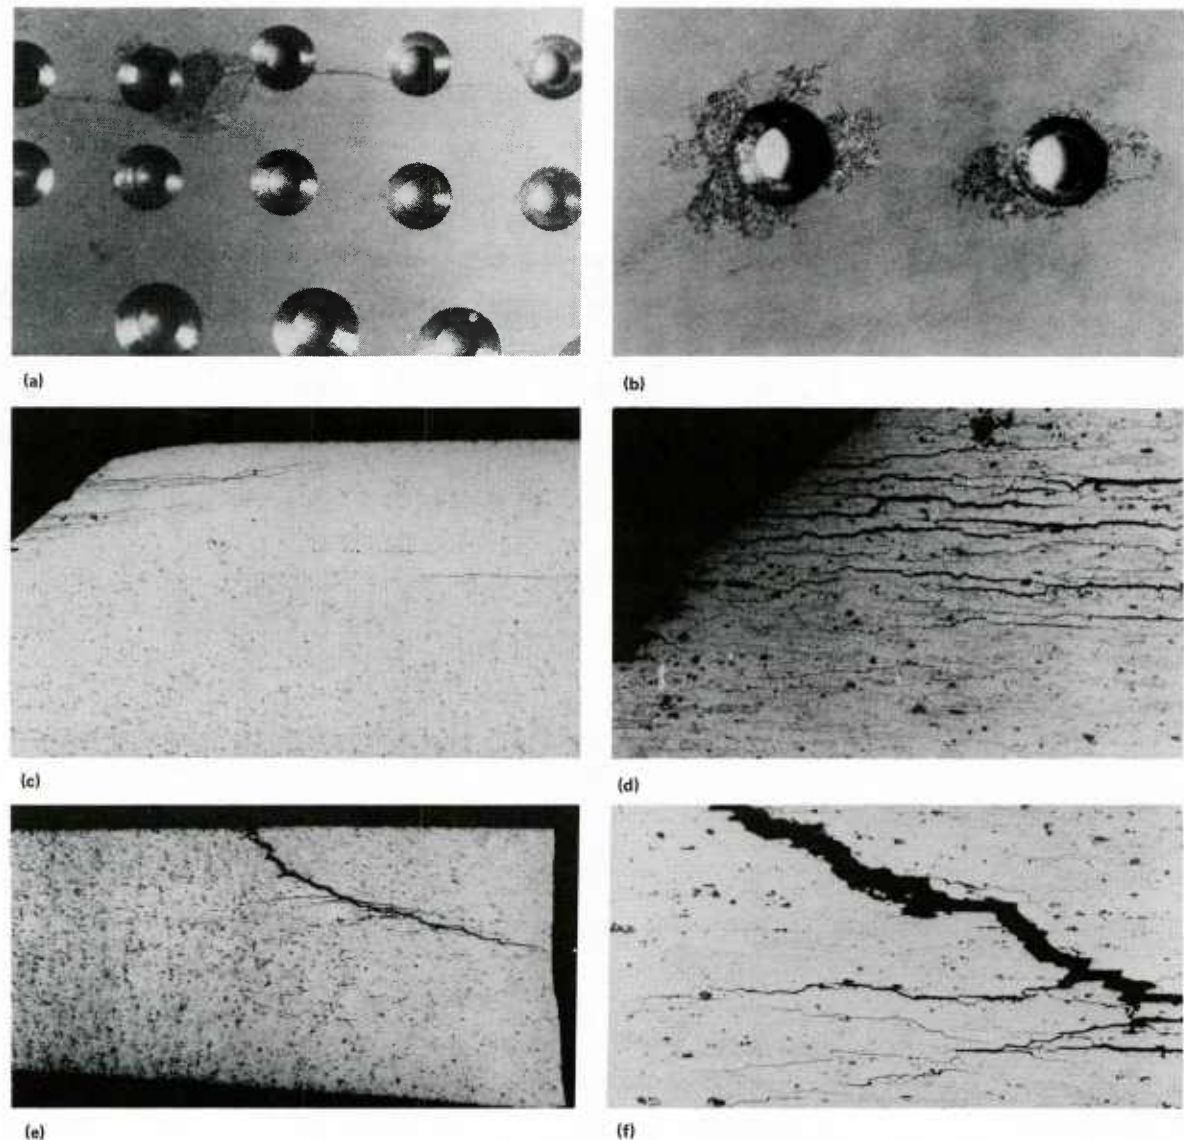
Fig. 10-8 Intergranular corrosion and exfoliation of a 7075-T6 wing box lower panel

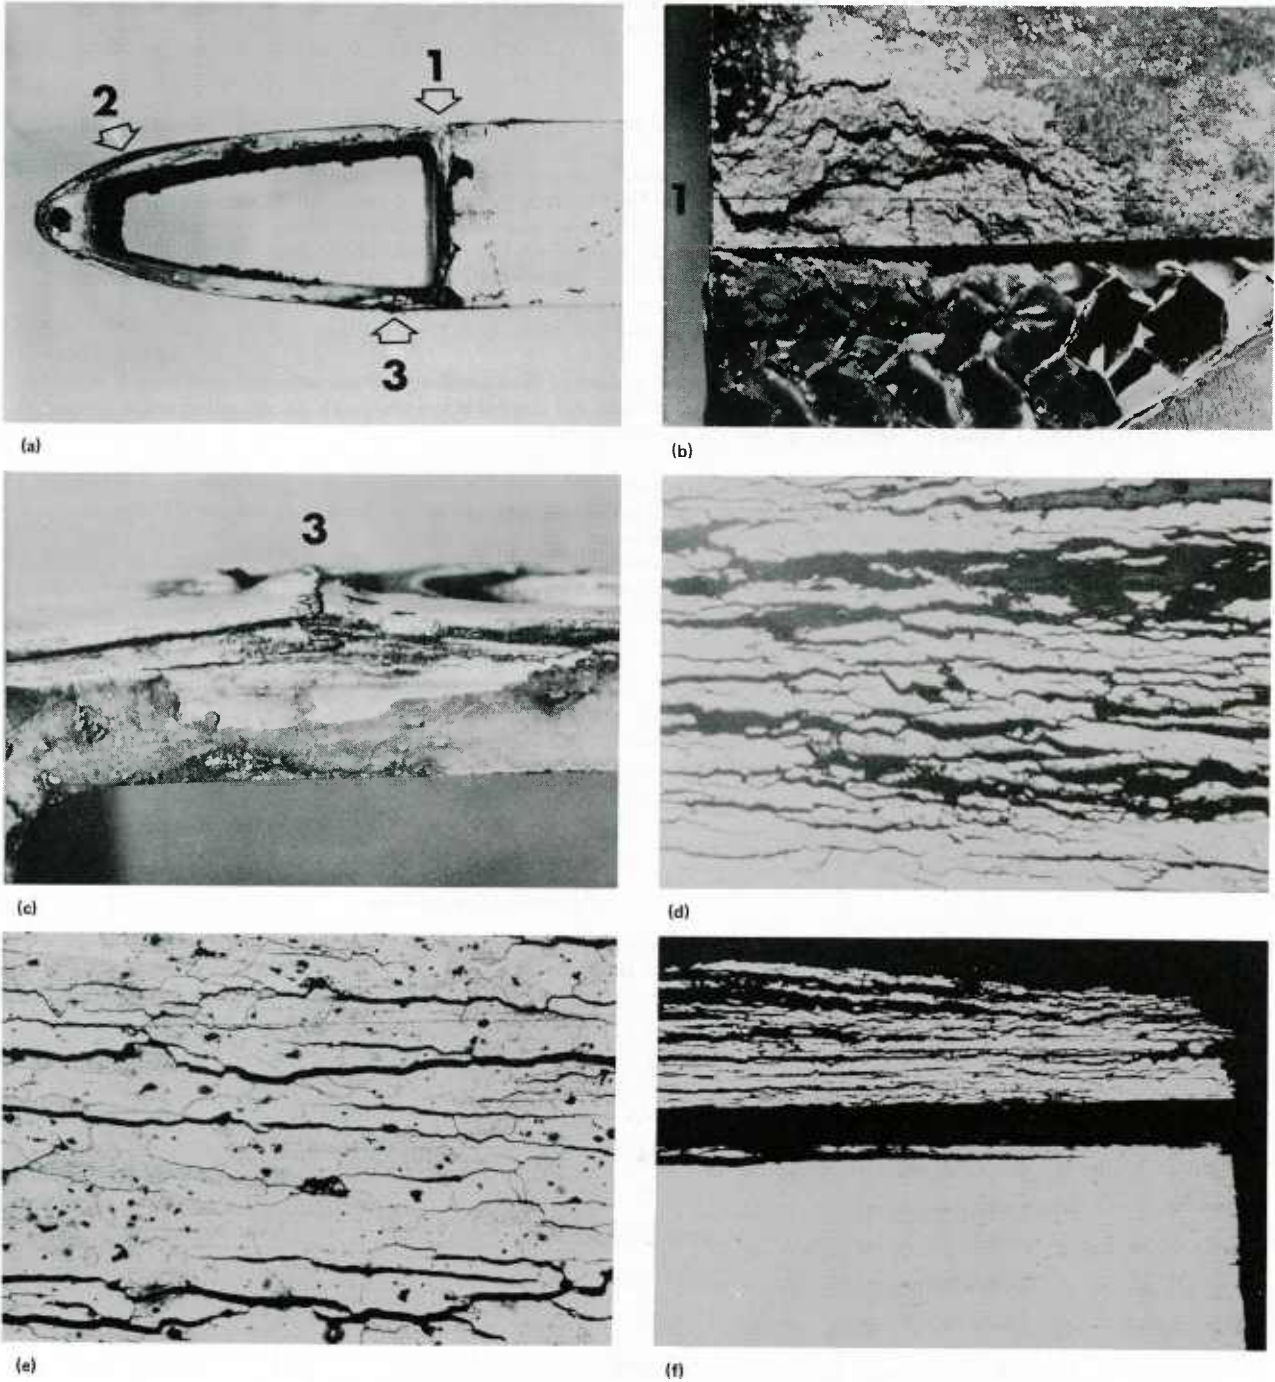
Fig. 10-9 Corrosion of a 2024 aluminium alloy helicopter rotor blade

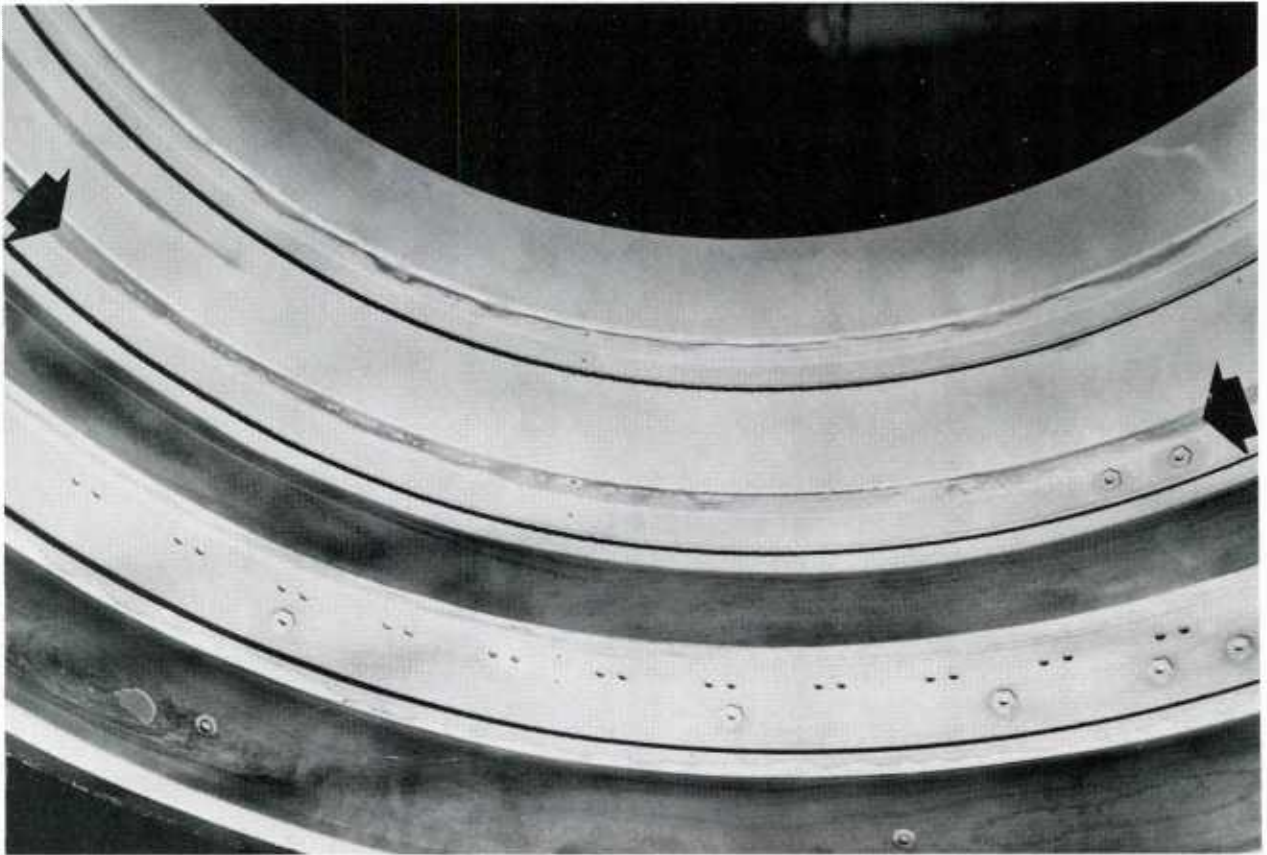
Fig. 11-2 Fretting corrosion in a magnesium alloy (EZ-33) compressor casing, indicated by arrows

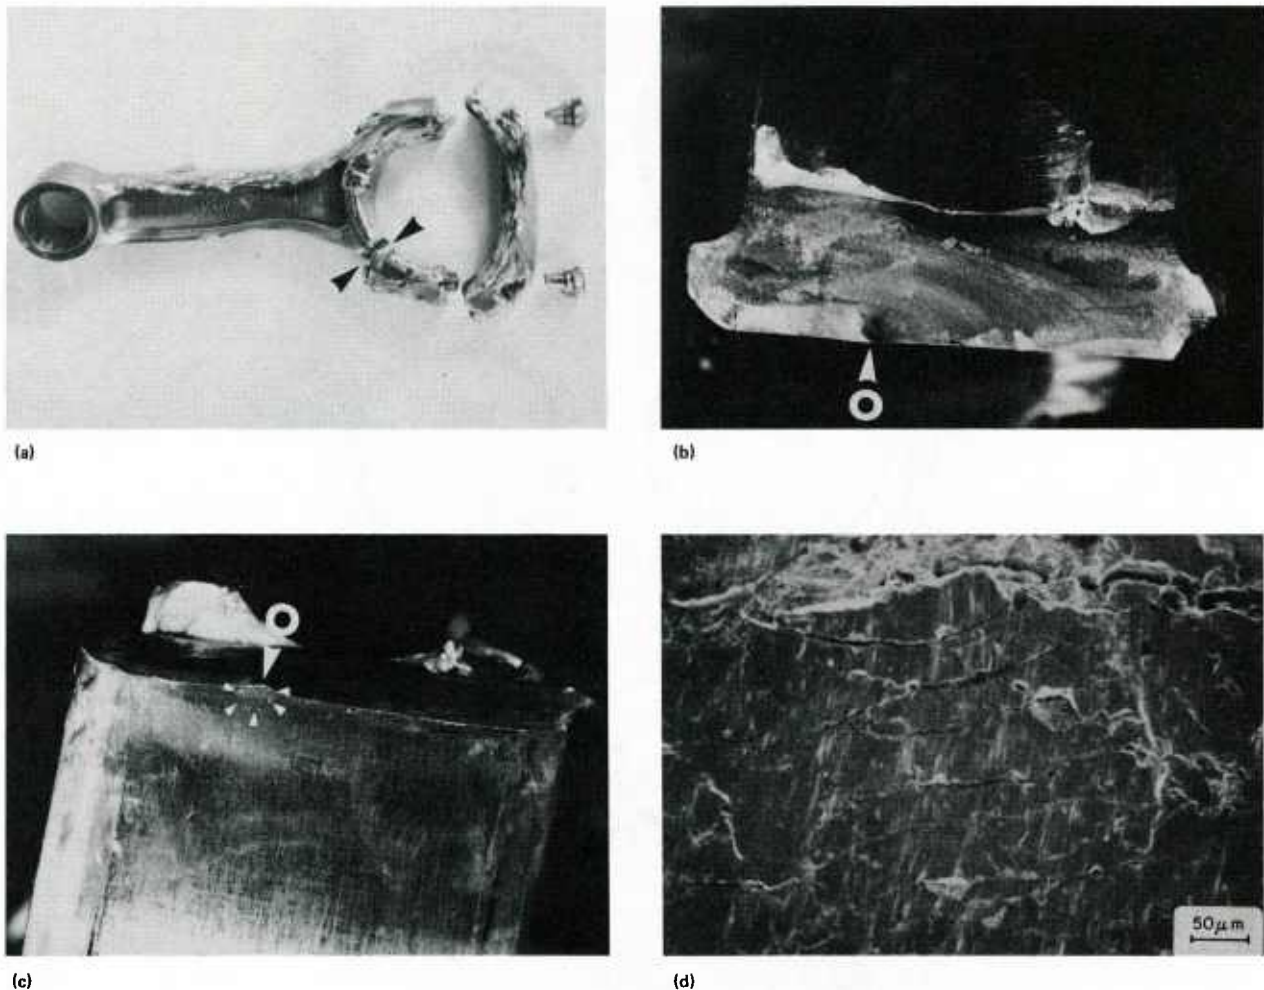
Fig. 11-3 Fretting corrosion and fatigue of a helicopter engine connecting rod

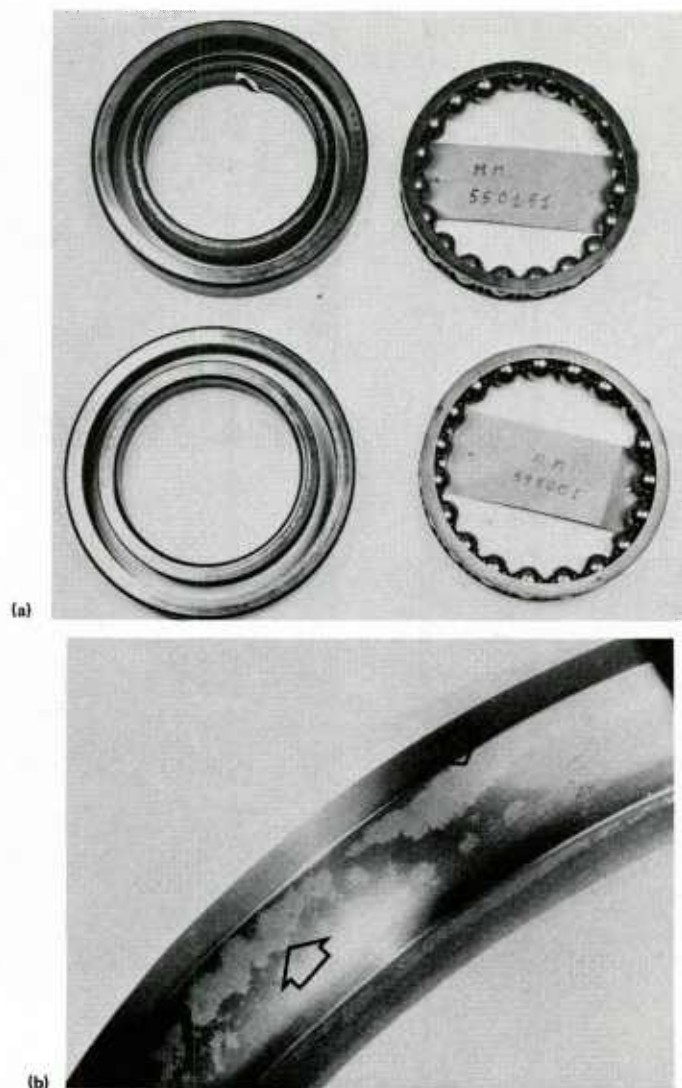
Fig. 11-4 Fretting corrosion in propeller shaft ball bearings

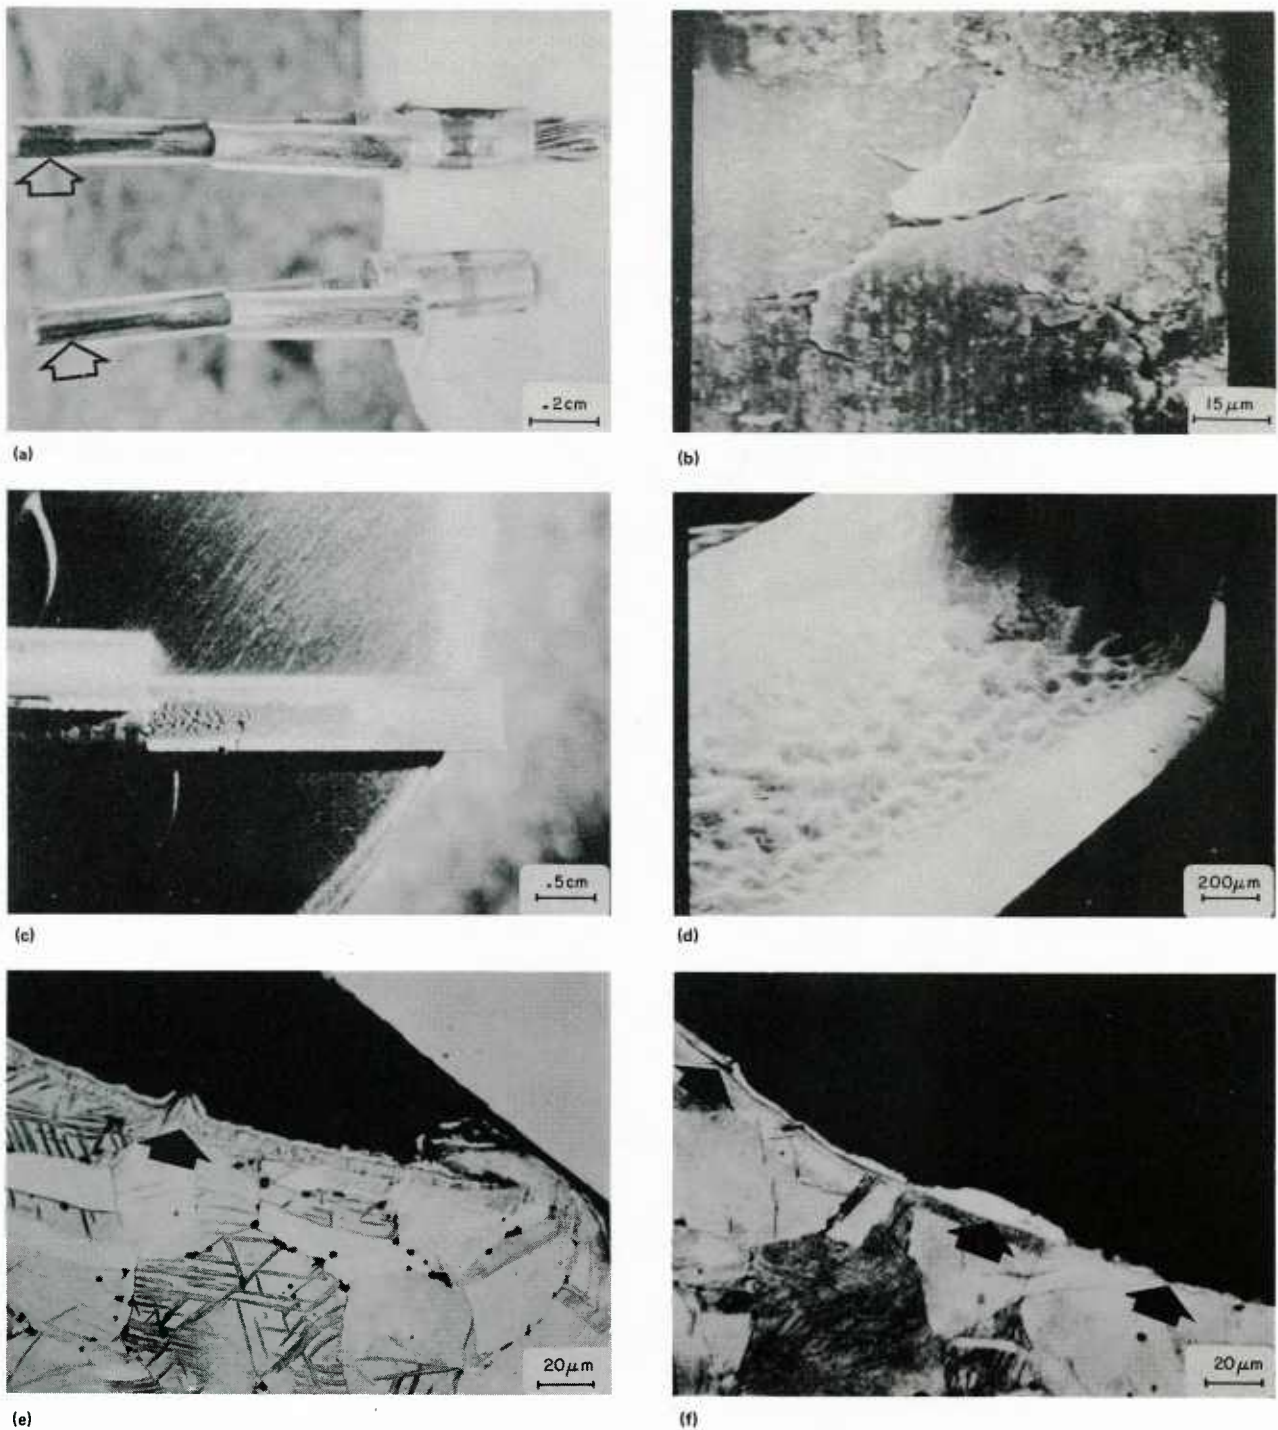
Fig. 11-5 Fretting corrosion in electrical connectors

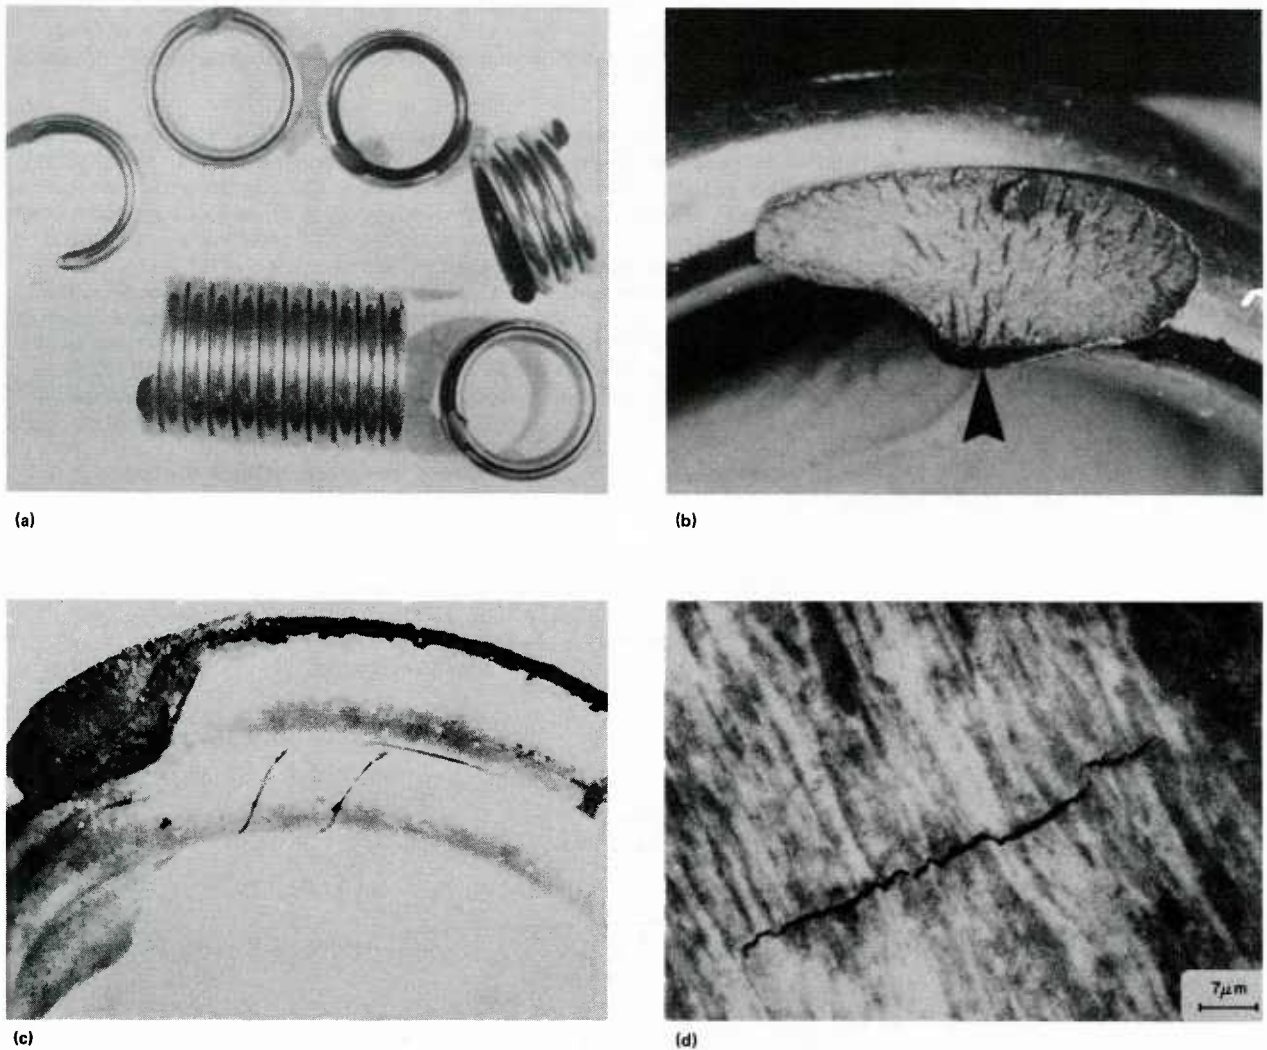
Fig. 12-7 Hydrogen embrittlement of a carbon steel flap control return spring

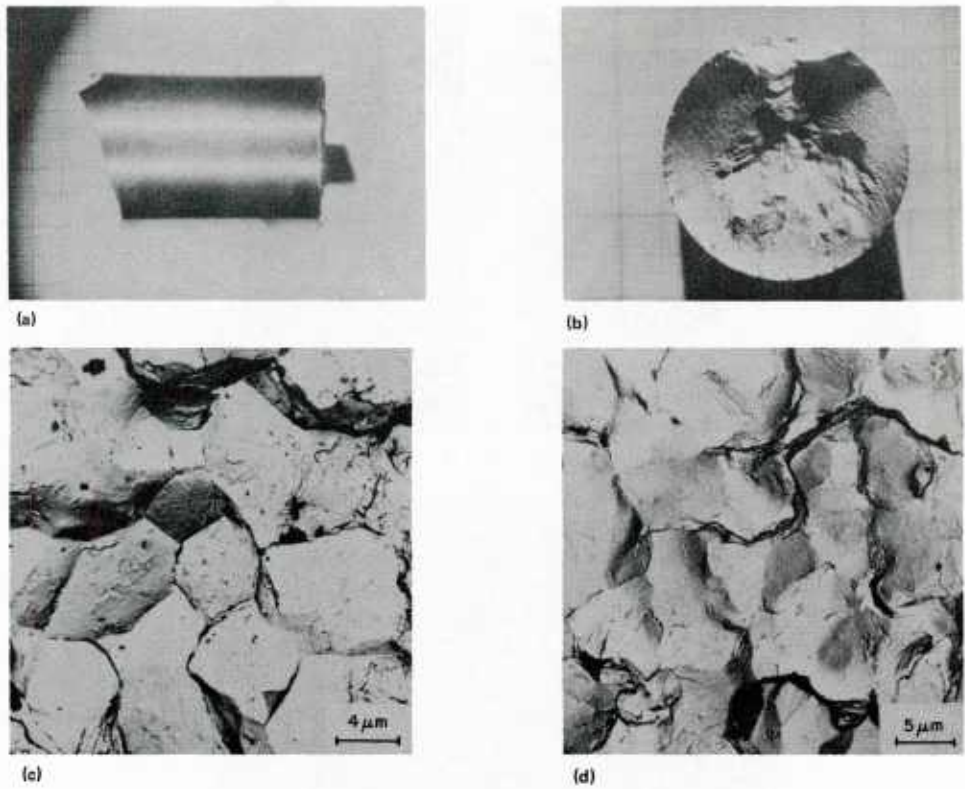
Fig. 12-8 Hydrogen delayed cracking in a 4340 main landing gear pivot pin

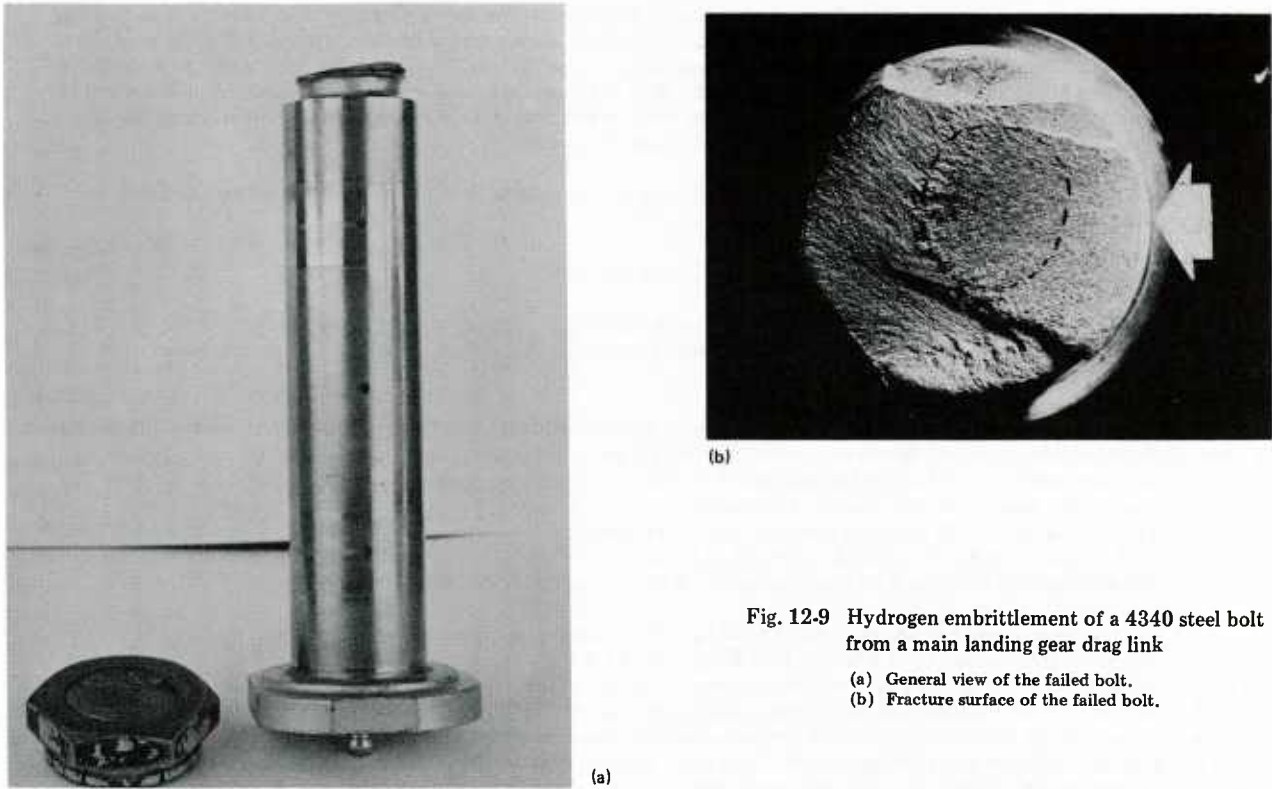
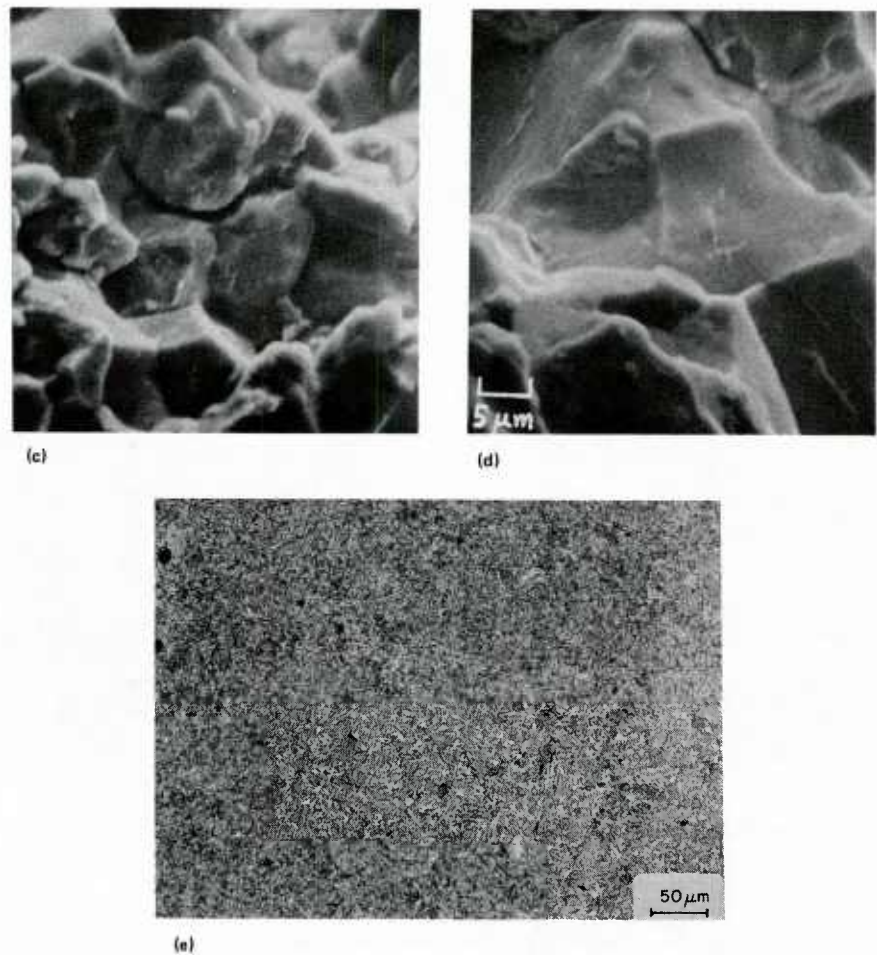
Fig. 12-9 Hydrogen embrittlement of a 4340 steel bolt from a main landing gear drag link

- (a) General view of the failed bolt.
- (b) Fracture surface of the failed bolt.

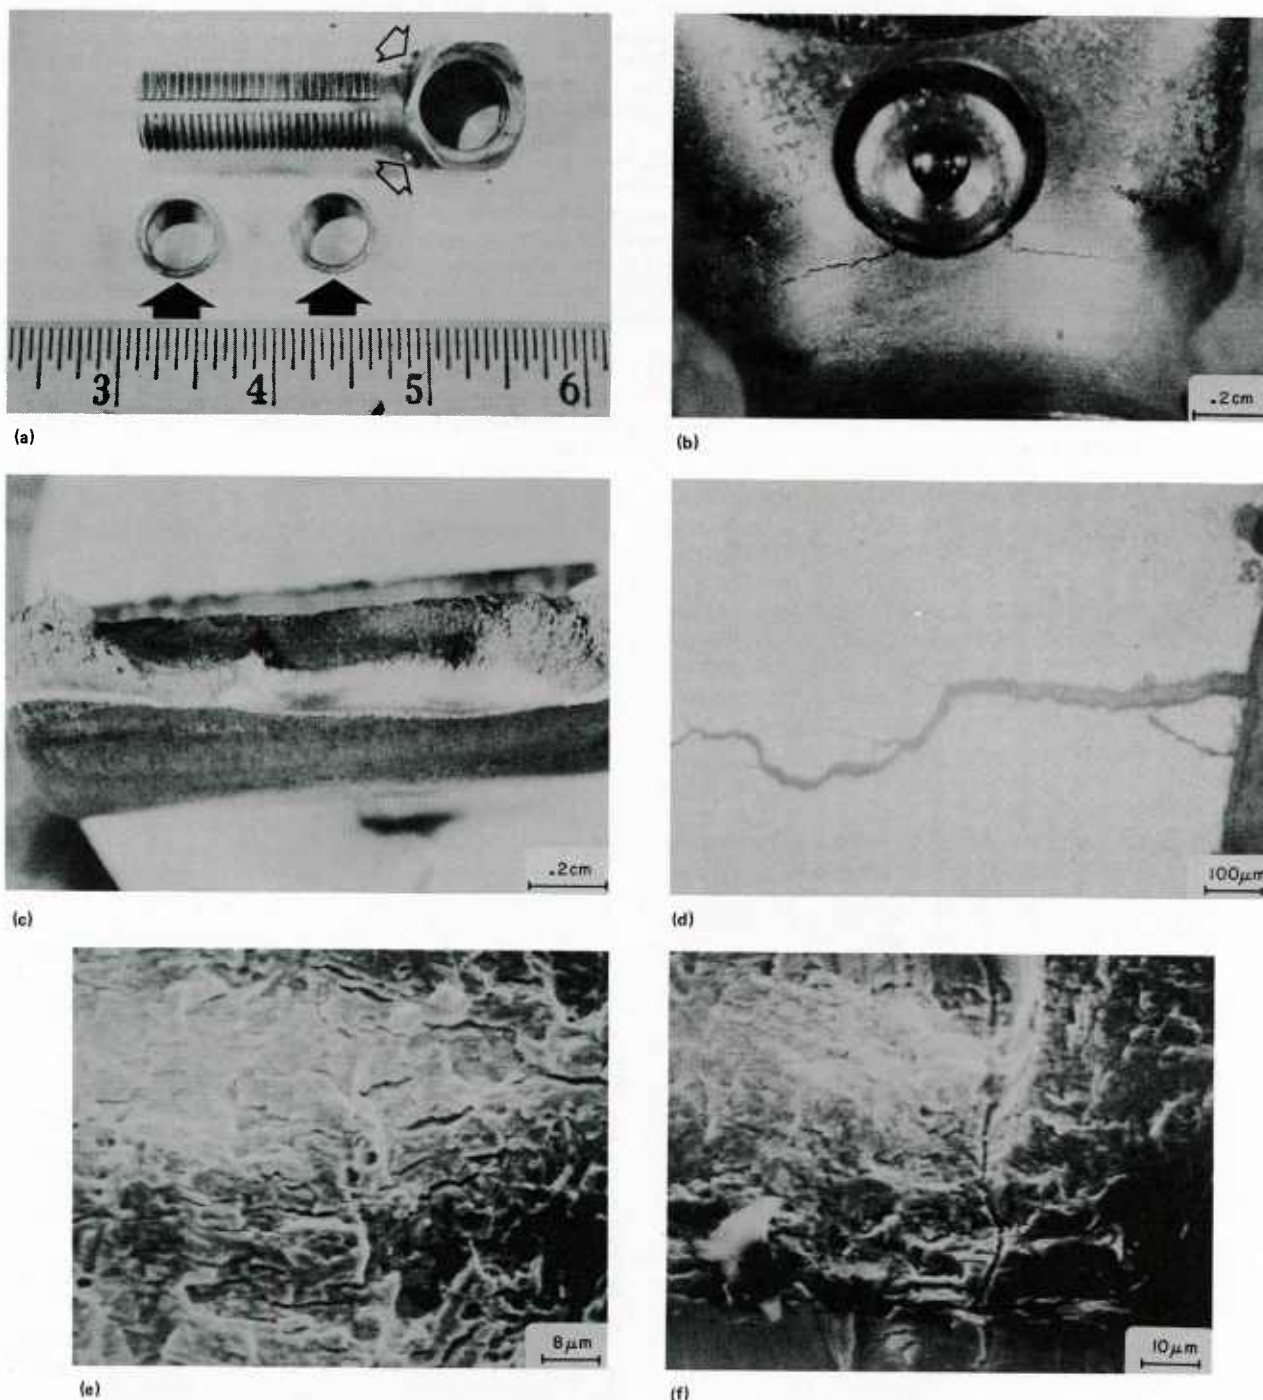
Fig. 12-10 Failure of a 4340 steel tie rod end

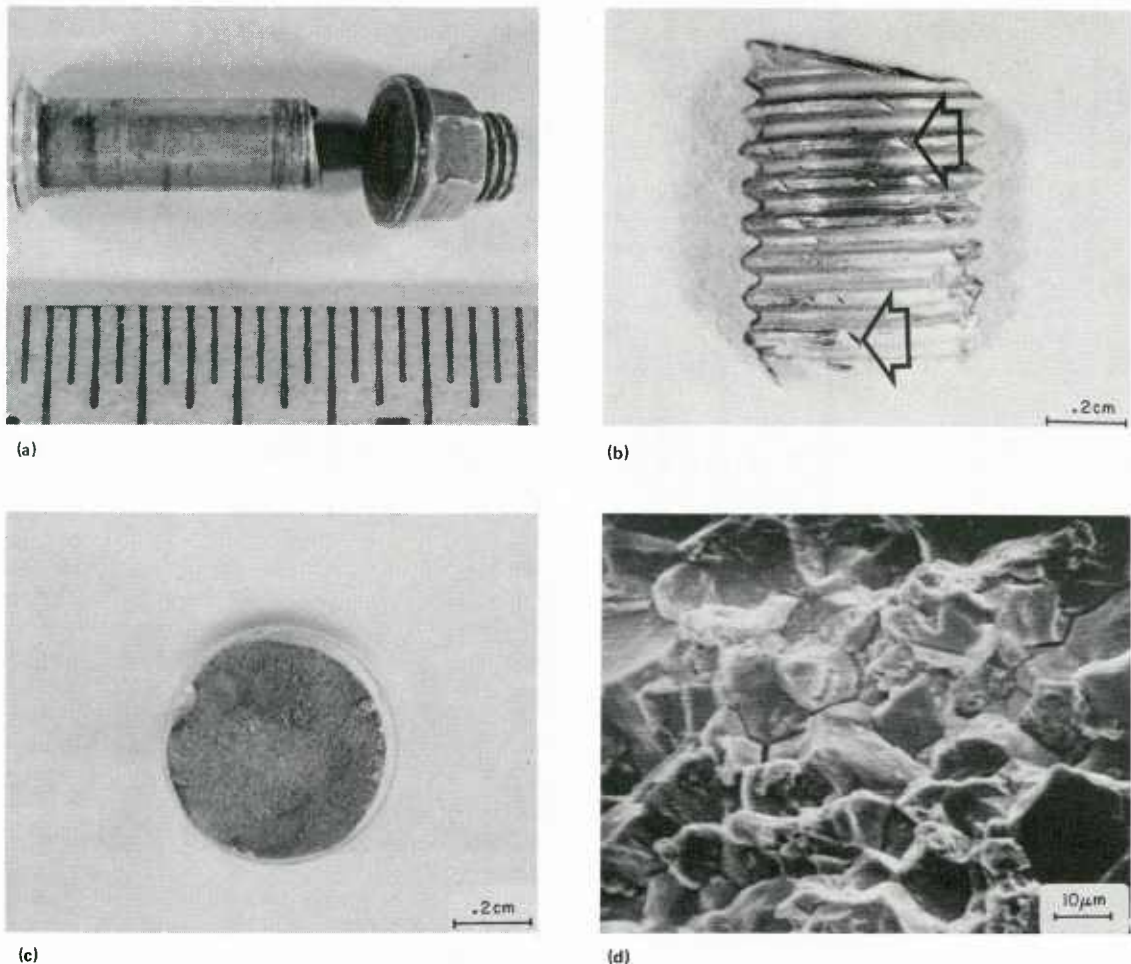
Fig. 12-11 Failure of a low alloy steel bolt

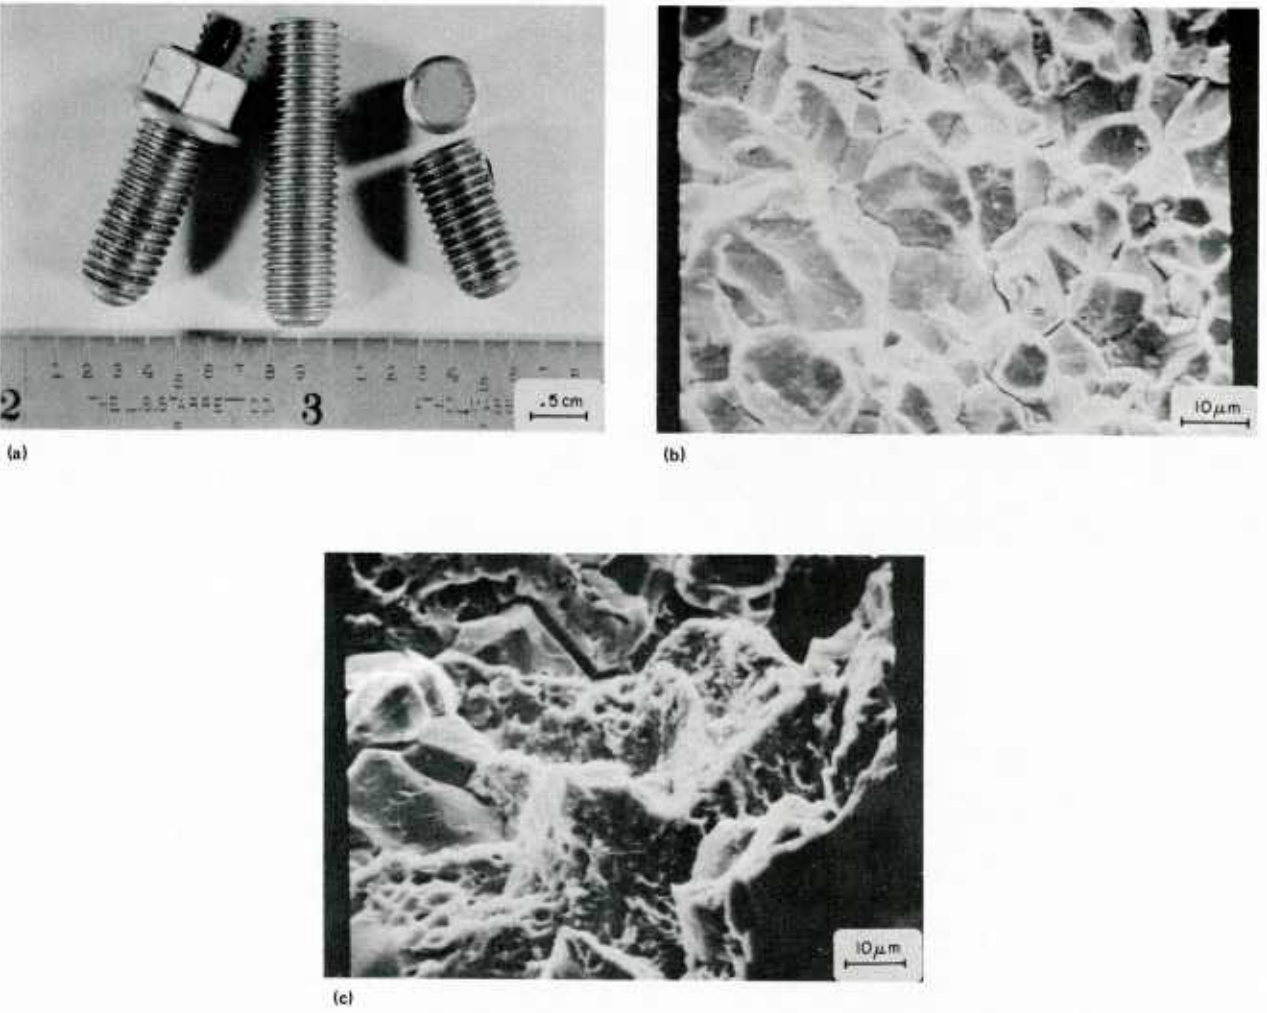
Fig. 12-12 Hydrogen induced failure of some 4037 steel setscrews

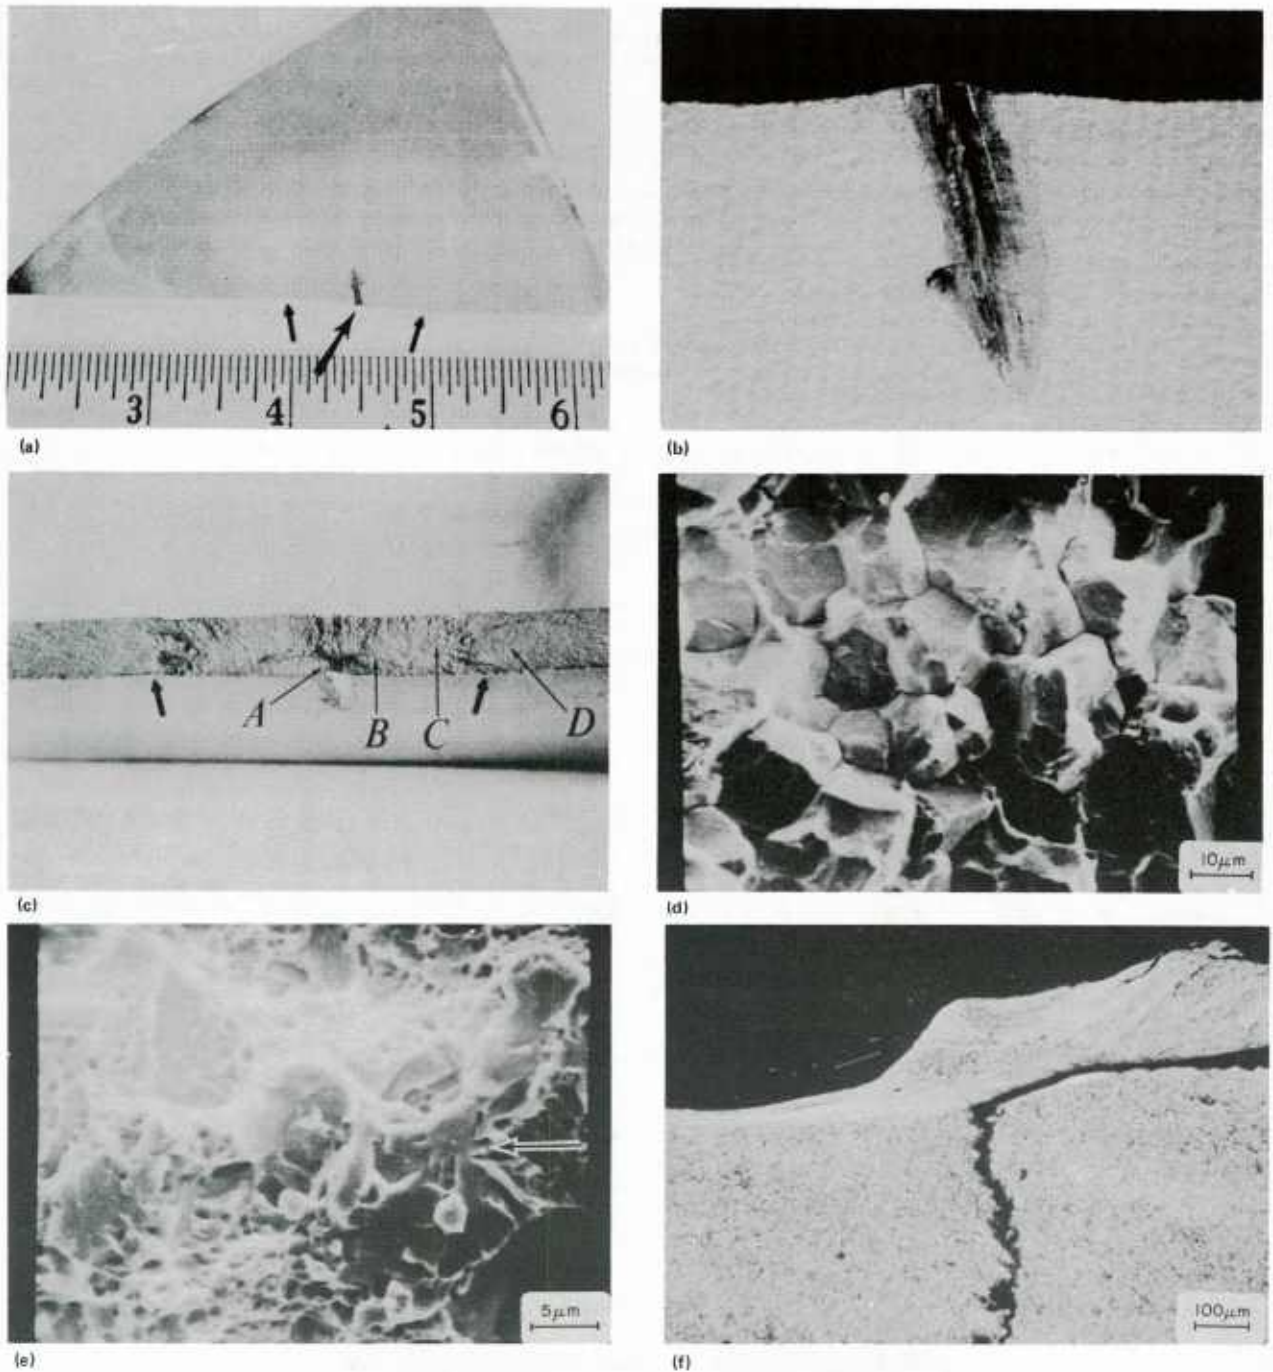
Fig. 12-13 Failure of a 4340 steel landing gear cylinder

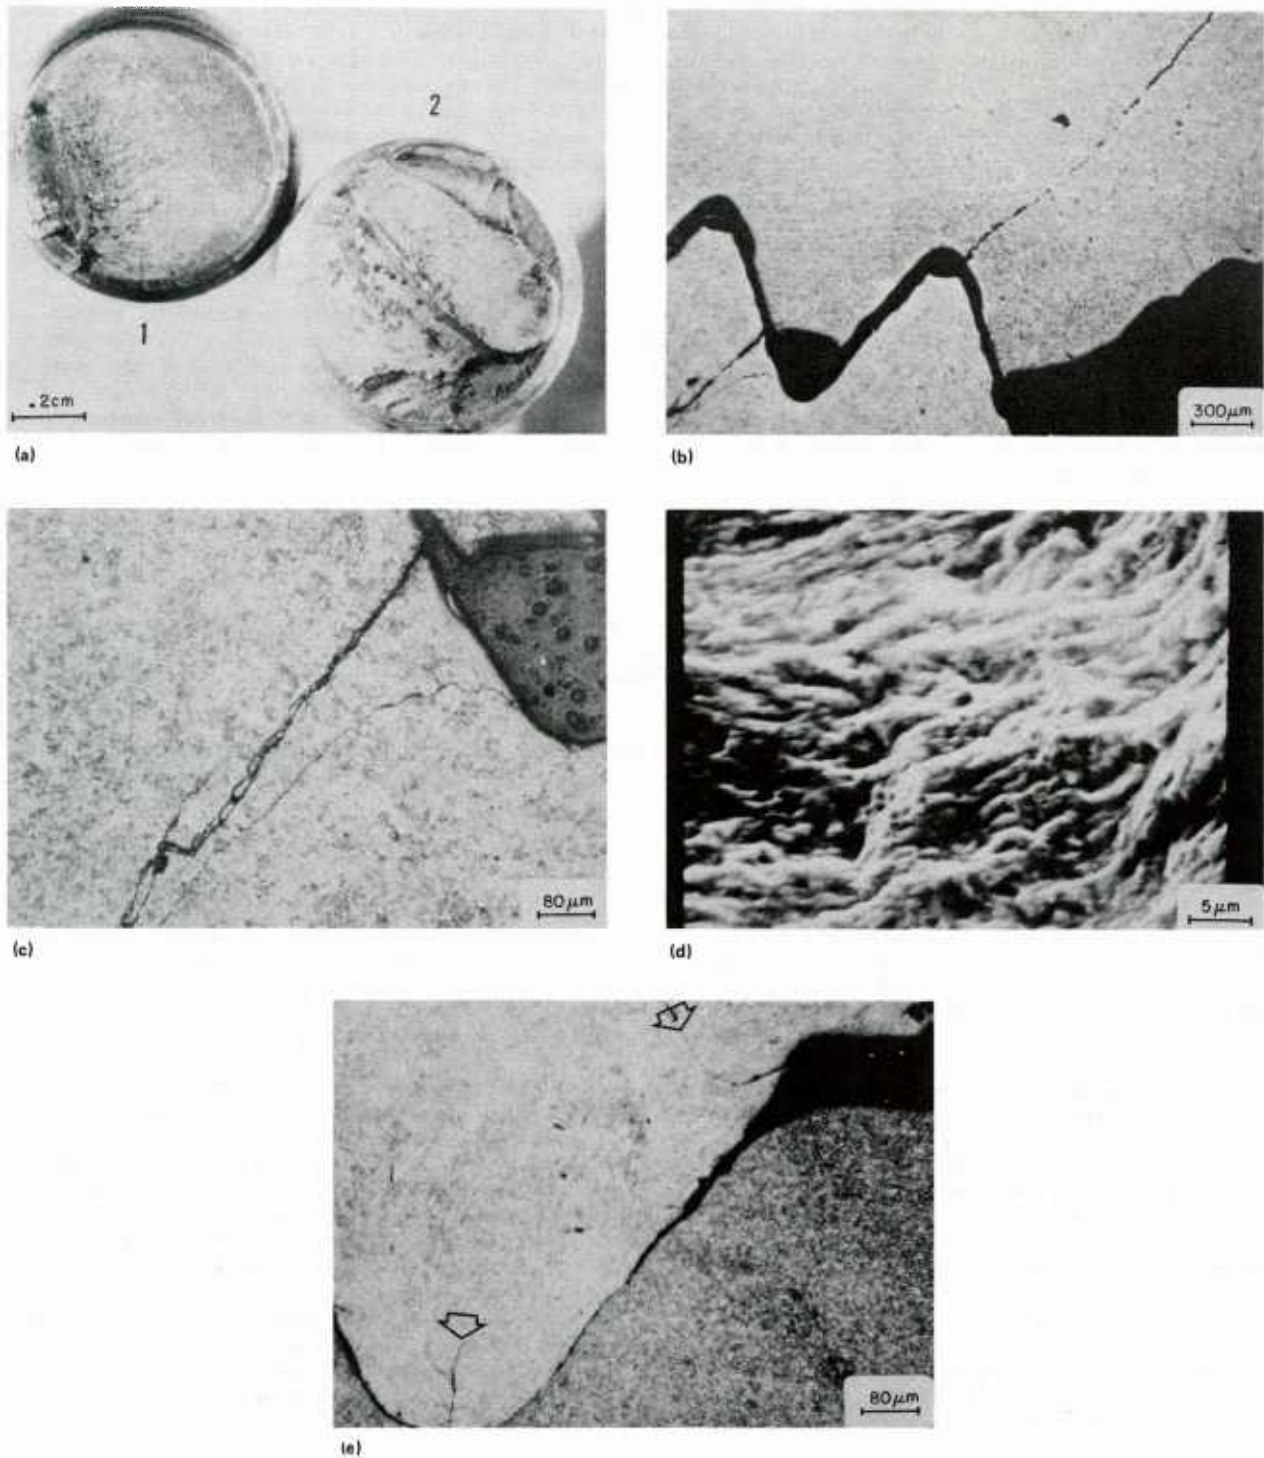
Fig. 12-14 Failure of two low alloy steel bolts

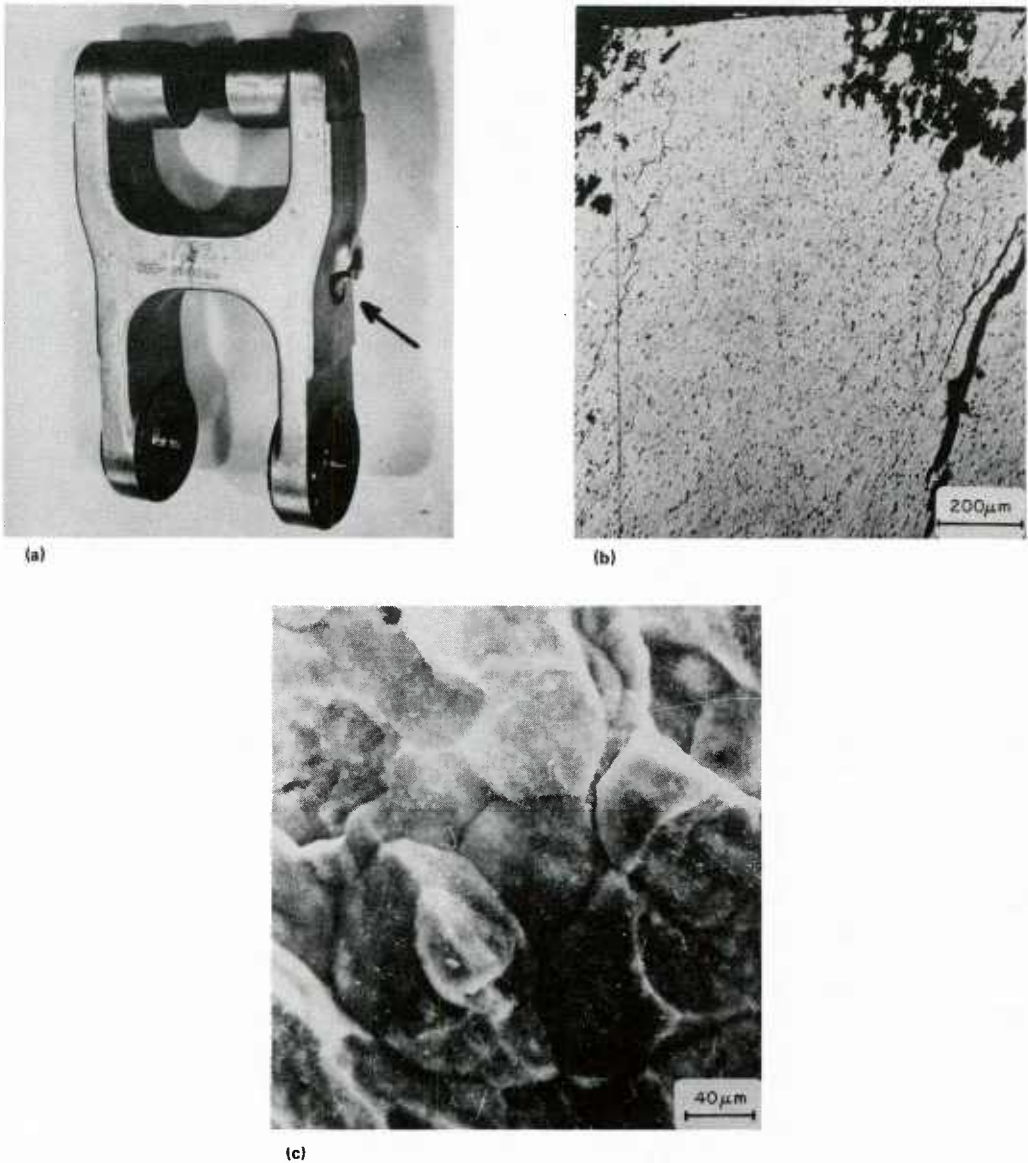
Fig. 13-7 Stress corrosion cracking occurring from corrosion pits and intergranular corrosion cracking in the parting plane of a 7079-T6 H-link.
