AGARDograph No. 278

AGARD Corrosion Handbook Volume 1 Aircraft Corrosion: Causes and Case Histories

AIRCRAFT CORROSION: CAUSES AND CASE HISTORIES

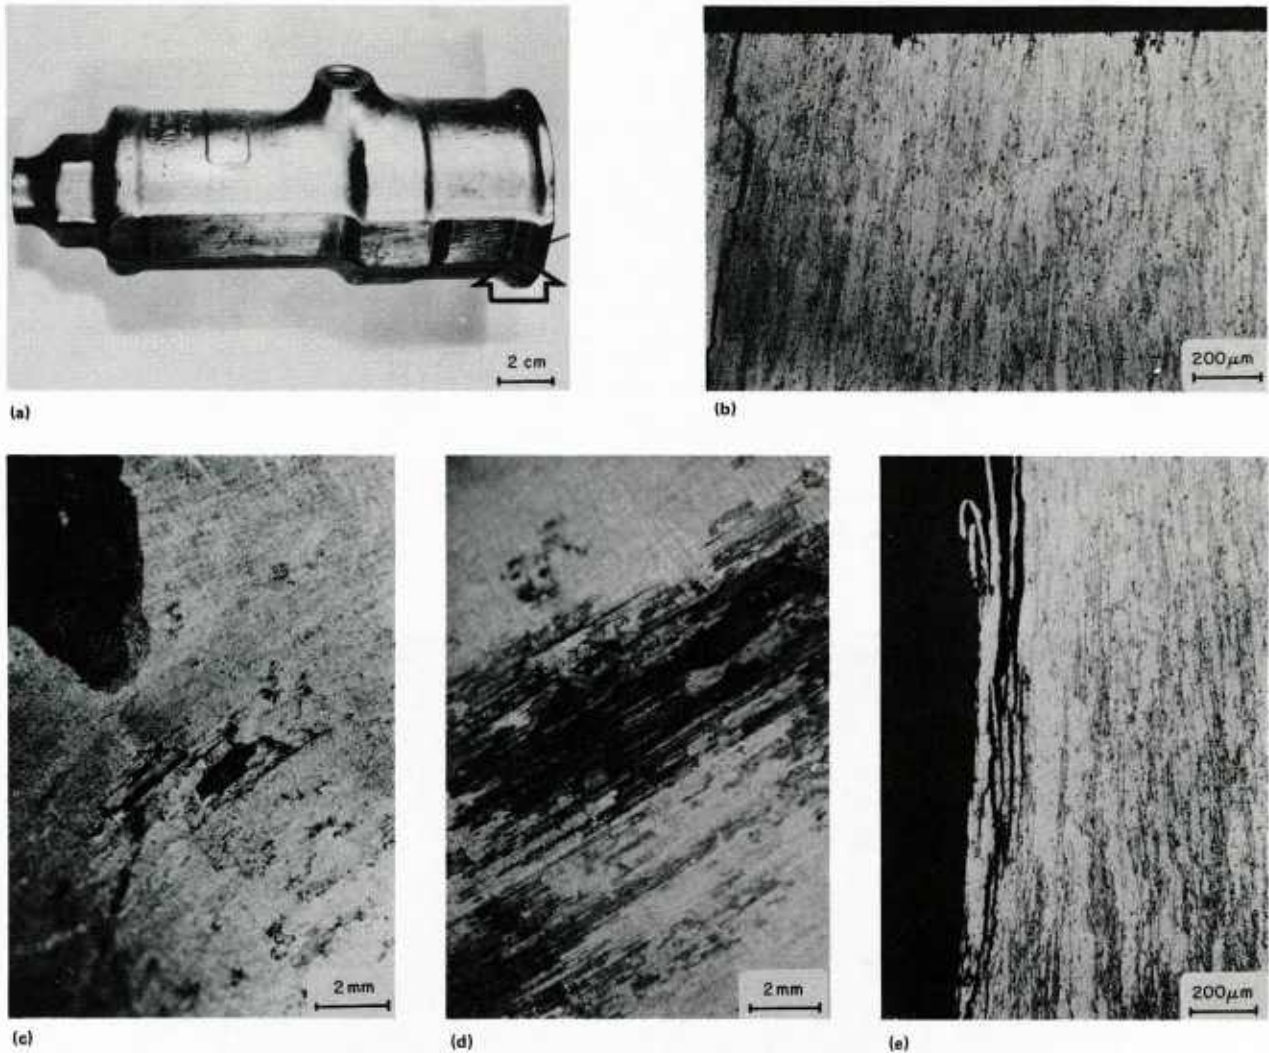
Fig. 13-26 Stress corrosion cracking in a 7079-T6 main landing gear locking cylinder, case history 13-1.

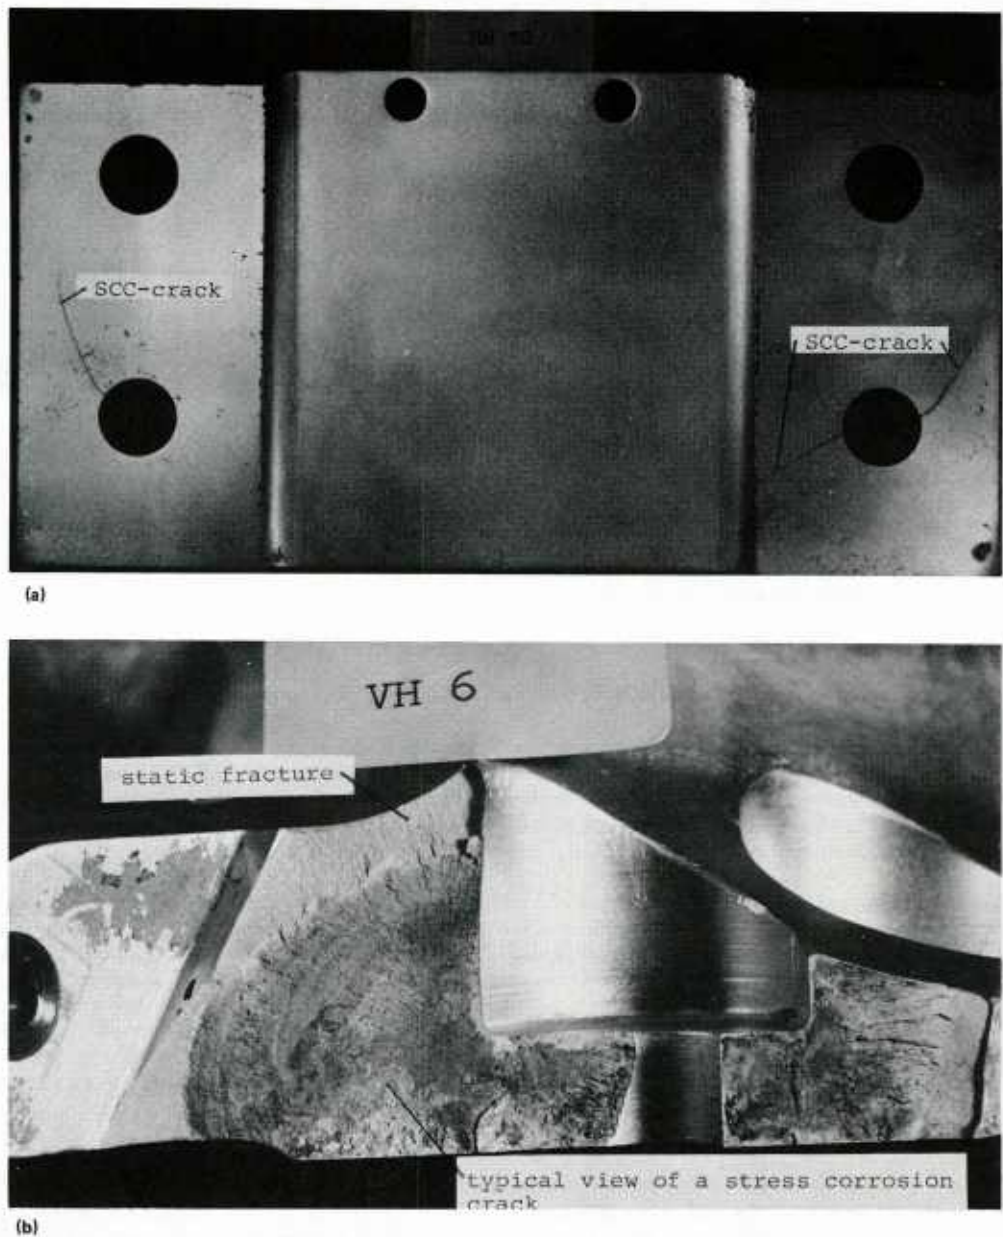
Fig. 13-28 Stress corrosion cracking in the 7079-T6 spars of a vertical fin, case history 13-2.

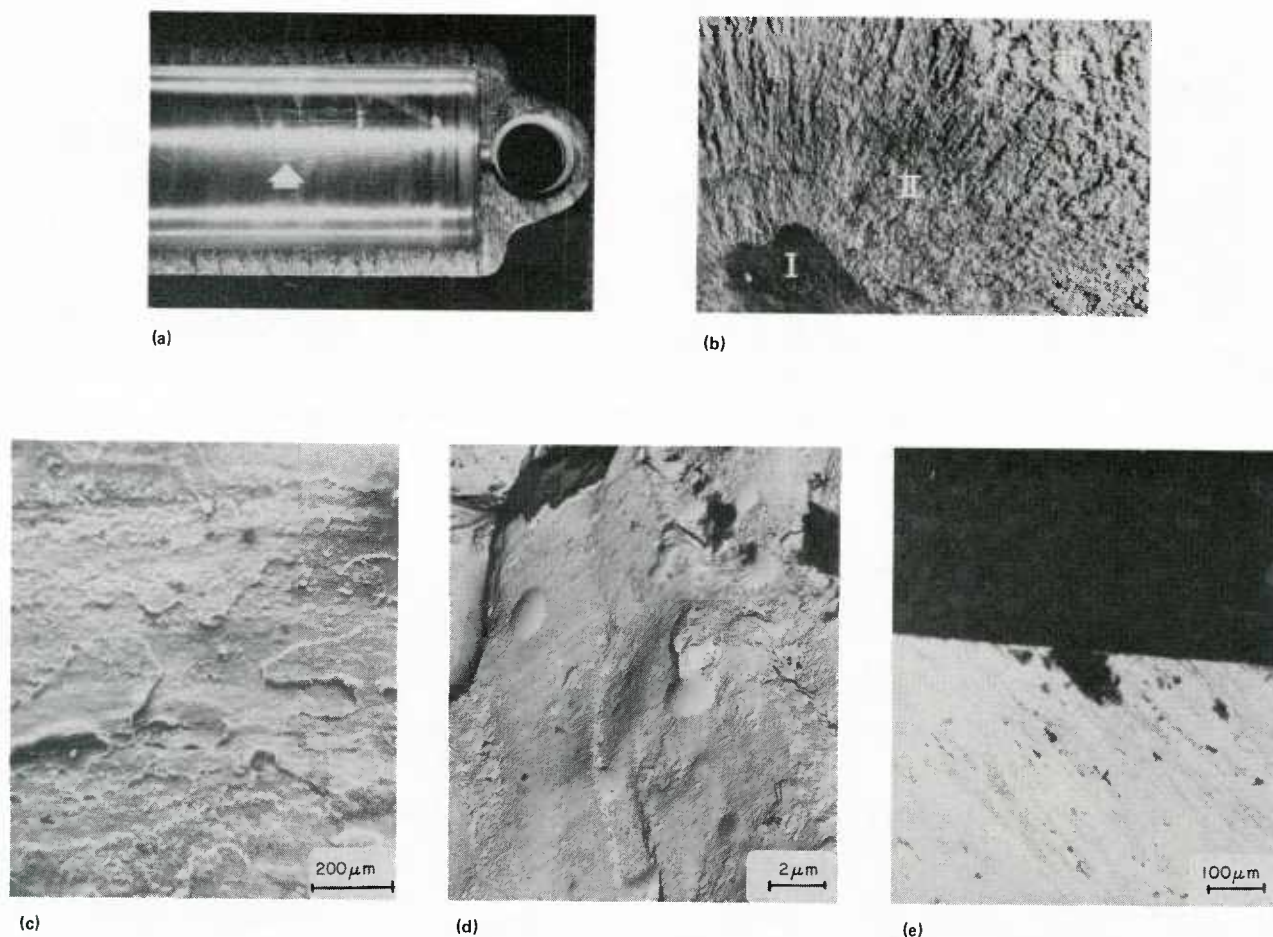
Fig. 13-31 Stress corrosion cracking of a 7075-T6 hydraulic cylinder, case history 13-5.

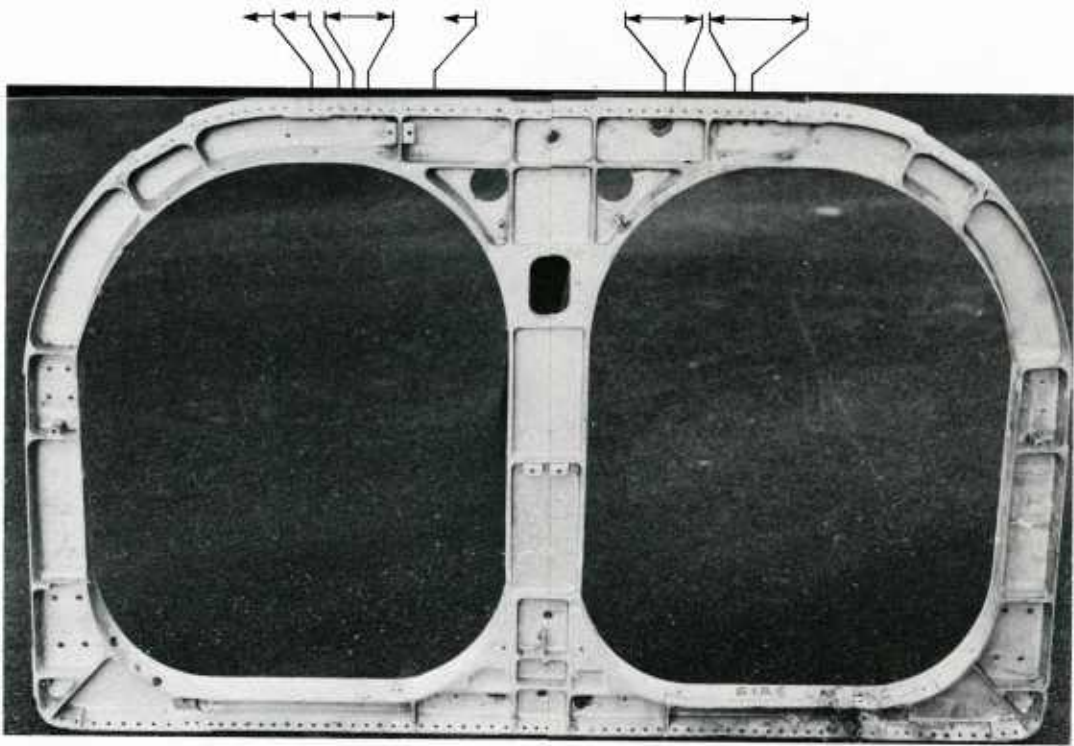
Fig. 13-39 Stress corrosion cracking in a 7075-T6 fuselage frame, case history 13-8. Arrows indicate the directions of cracking away from fastener holes.

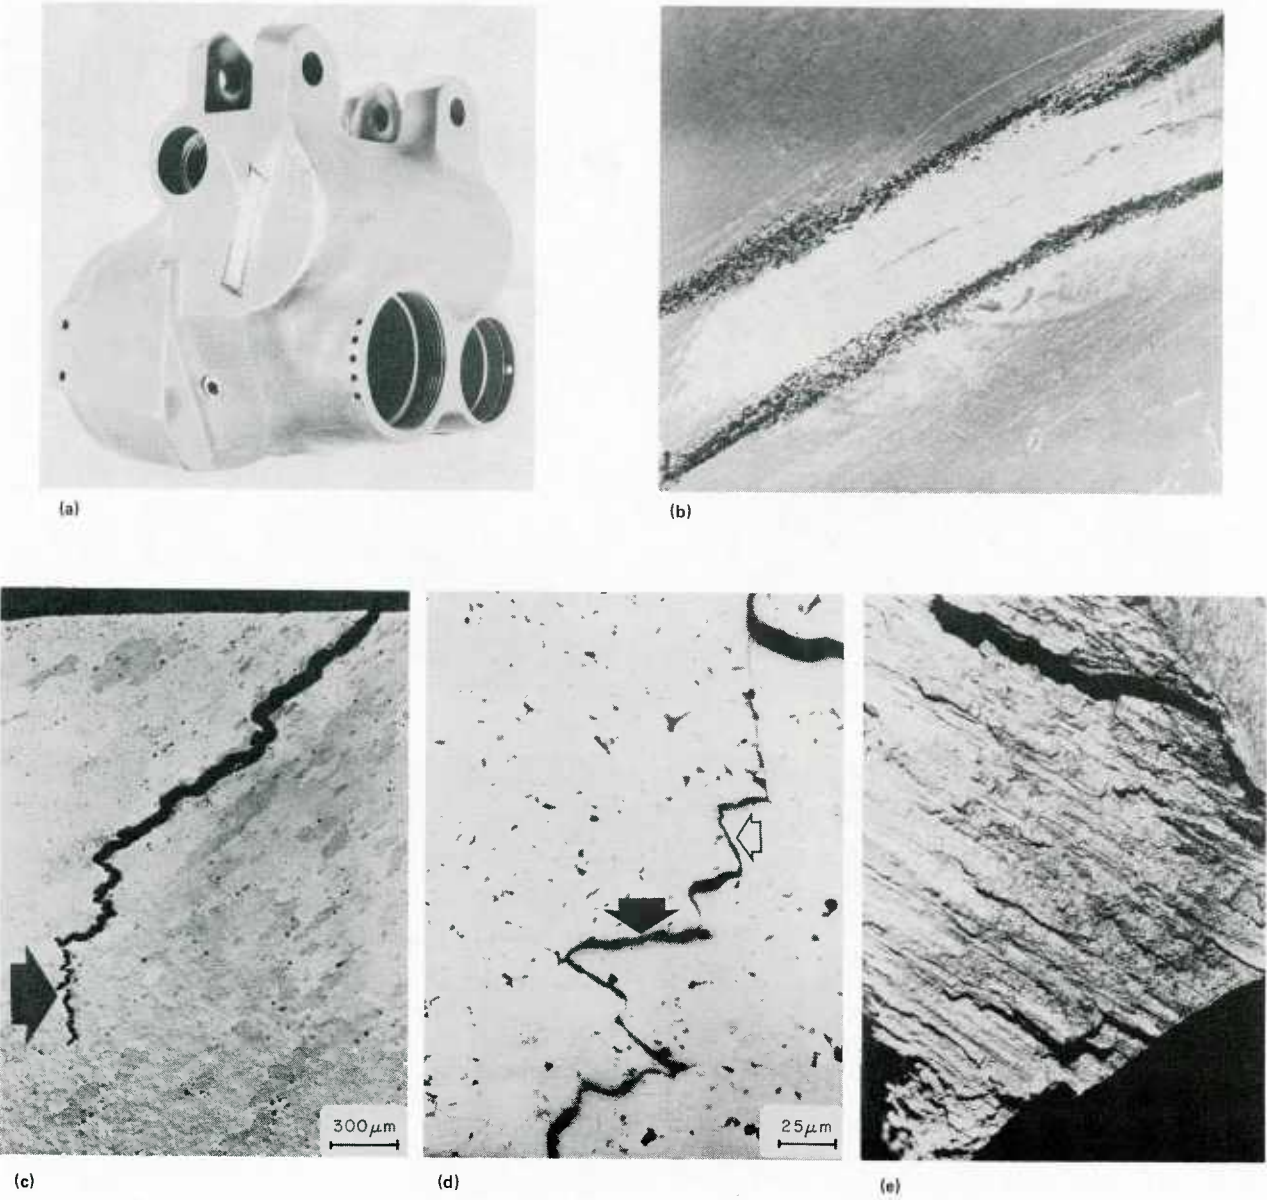
Fig. 13-44 Cracking in a 2014 aluminium nose wheel steering damper, case history 13-9.

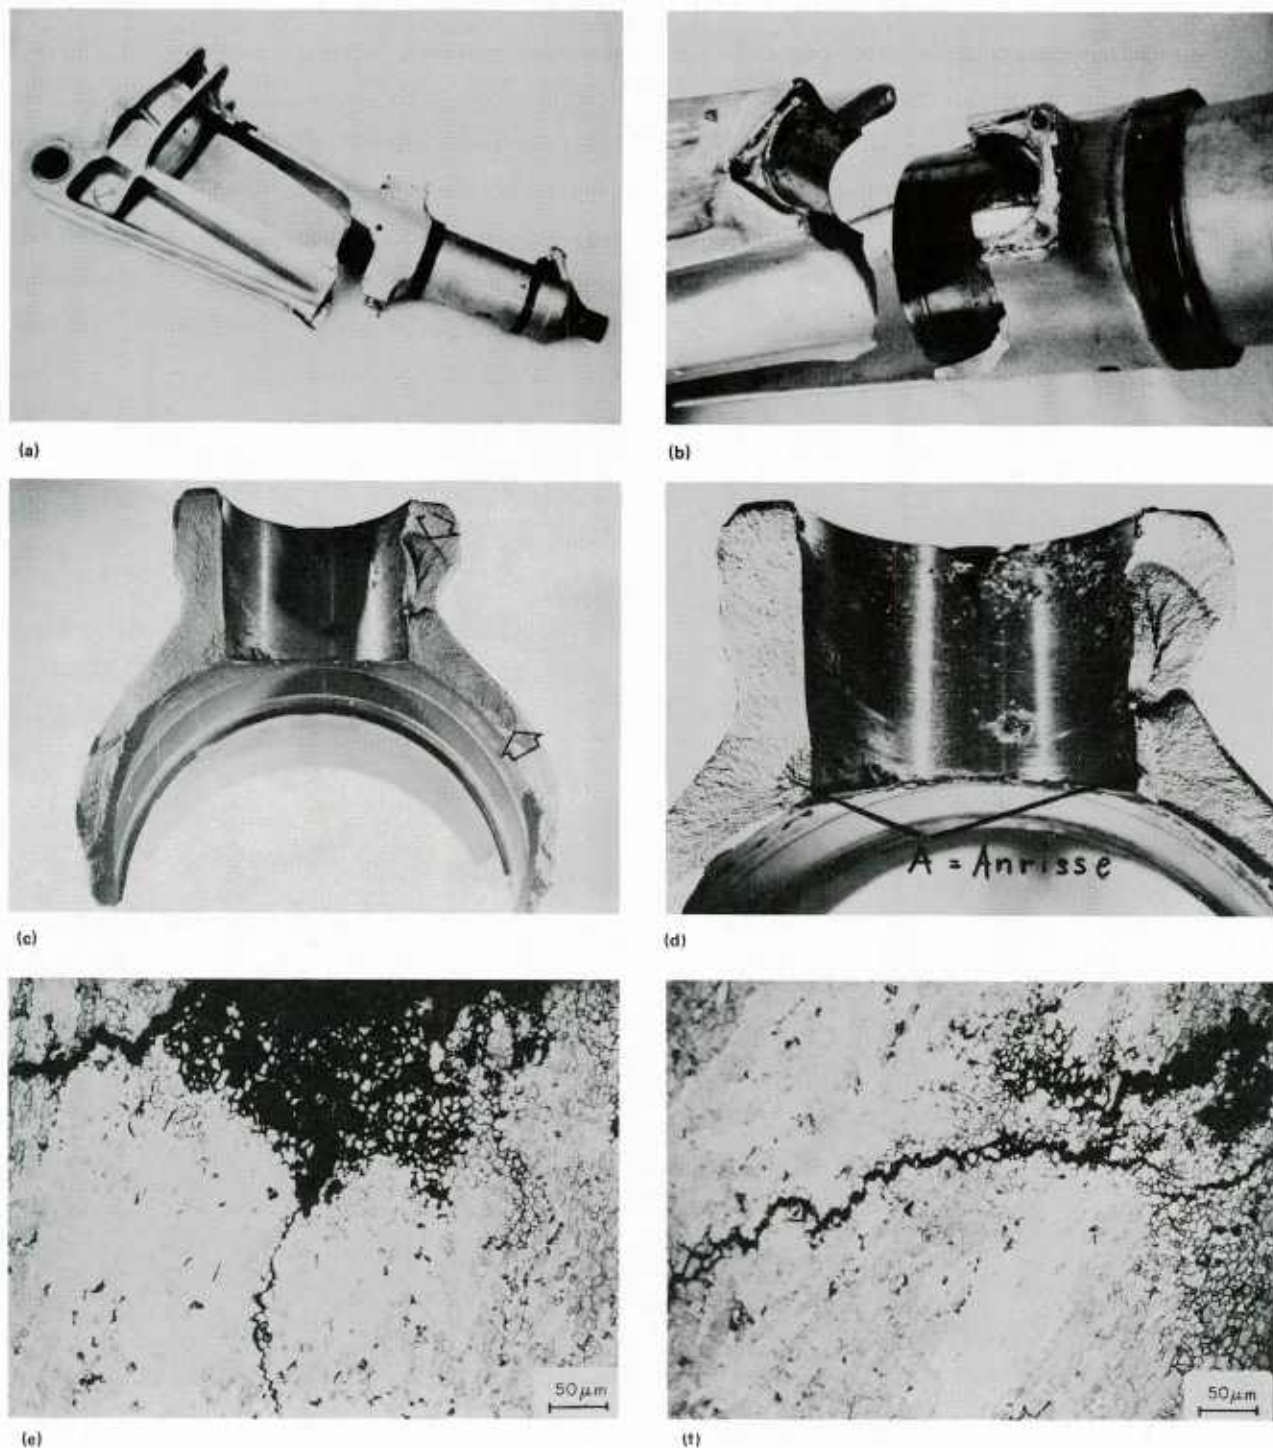
Fig. 13-45 Failure of an Al-Cu main landing gear part, case history 13-10.

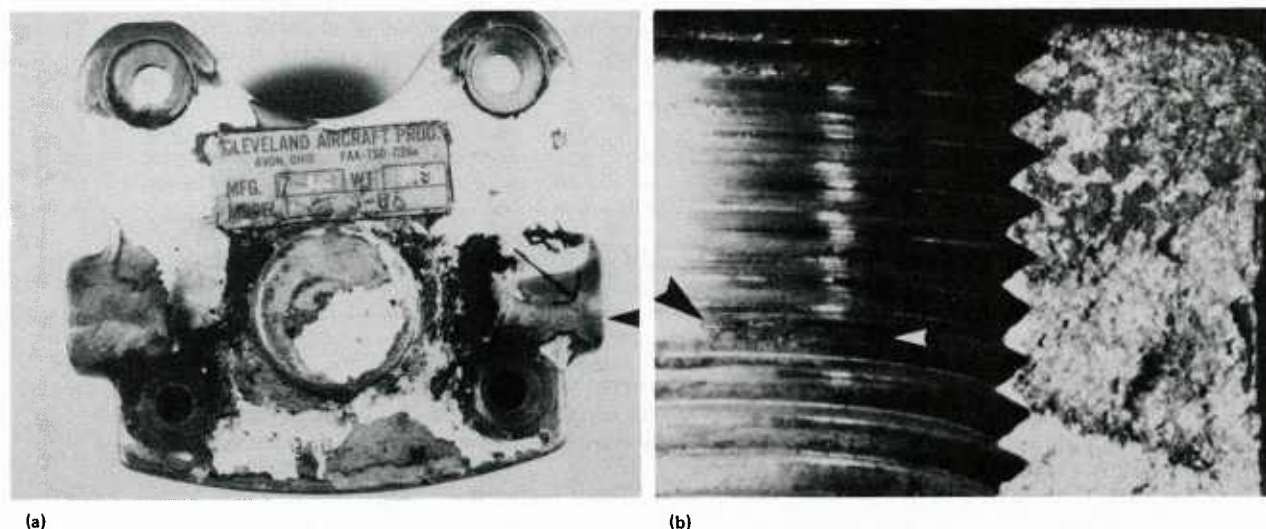
Fig. 13-46 Stress corrosion cracking of a magnesium alloy brake housing, case history 13-11.

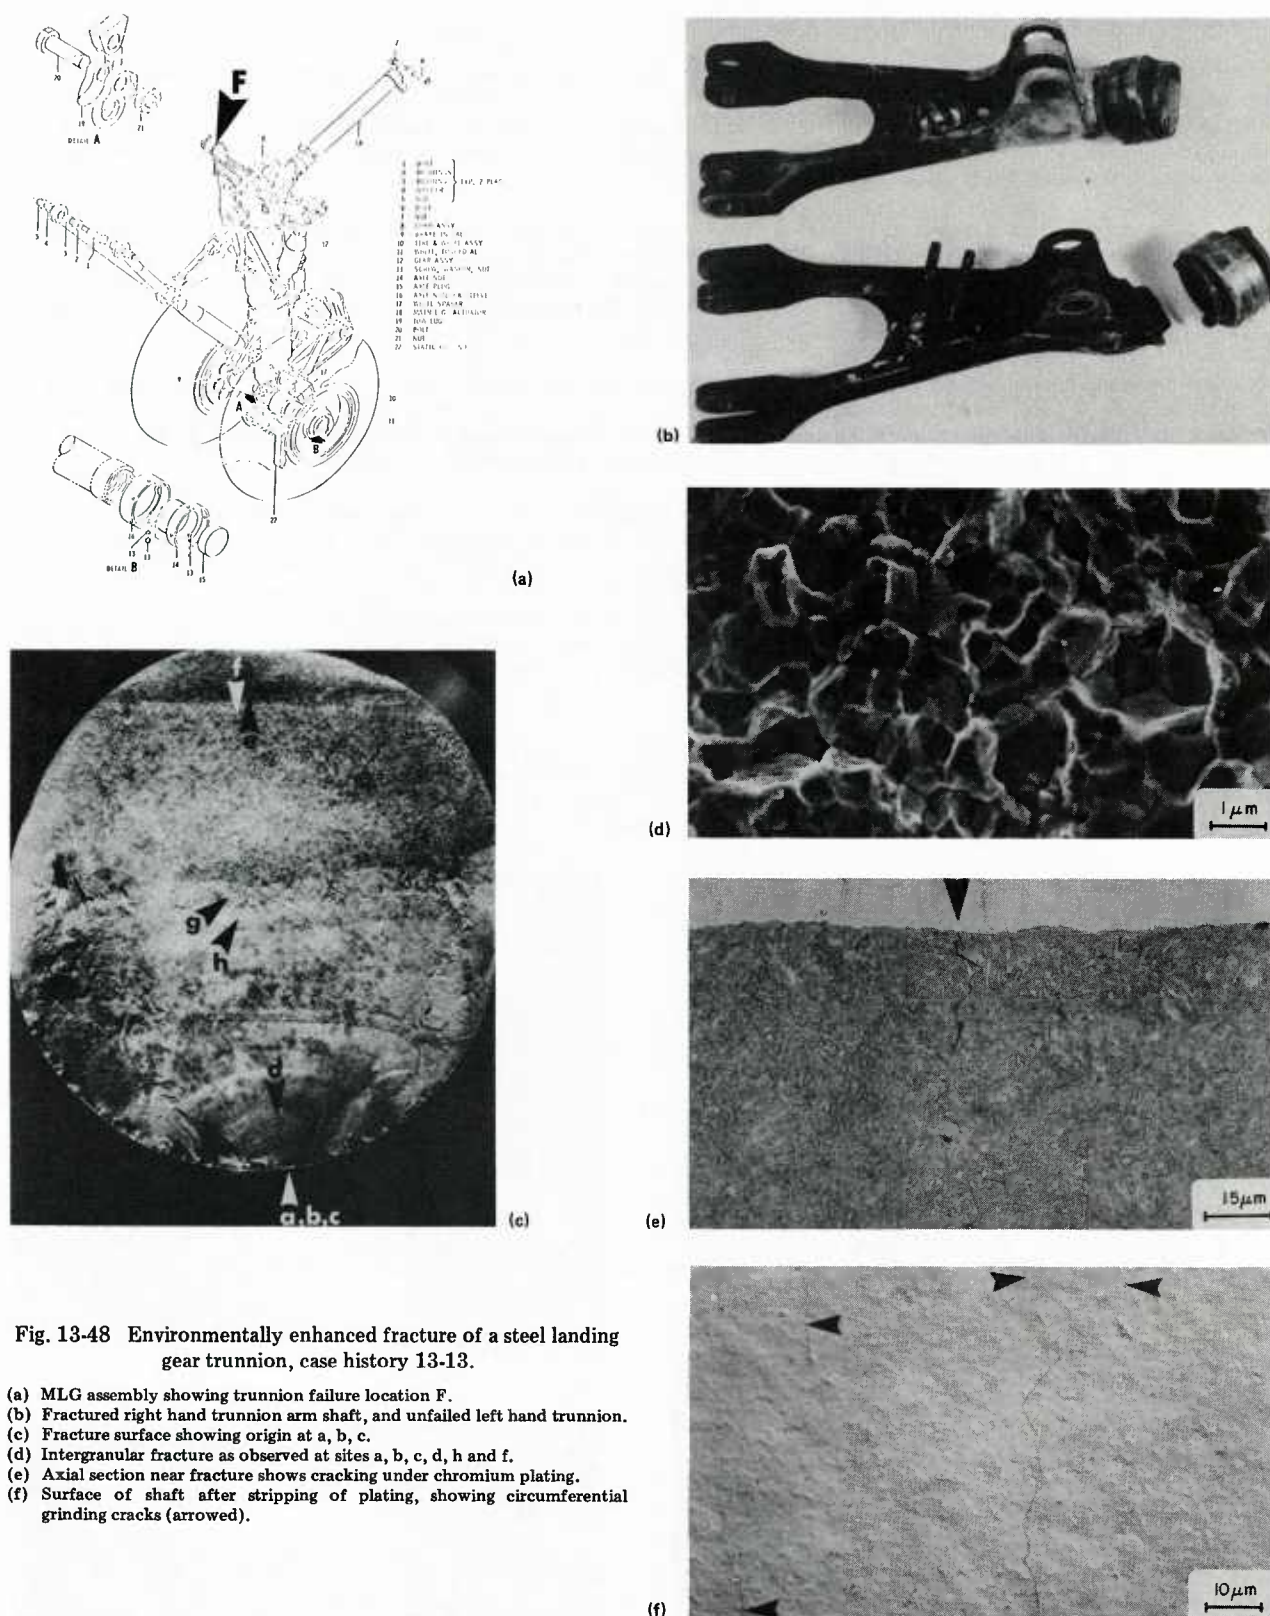
Fig. 13-48 Environmentally enhanced fracture of a steel landing gear trunnion, case history 13-13.

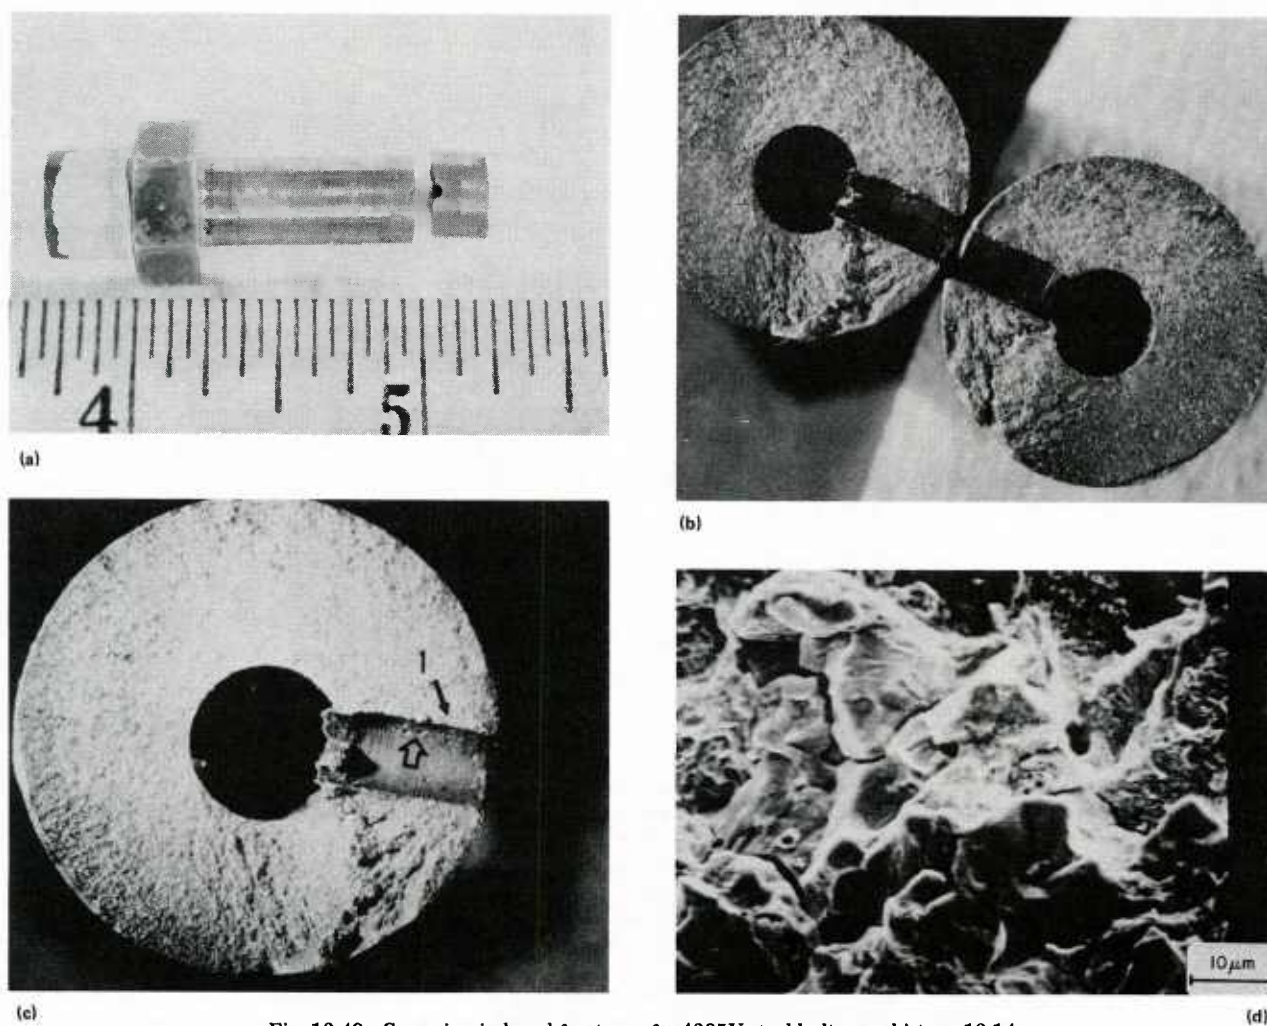
Fig. 13-49 Corrosion induced fracture of a 4335V steel bolt, case history 13-14.

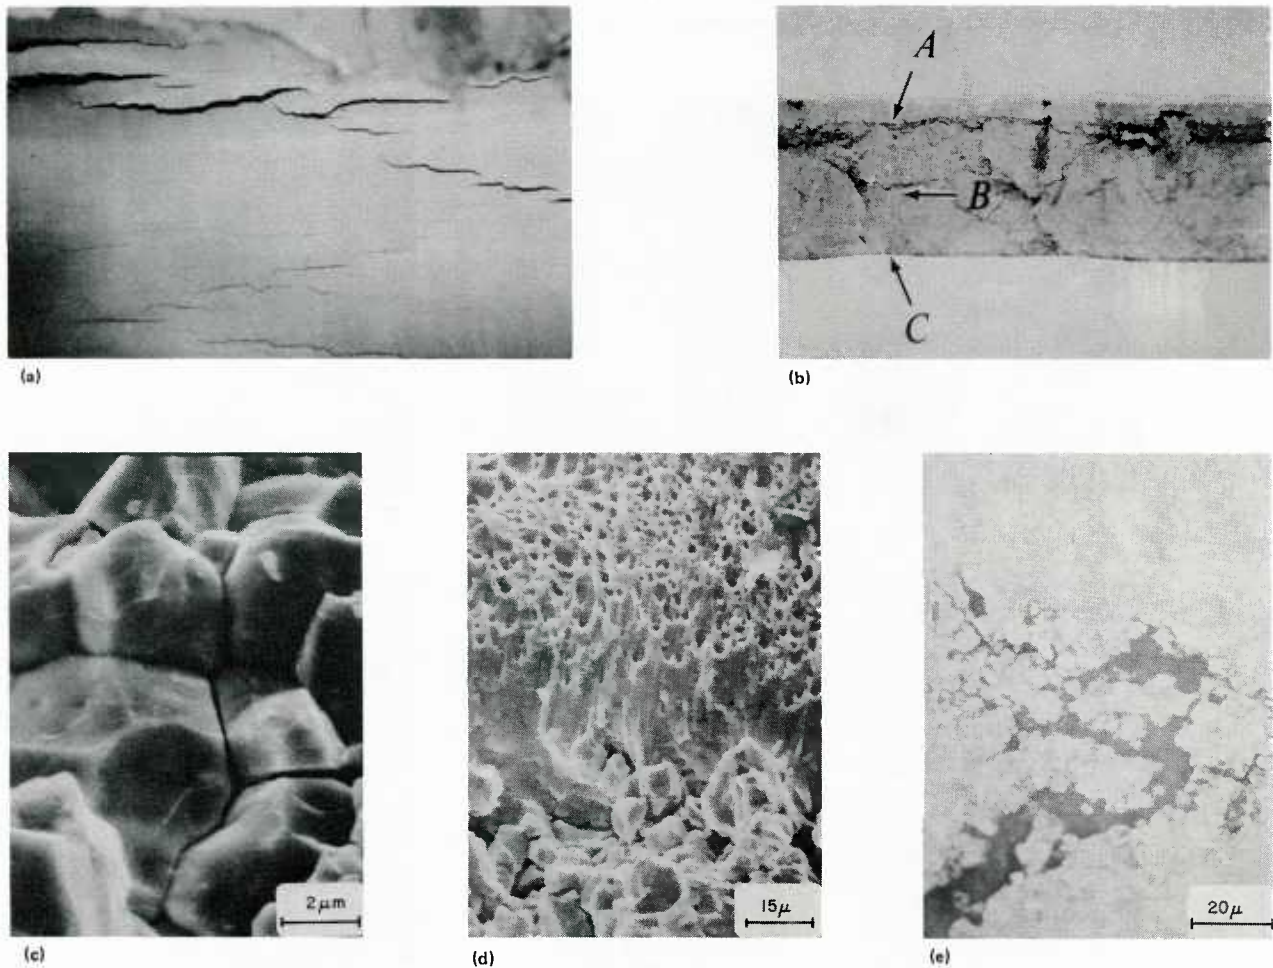
Fig. 13-50 Failure of a 18-Ni maraging steel pressure vessel, case history 13-15.

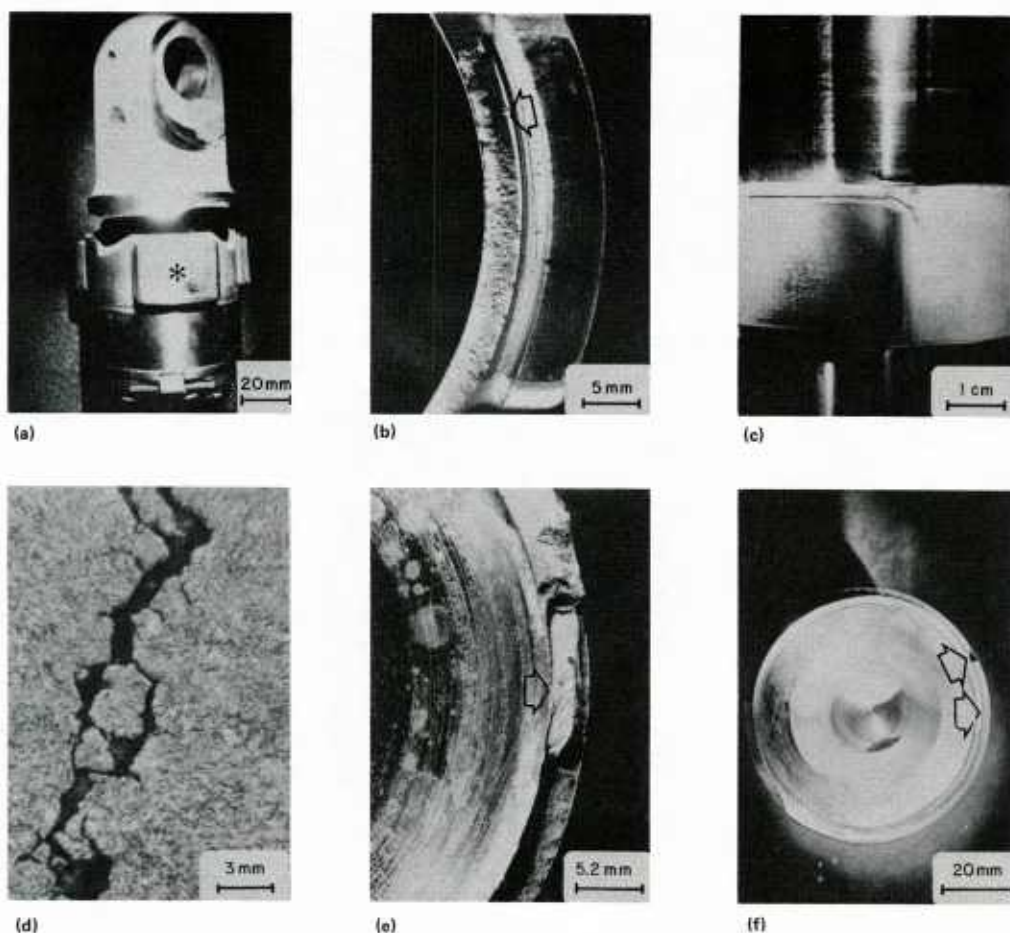
Fig. 13-51 Corrosion induced failure of four 4340 landing gear retraction cylinders, case history 13-16.

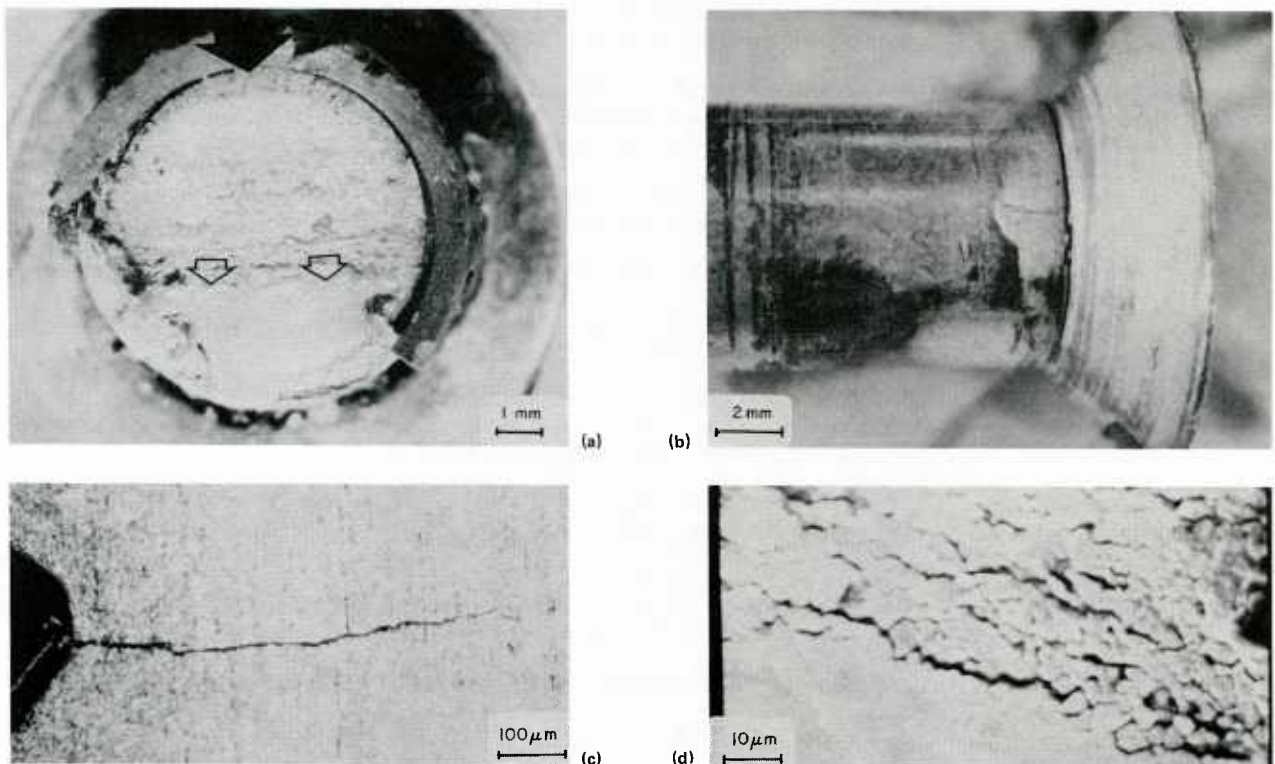
Fig. 13-52 Corrosion induced failure of a 1040 plain carbon steel bolt, case history 13-17.

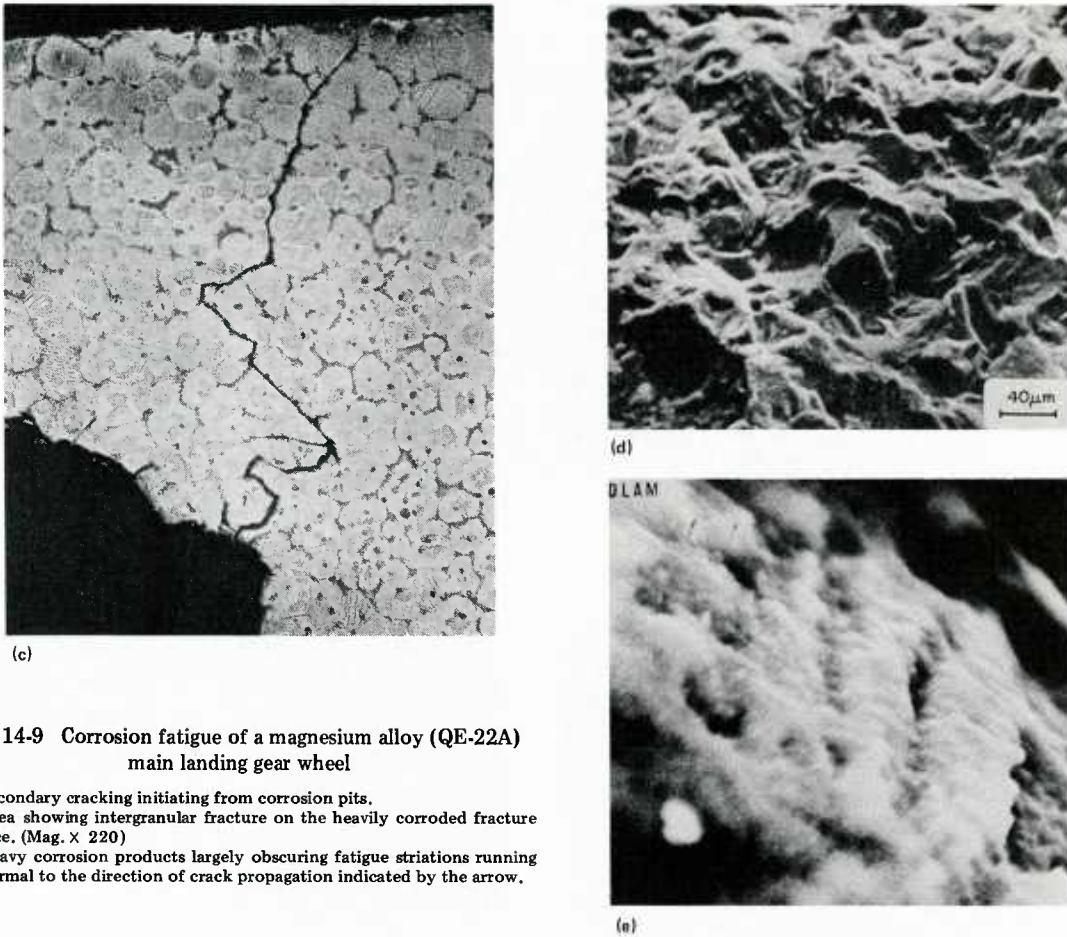
**Fig. 14-9 Corrosion fatigue of a magnesium alloy (QE-22A)
main landing gear wheel**

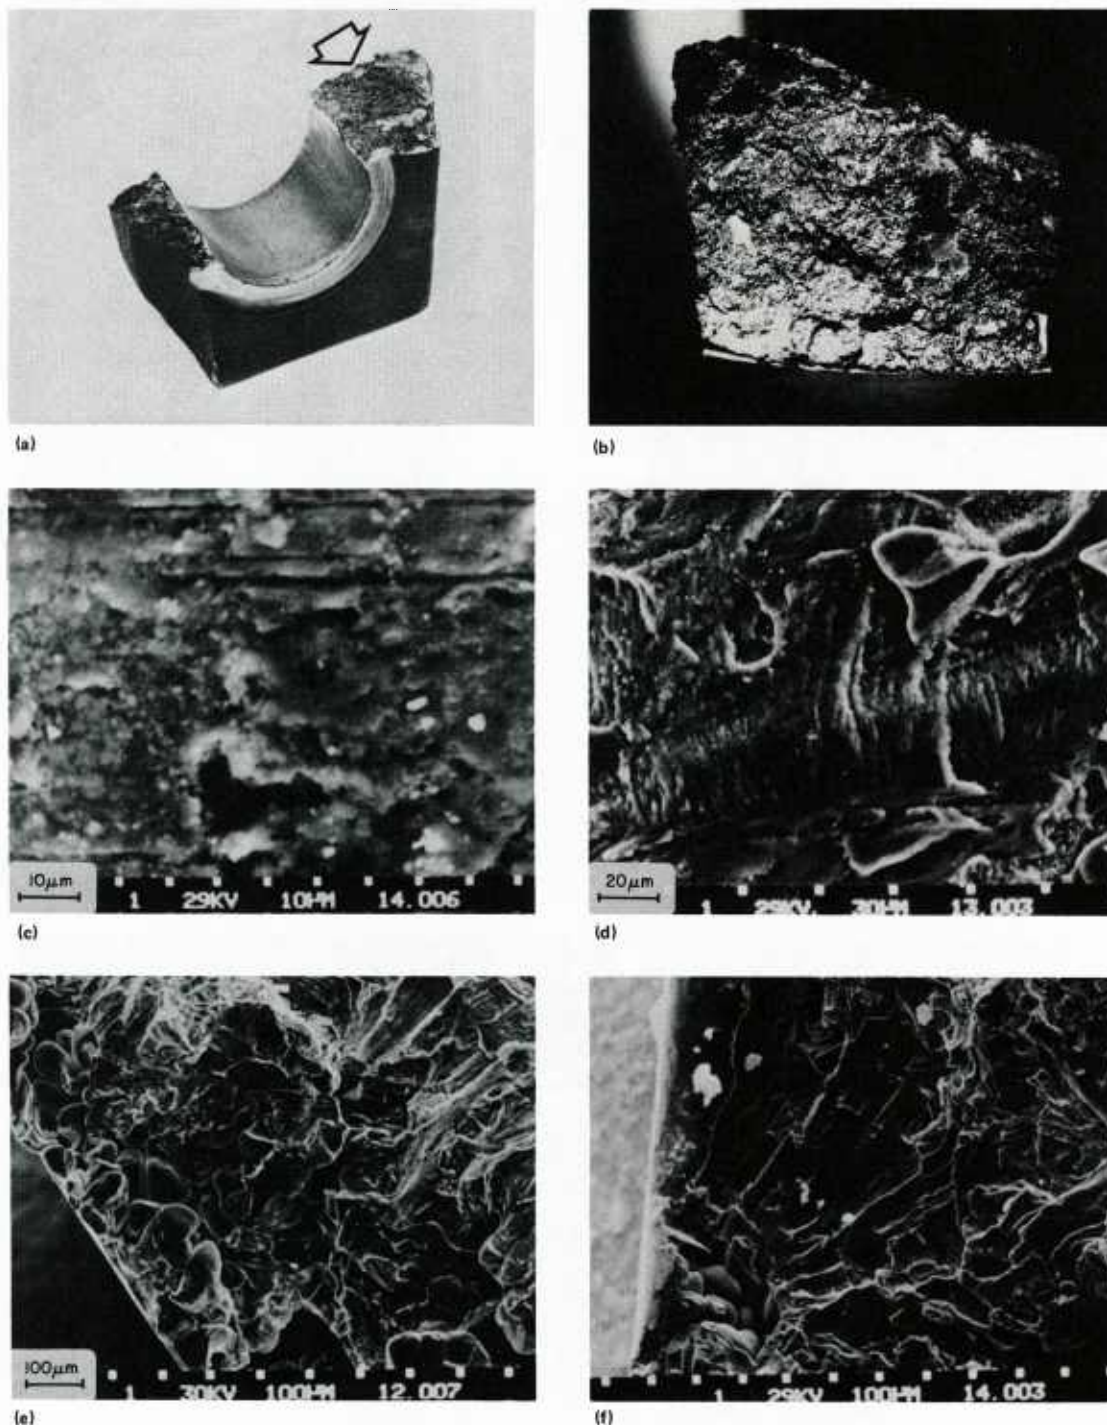
Fig. 14-11 Corrosion fatigue of a cast aluminium rocker arm journal bearing

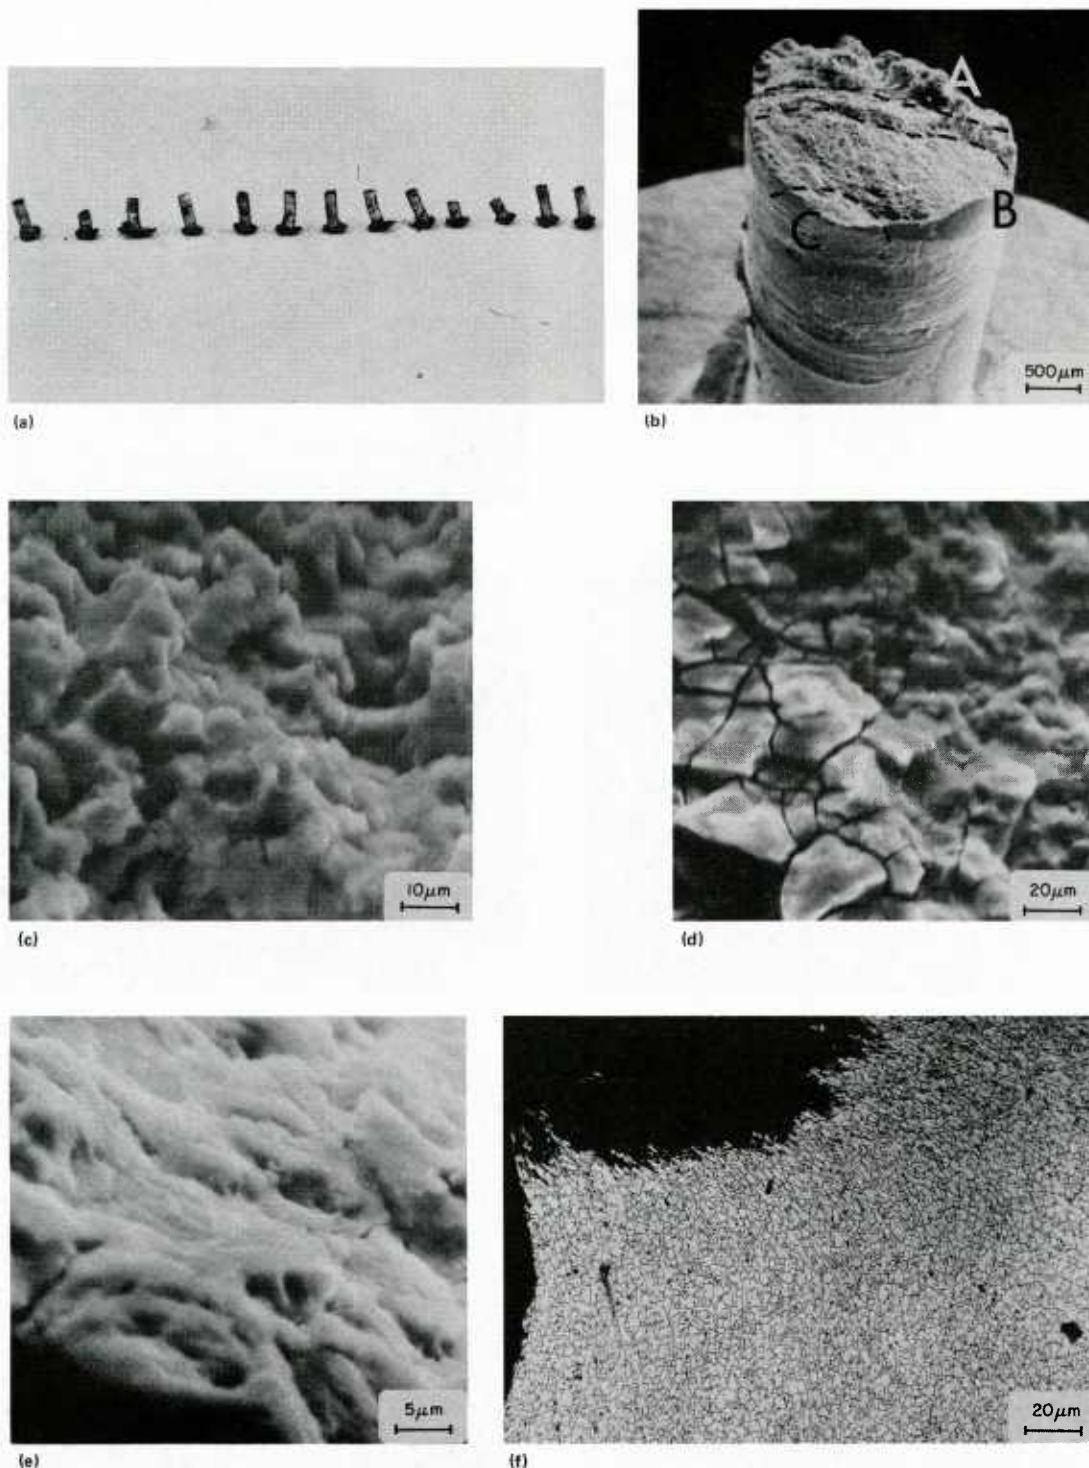
Fig. 14-12 Corrosion fatigue of 5052 aluminium alloy rivets

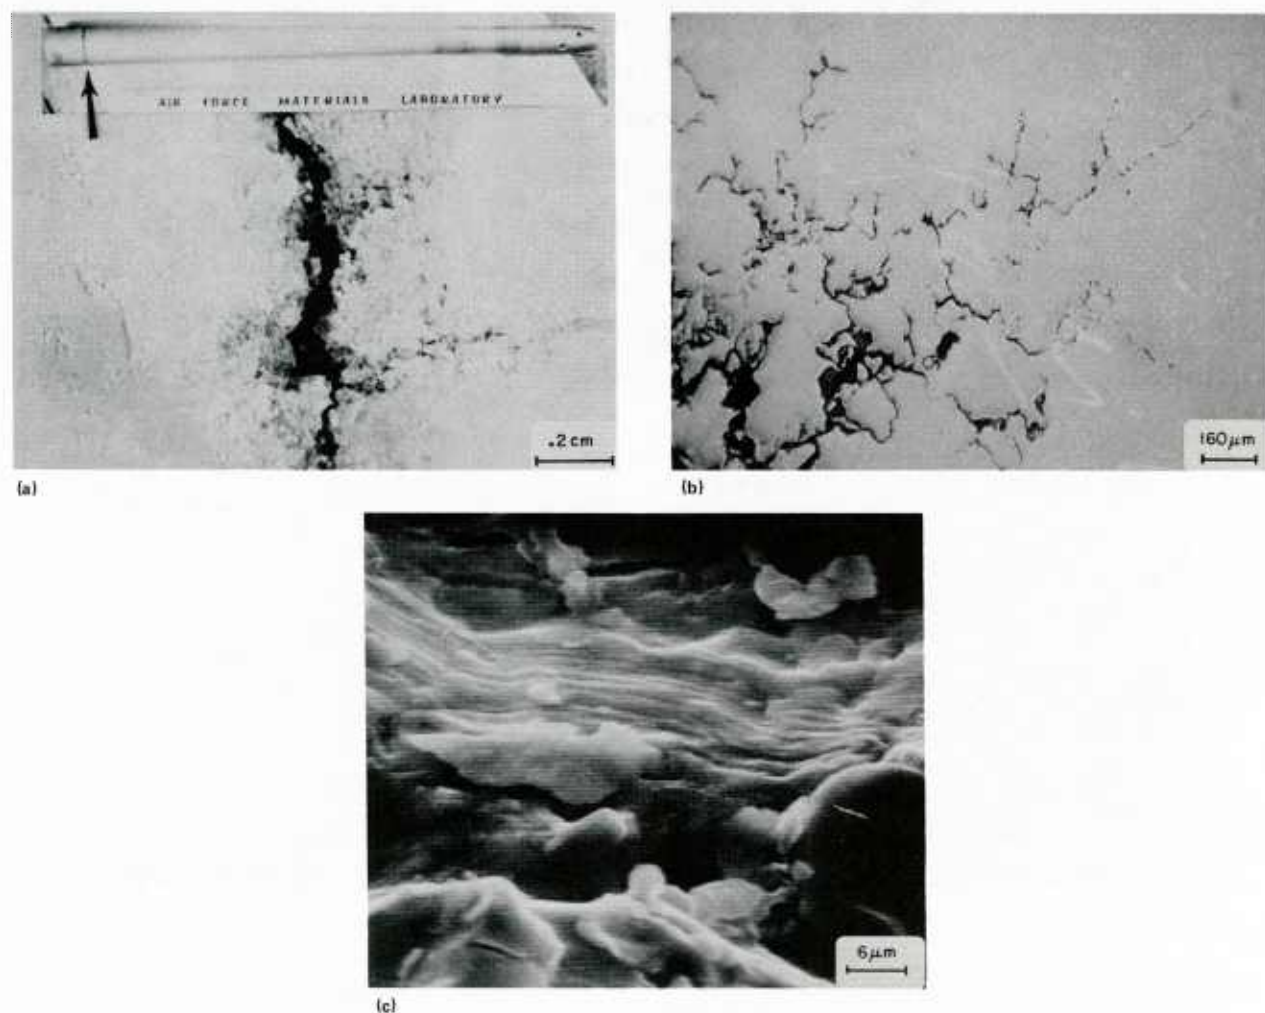
Fig. 14-13 Corrosion fatigue in a 6061 aluminium pitot support tube

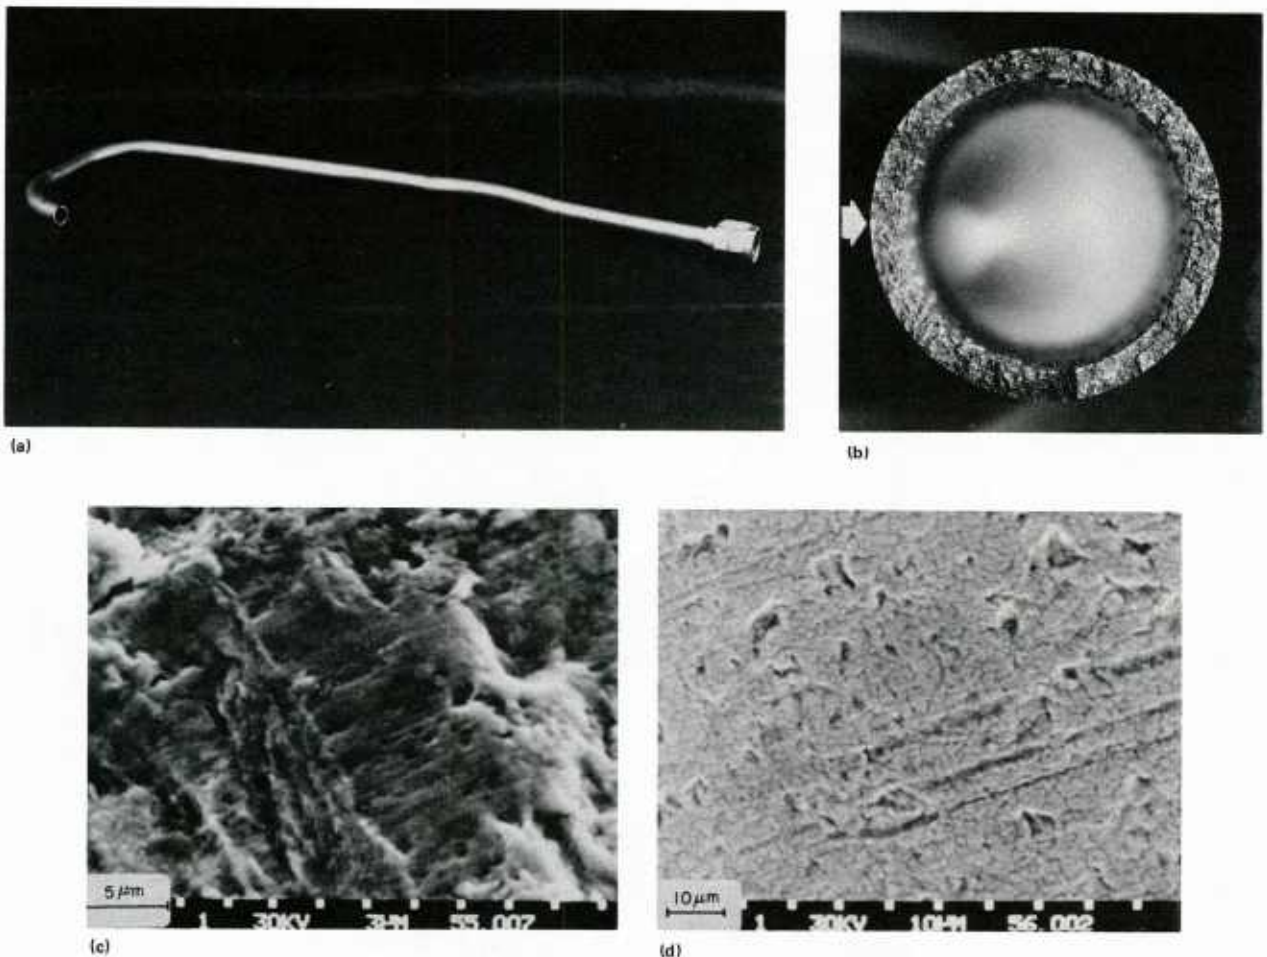
Fig. 14-14 Corrosion fatigue of a 321 stainless steel hose assembly
