AGARDograph No. 278

AGARD Corrosion Handbook Volume 1 Aircraft Corrosion: Causes and Case Histories

AIRCRAFT CORROSION: CAUSES AND CASE HISTORIES

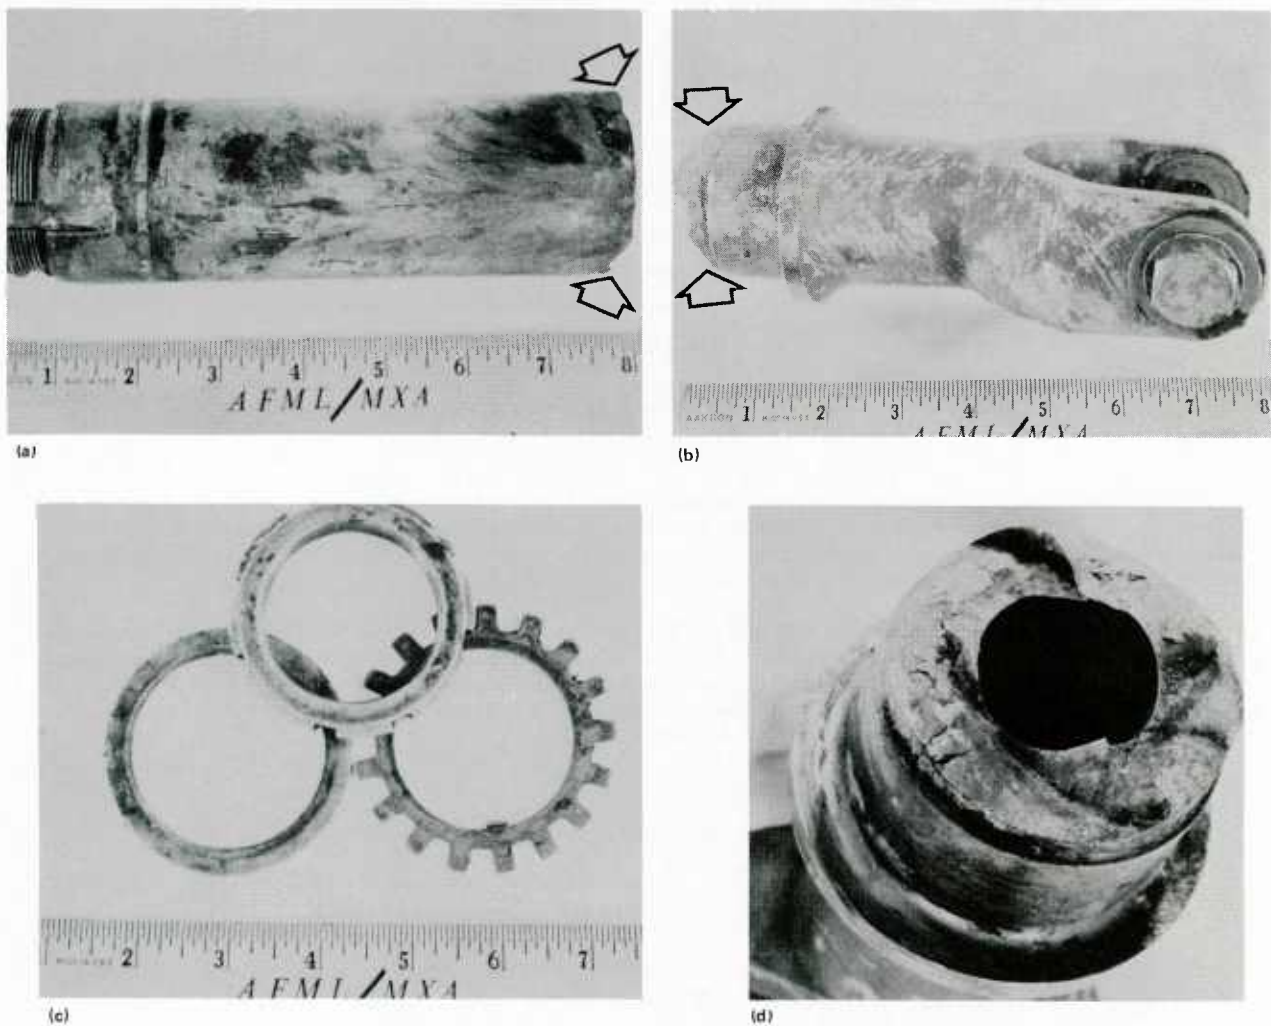
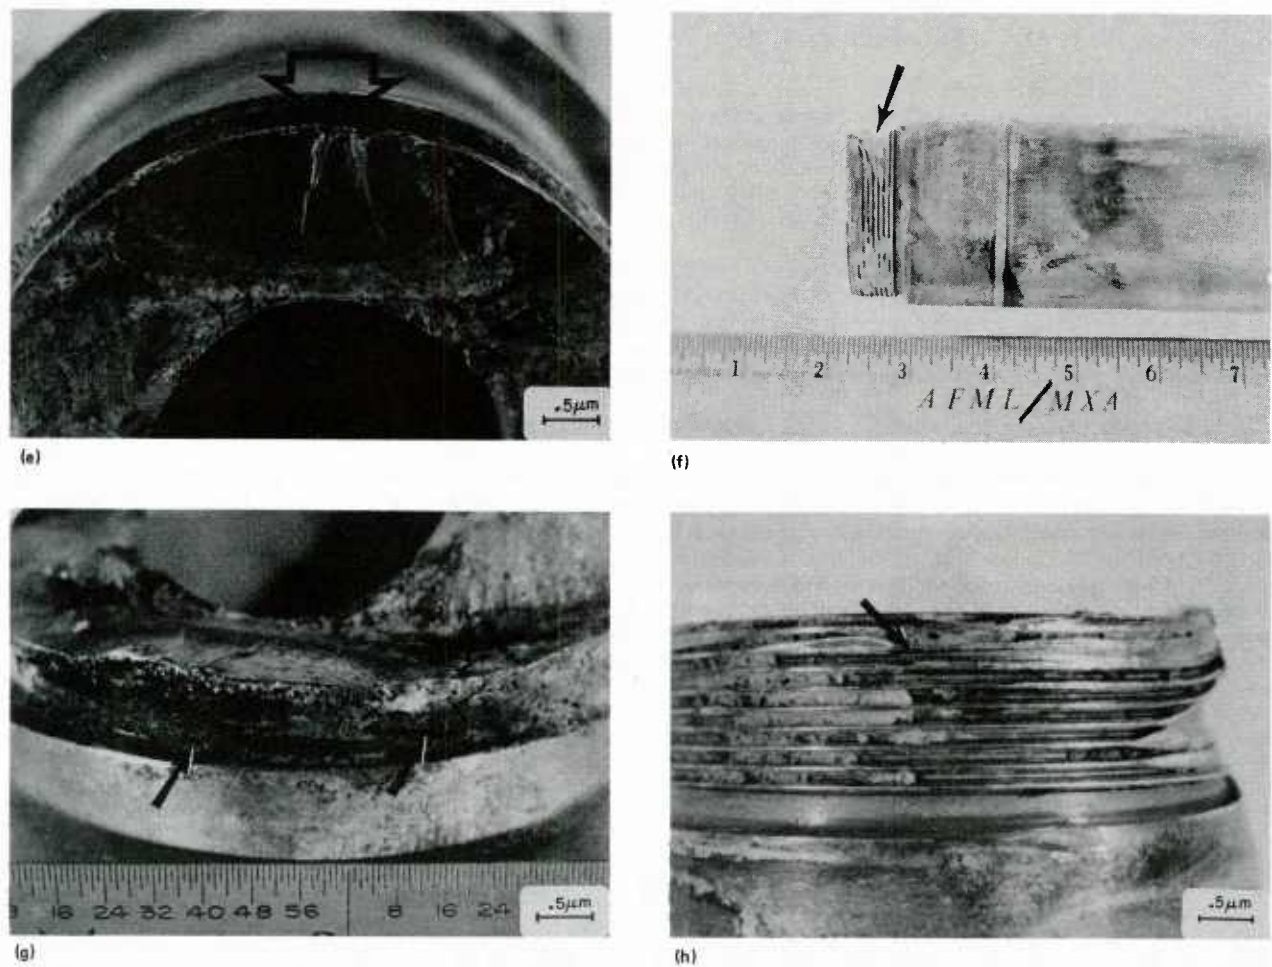
Fig. 14-15 Corrosion fatigue of a 4340 steel rotor attachment assembly

(d) Fracture face of the pin before cleaning.
