Rain Impact Assessment of Advanced Thermal Protection System Materials Phase I Test Results

R. M. COOPER
Materials Sciences Laboratory
Laboratory Operations
The Aerospace Corporation
El Segundo, CA 90245

5 September 1985

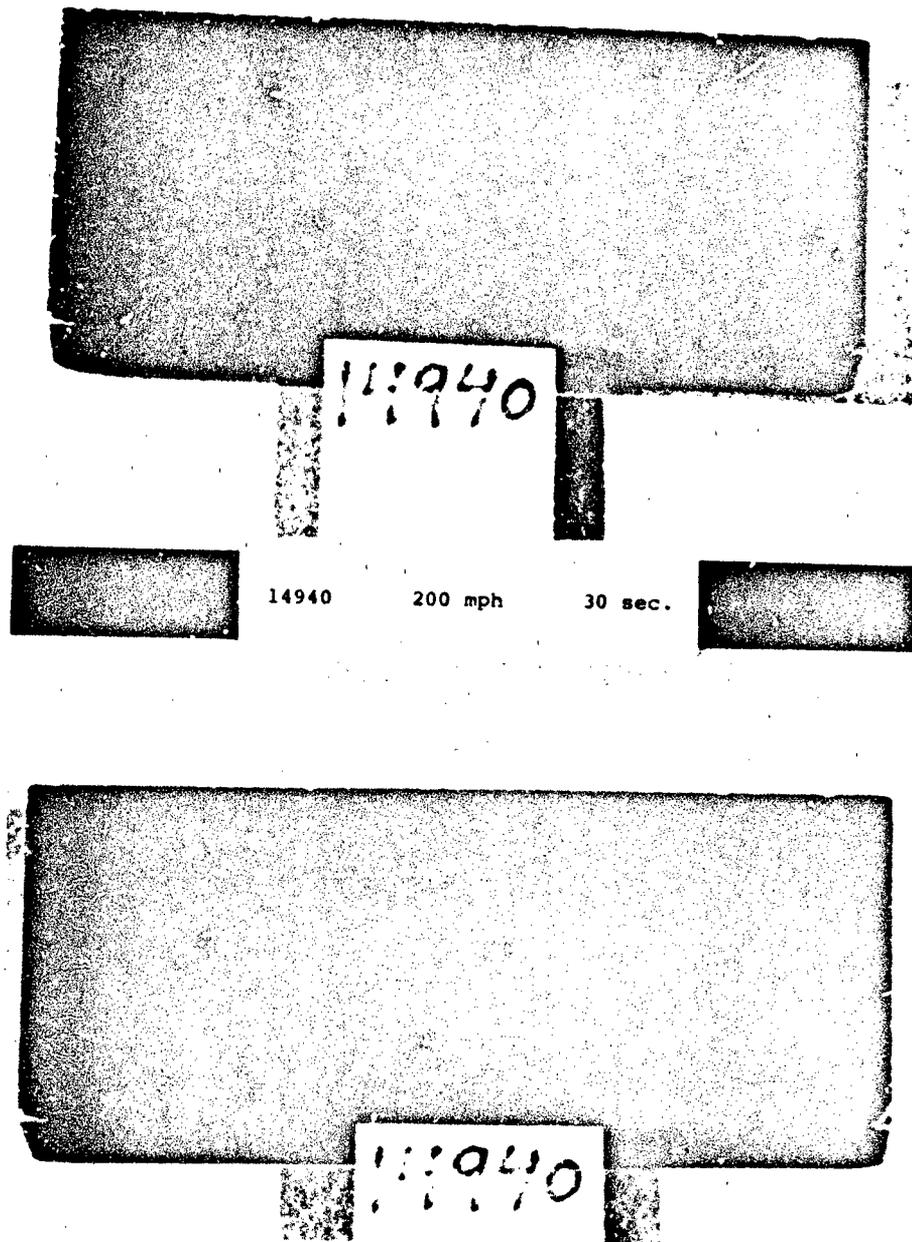
Fig. 5. Pre- and post exposure, FRCI-20-20 with standard RCG ceramic coating, showing subsurface fractures after 30 sec exposure at 200 mph

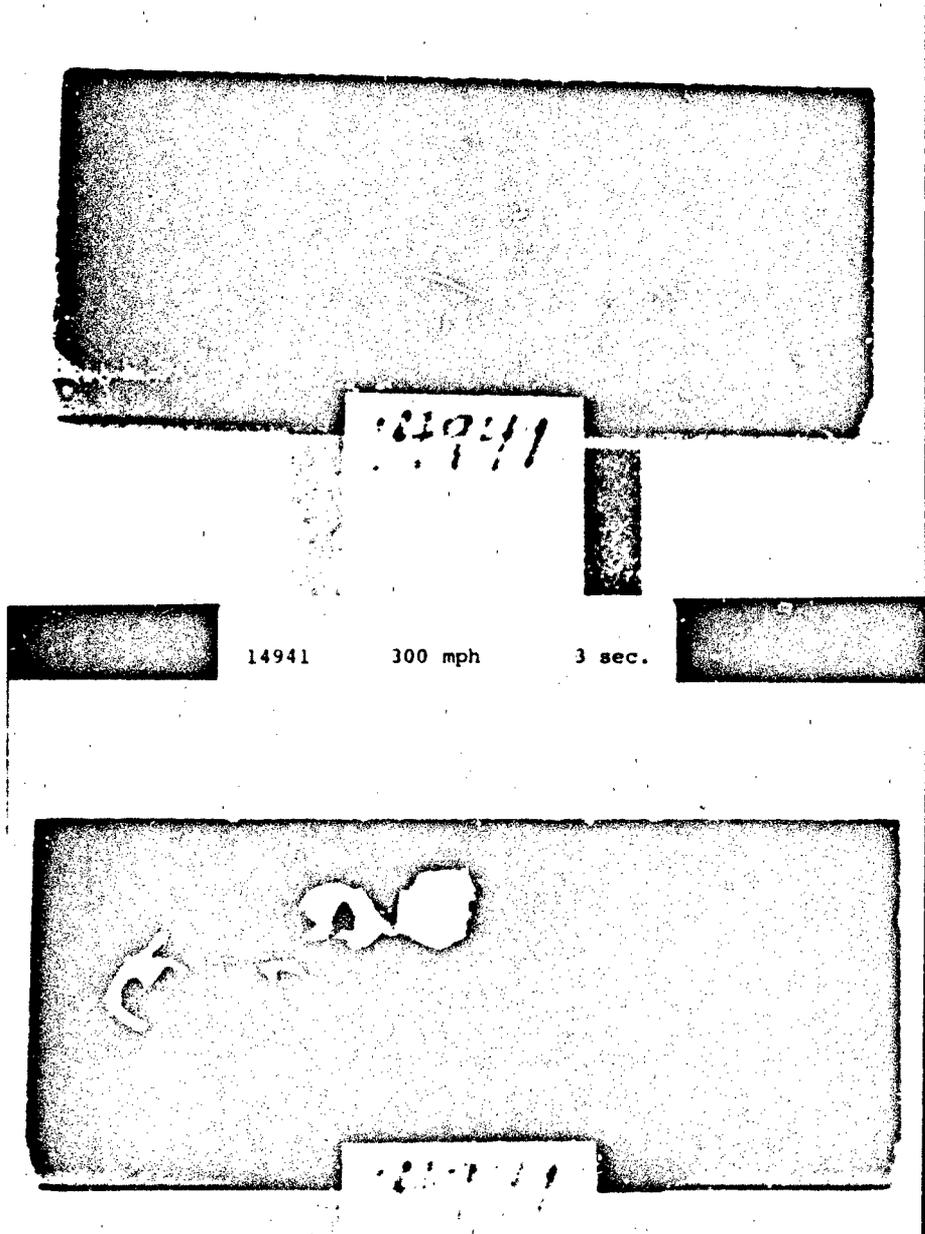
Fig. 6. Pre- and post exposure, FRCI-20-20 with standard RCG ceramic coating, showing damage after 3 sec exposure at 300 mph

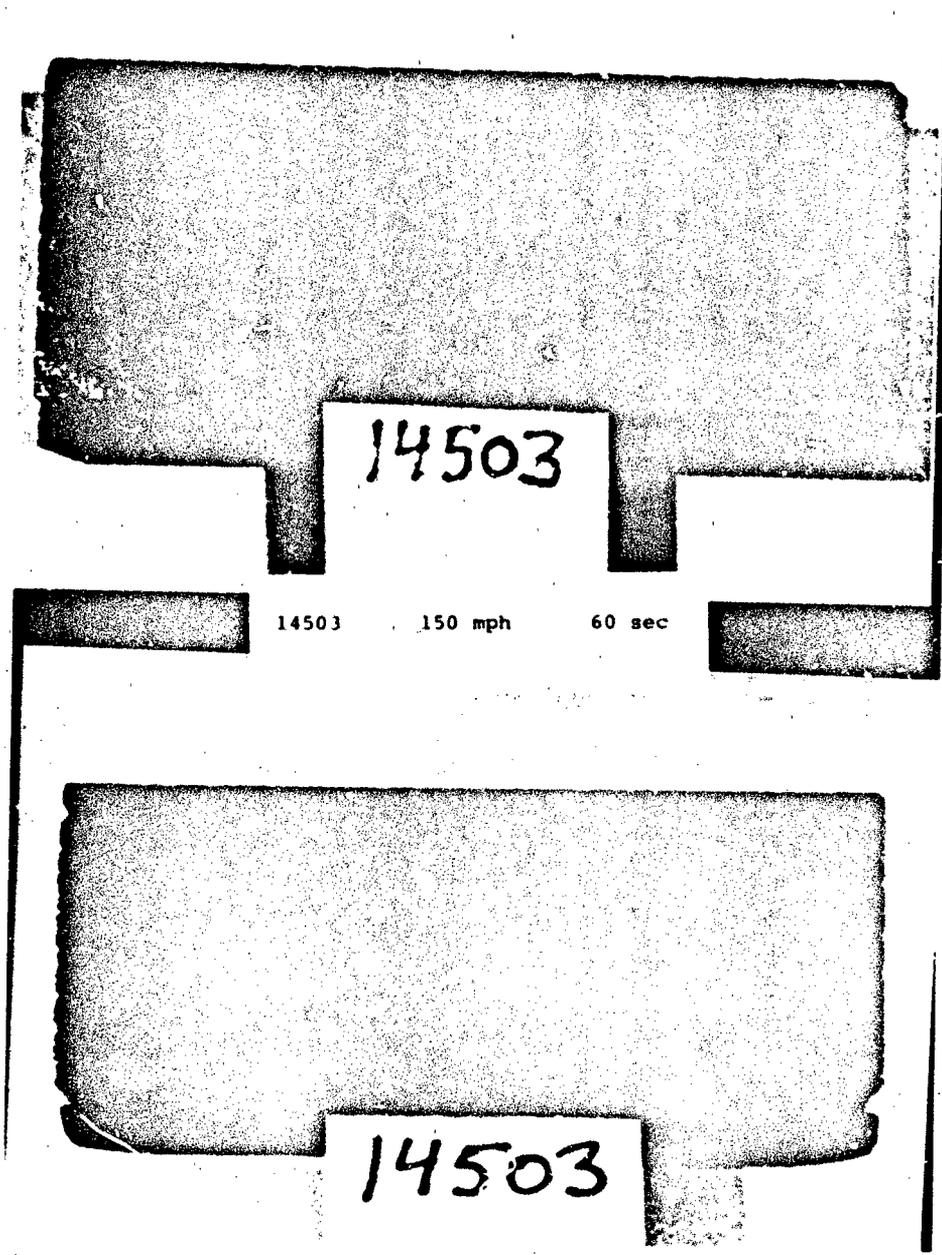
Fig. 7. Pre- and post exposure, LI-2200 with standard RCG ceramic coating, showing star-shaped crack after 60 sec exposure at 150 mph

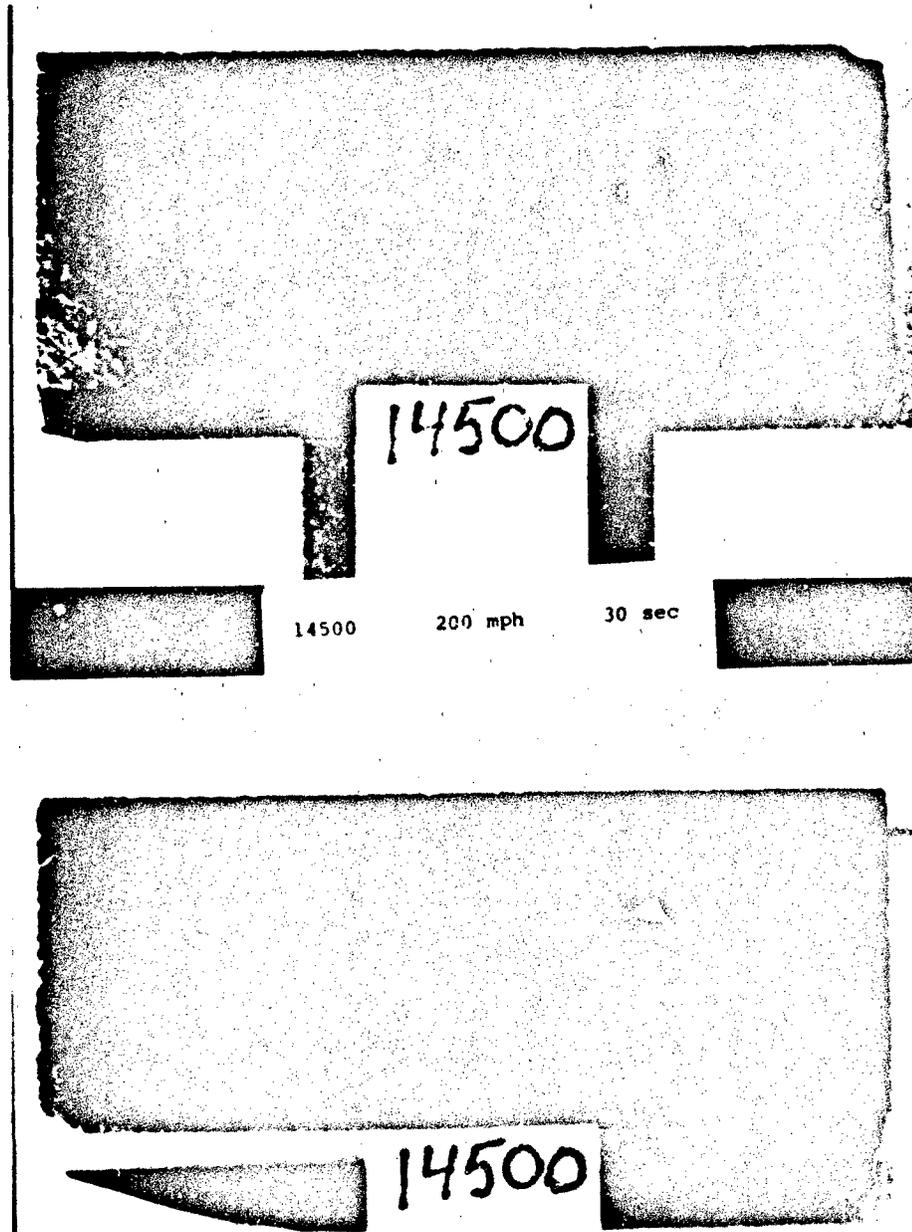
Fig. 8. Pre- and post exposure, LI-2200 with standard RCG ceramic coating, showing damage after 30 sec exposure at 200 mph

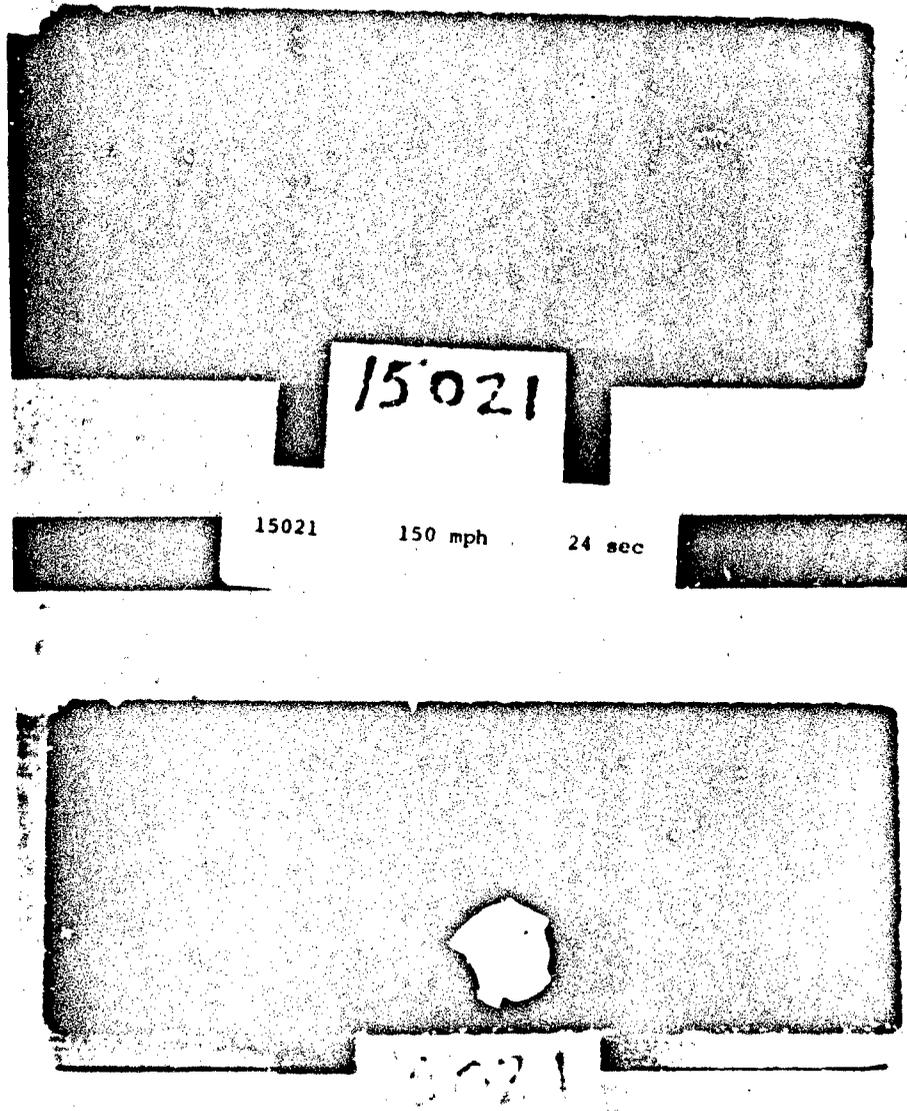
Fig. 9. Pre- and post exposure, FRCI-20-12 with standard RCG ceramic coating, showing surface cracks and loss of coating segment after 24 sec exposure at 150 mph

for a 30 sec duration would be expected at slightly below 150 mph. On the other hand, the FRCI-20-12 samples with twice the standard RCG coating thickness performed as well or slightly better than the FRCI-20-20 with standard coating thickness. At 200 mph, isolated fractures were found after 60 sec exposure time or longer in the case of FRCI-20-12 (Figure 10), whereas damage occurred within 30 sec in the case of the FRCI-20-20 with standard coating thickness.

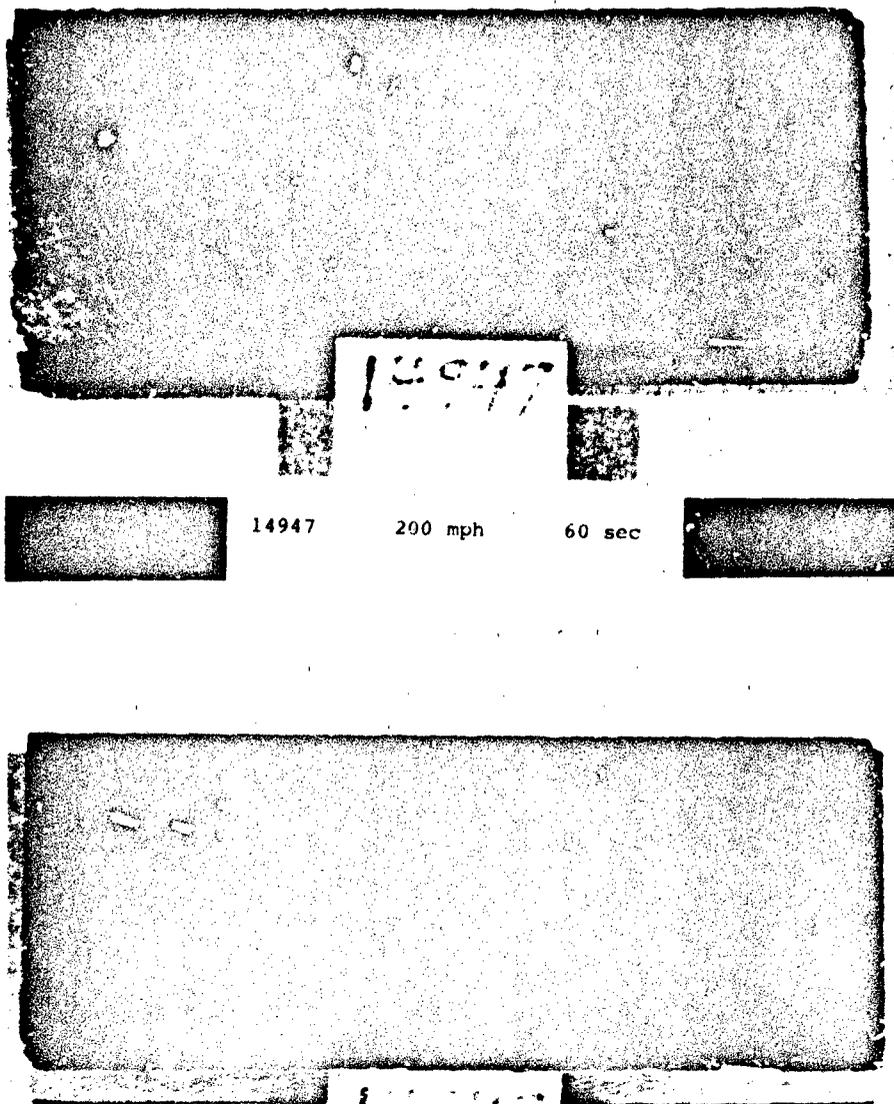
Fig. 10. Pre- and post exposure, FRCI-20-12 with twice standard thickness RCG ceramic coating, showing one subsurface fracture after 60 sec exposure at 200 mph

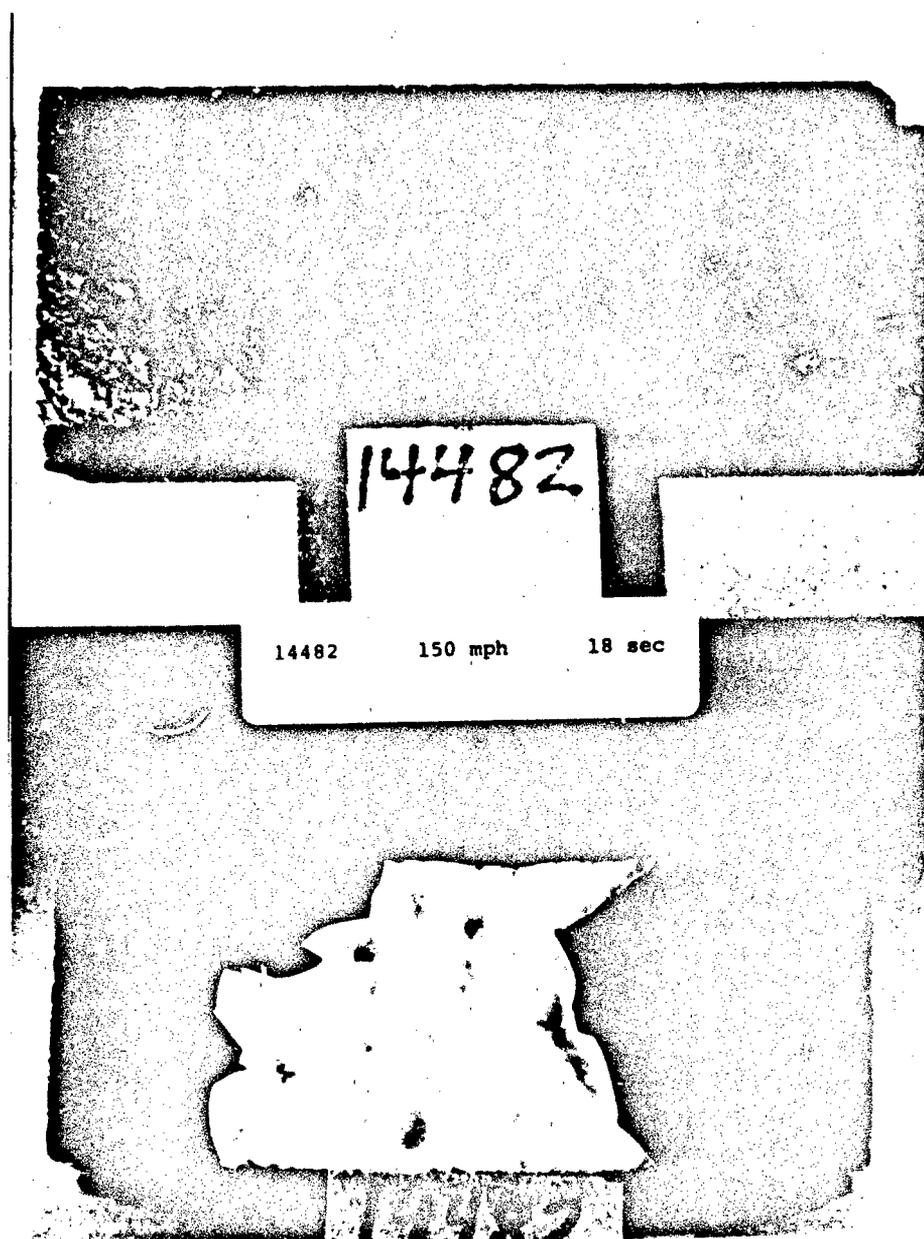
Fig. 11. Pre- and post exposure, LI-900 with standard RCG ceramic coating, showing ceramic coating loss and tile erosion after 18 sec exposure at 150 mph

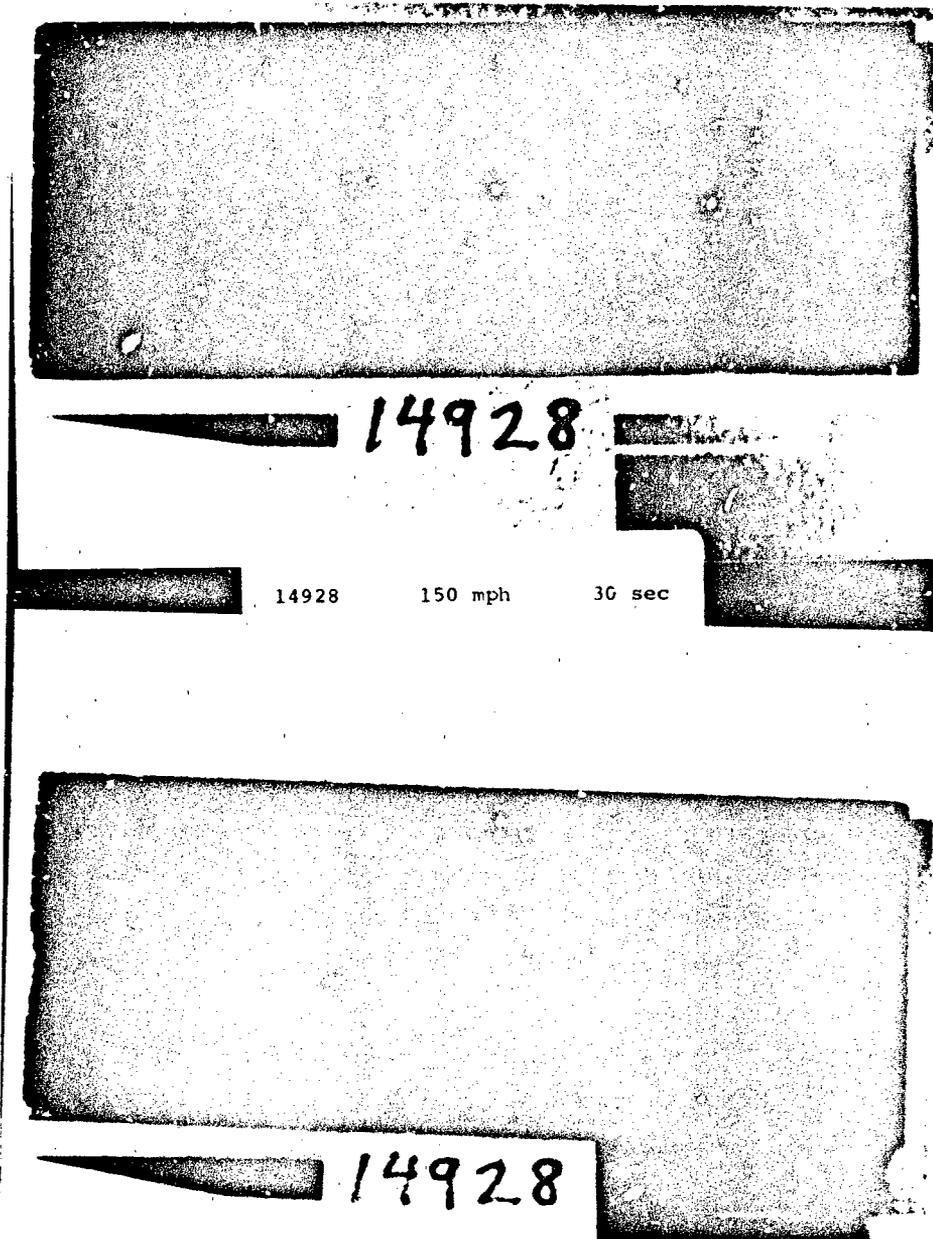
Fig. 13. Pre- and post exposure, FRCI-40-20 with 0.046 lb/ft^2 SiC (CVD) coating, showing cratering after 30 sec exposure at 150 mph

nification, the FRCI-40-20 SiC coated sample surfaces have a straw-like appearance because the Nextel and Silica filaments making up the basic tile can still be seen even though impregnated with the SiC.

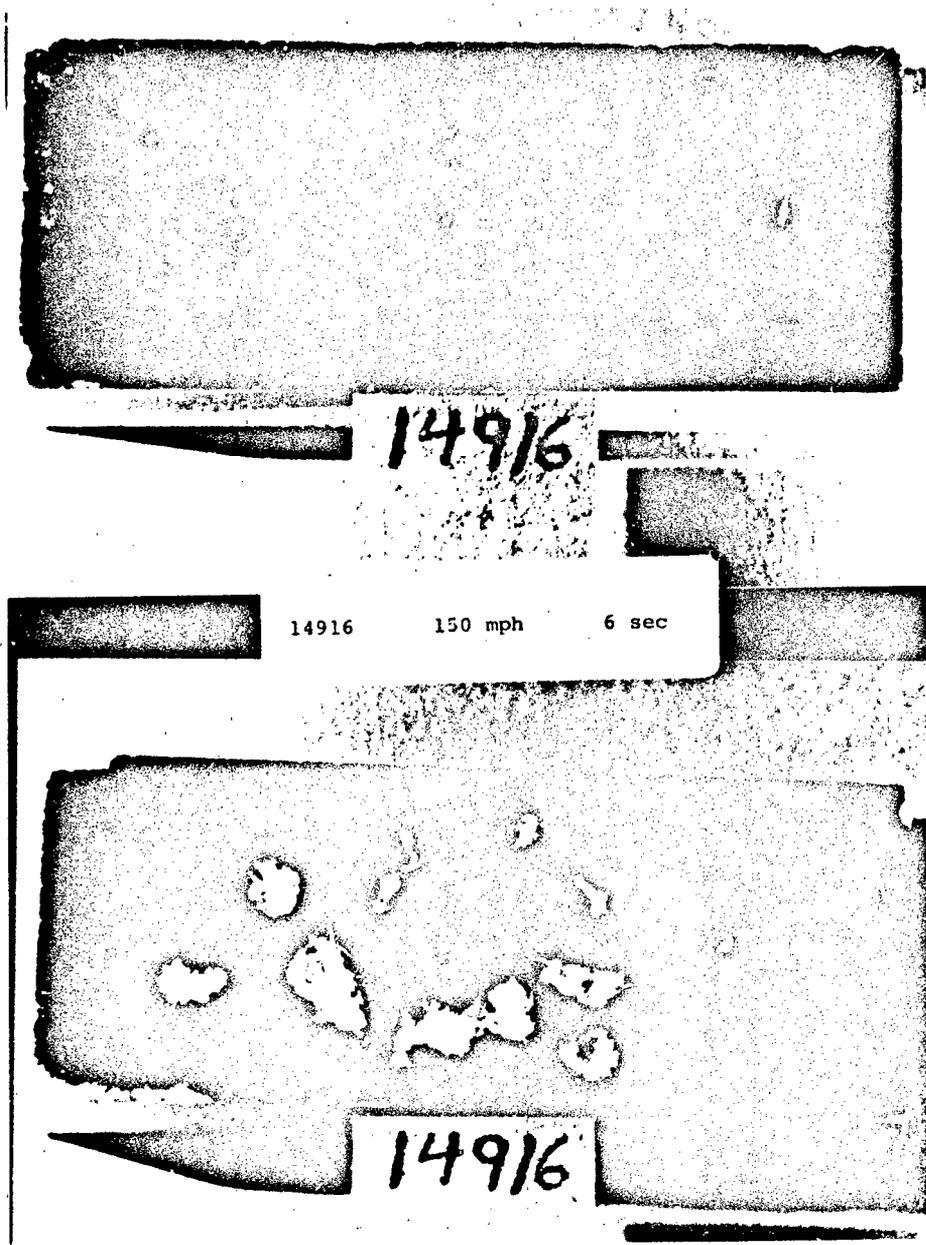
Fig. 14. Pre- and post exposure, Li-2200 with 0.023 lb/ft^2 SiC (CVD) coating, showing cratering and tile erosion after 6 sec exposure at 150 mph

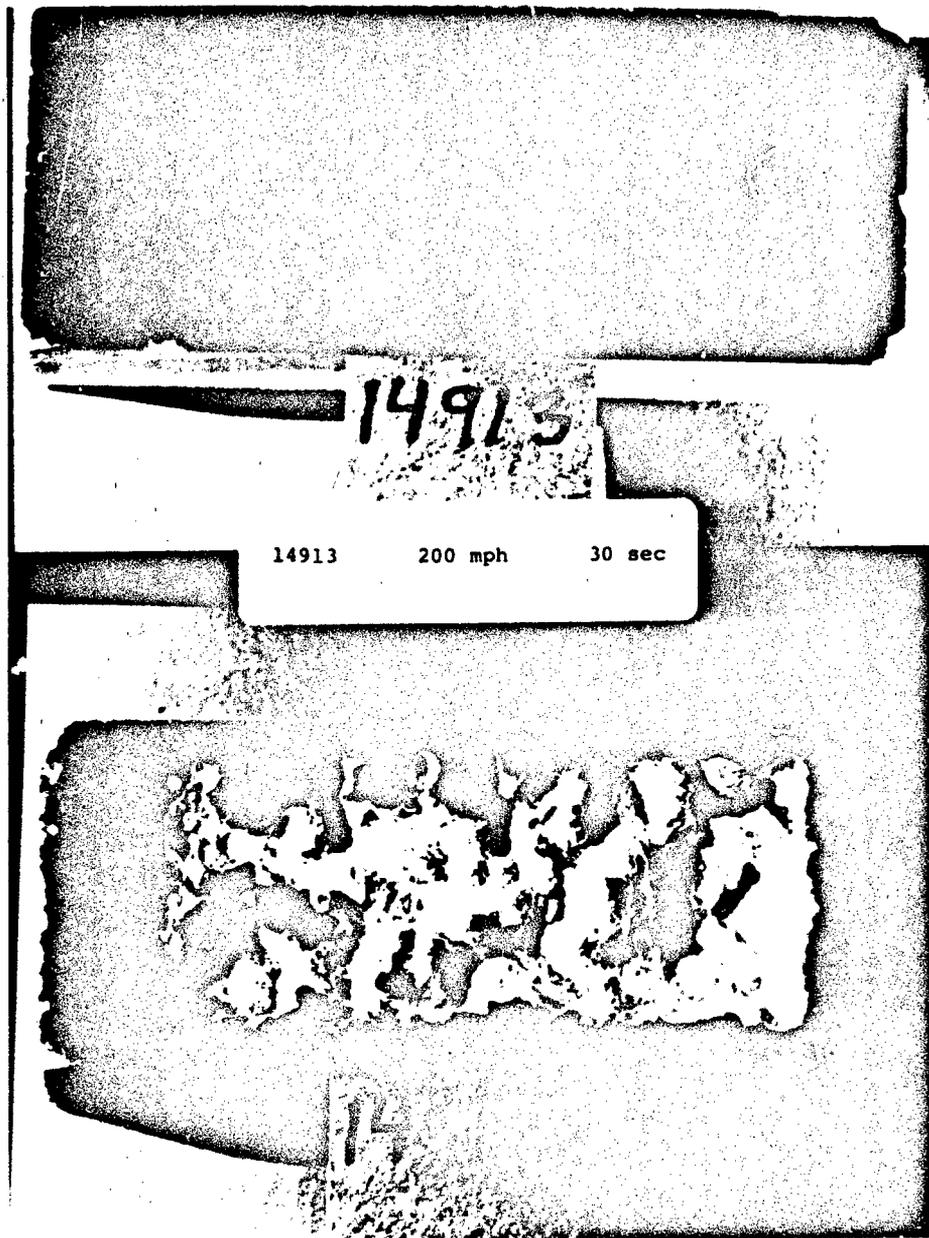
The onset of damage to the CVD SiC coatings is characterized by the local fracturing of small chunks of SiC-impregnated surface materials over a small, roughly circular area apparently within a drop impact zone, which are initially driven into underlying voids. The fractured chunks remain within the underlying crater at most of the damage sites in the FRCI-40-20 and FRCI-60-20 samples exposed at the lowest test speed (150 mph for 30 sec; see Figure 13). The damage craters have sharp edges, suggesting a shear failure, in contrast to the classical lipped crater typically formed when metals are impacted. Sharp edged craters are also formed in the bare tile sample surfaces. The similar crater formation seen in the uncoated and CVD coated samples is not unexpected, since the CVD process represents an impregnation to some depth of the porous tile surface rather than the building up of a ceramic layer on the tile surface such as in the RCG ceramic coating case. When seen under mag-

Fig. 15. Pre- and post exposure, LI-2200 with 0.023 lb/ft^2 SiC (CVD) coating, showing coating loss and tile erosion after 30 sec at 200 mph
