## BOMB CRATER REPAIR TECHNIQUES FOR PERMANENT AIRFIELDS

TECHNICAL REPORT GL-81-12

Report 2  
SERIES 2 AND 3 TESTS

Report 2 of a Series  
October 1985

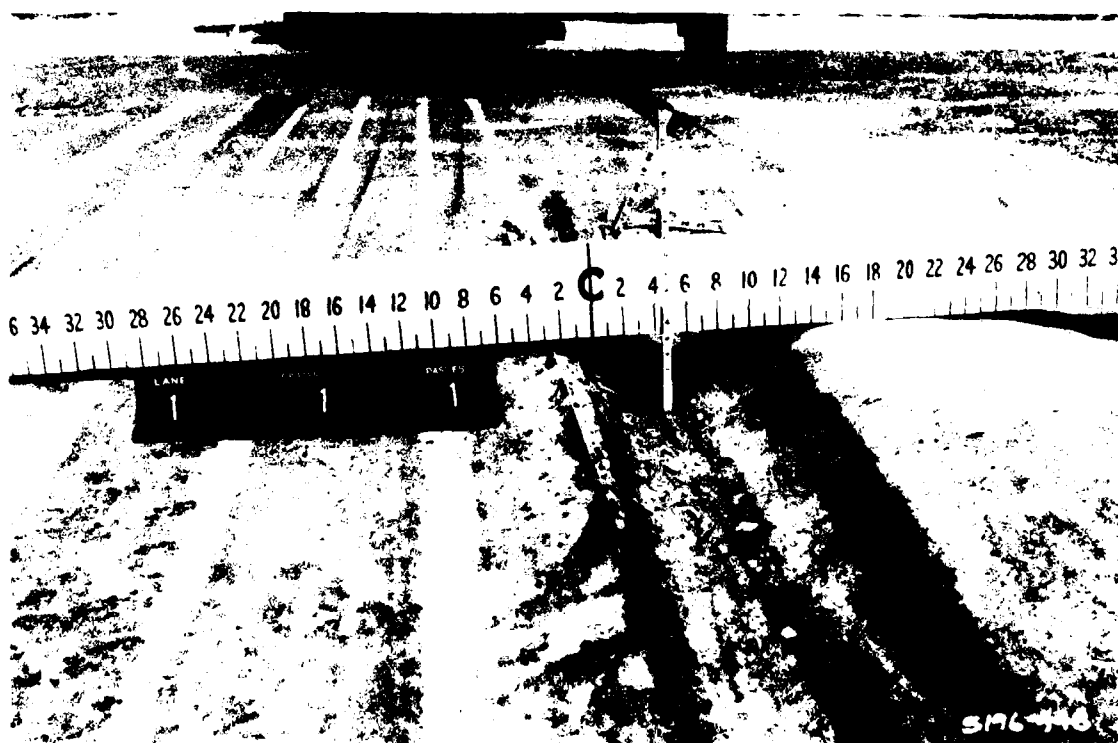
38. Lane 1. Photo 52 shows the T-17 membrane in place over the WES blended material, prior to traffic. The F-4 tracking rig became stuck on the first pass over the crater repair (Photo 53). Photo 54 shows the tear in the membrane and a 5-in. rut left by the one pass. No further traffic was applied to this lane. Figure 5 shows typical cross-section data and the elevation of the T-17 used in the layers.

40. Discussion. The WES blended material performed the same as the 0-32 mm German crushed aggregate, that is, it was very unstable. This material needs more fines added or chemically stabilized before it can be used as a crater repair material.

Photo 54. Damage caused by one pass of the F-4

- d. To use the WES blended material simulating the German 0-32 mm gradation for a crater repair, it is necessary to stabilize such material with added fines or a stabilization material, such as asphalt or portland cement (Series 3, crater 1).

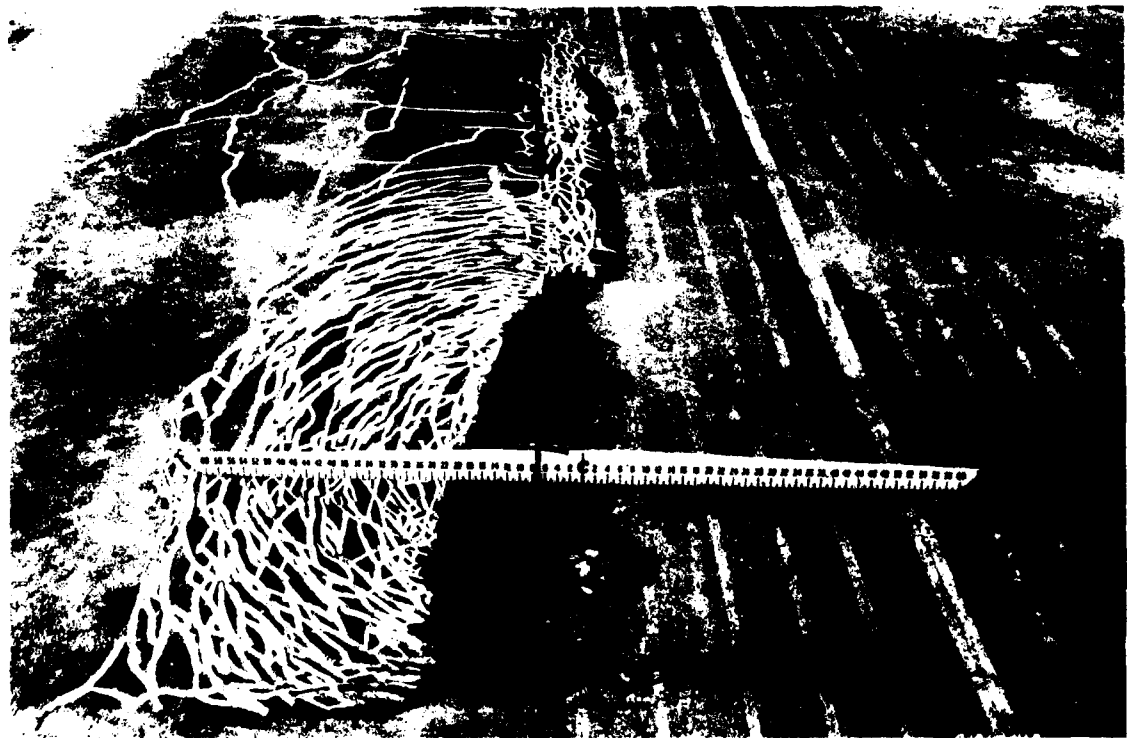
the crater repair after 68 passes or 20 coverages. After 170 passes or 50 coverages the west end of the traffic lane started to consolidate, break up, and spall. As traffic continued the surface began to deteriorate, the grout breaking down into sand and cement. After 272 passes or 80 coverages this sand and cement were approximately 1 in. deep in an area 1.5 by 9 ft. At 340 passes or 100 coverages the maximum deformation was 3 in. (Photo 65). This was due to continuing consolidation and grout displacement under traffic. At 612 passes or 180 coverages the maximum deformation had increased to 4 in. in the west end of the traffic lane where the greatest amount of consolidation and grout displacement had occurred. Photo 66 shows conditions at 680 passes or 200 coverages when the deformation averaged 3 in. over the traffic lane and traffic was stopped. Figure 9 shows cross-section data from the center of the traffic lane.

Photo 66. Series 3, crater 3, lane 1, after 200 coverages

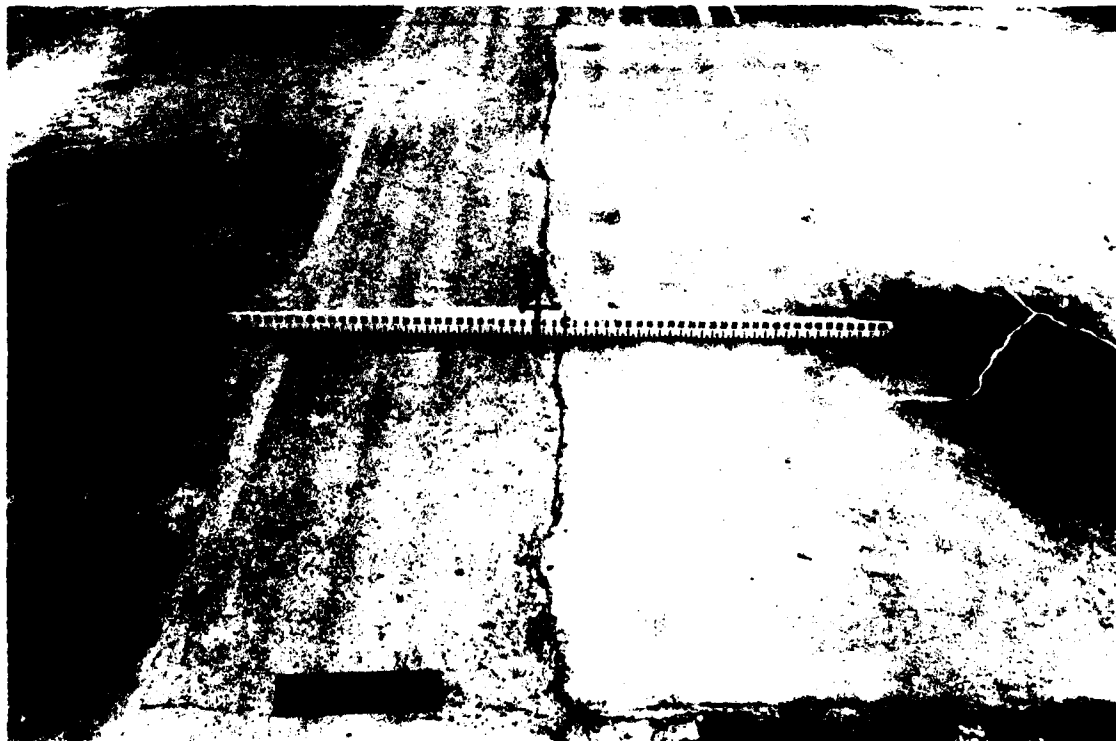
49. Lane 2. C-141 traffic was started 24 hr after placement of the PCC (Photo 73). At 204 passes or 60 coverages one transverse crack occurred in the center of the crater repair. A longitudinal crack was noted outside the traffic lane but in the crater repair area after 340 passes or 100 coverages; no traffic was being applied to the lane when the crack was found. This may have been a shrinkage crack. After 578 passes or 170 coverages there were three transverse cracks and the longitudinal crack in the crater repair. Photo 74 shows surface conditions at 680 passes or 200 coverages. This was the coverage level when the 7-day breaks, mentioned in lane 1, were broken. Traffic continued to 2380 passes or 700 coverages with only a minor amount of additional cracks (Photo 75). Figure 12 shows cross-section data for this traffic lane.

50. Discussion. Due to the way the PCC performed under traffic, it might be possible to start traffic sooner on this type of repair. The cracks in the PCC did not open up or spall during traffic. Additional cracks occurred in the PCC after traffic was discontinued. This may

indicate that the cracks were due to incomplete curing of the PCC and may not be load associated.

Photo 74. Series 3, crater 4, lane 2, after 200 coverages

- g. The PCC crater repair performed excellently. There were cracks in the repair, but they did not impair the operation of traffic. These cracks were probably shrinkage cracks due to incomplete curing of the PCC. The cracks did not open up or spall under traffic. With the PCC mixture used, C-141 could be started earlier than the 24-hr
