TECHNICAL REPORT
NATICK/TR-86/008

DESIGN AND PRODUCTION OF DAMAGE-RESISTANT TRAY PACK CONTAINERS

RICHARD D. CUMMINGS
JULY 1985
FINAL REPORT 1984-1985

CUMMINGS SOLAR CORPORATION
WILMINGTON, MASSACHUSETTS

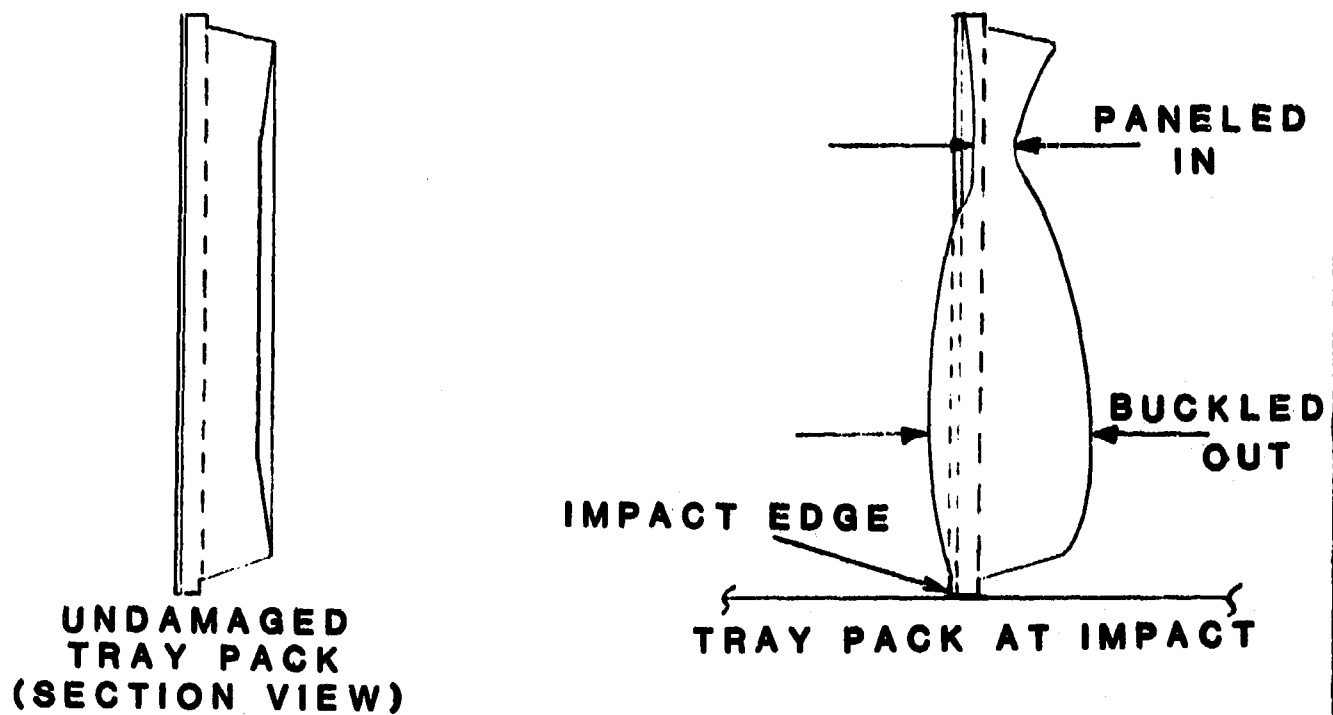
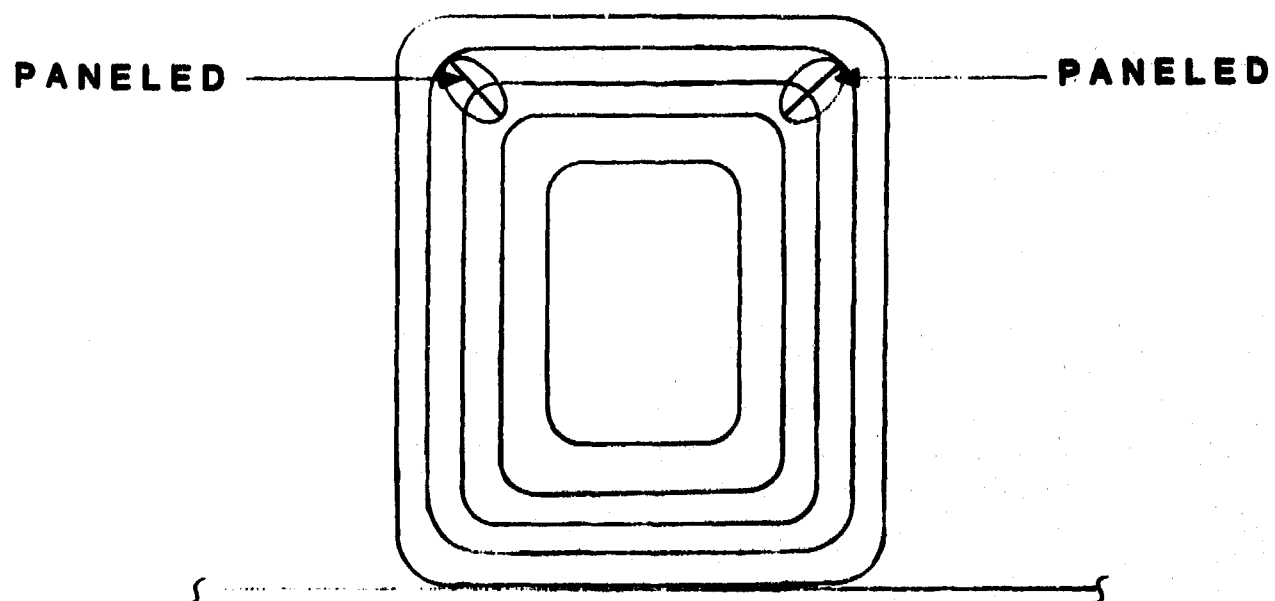
FIGURE 4.
TRAY PACK BUCKLING AND PANELING DAMAGE

As stated previously the causes of this damage are a combination of the vacuum in the container and the hydrodynamic forces in the fluid (food) packed in the container. Cummings Solar Corporation results show that the greater the vacuum, the larger the paneling (inward buckling) of the tray body. Similarly, if an overpressure is applied to the container, Cummings Solar Corporation found that the greater the overpressure, the larger the buckling (outward bulging) of the lid.

Buckling (bulging) of the Tray Pack sides is also caused by excessive vacuum. As stated previously, vacuum packing of Tray Packs results in atmospheric forces crushing the tray body

and lid together until these crushing forces are resisted by the fluid (food) in the Tray Pack. When a Tray Pack which is underfilled and vacuum-packed is dropped on its bottom, the fluid in the Tray Pack creates an overpressure on the sides causing them to buckle (bulge) outward.

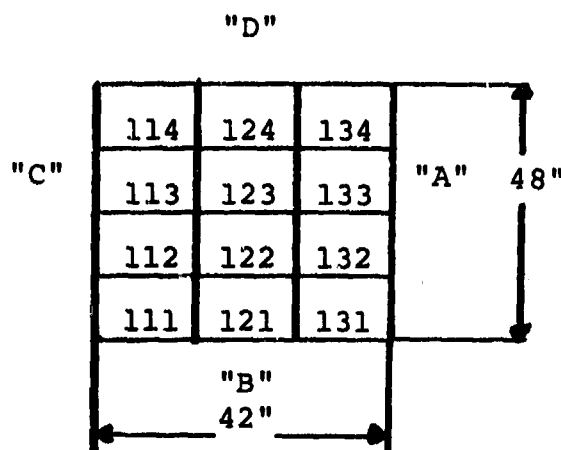
EDGE IDENTIFICATION:

EDGE	OBSERVATIONS
6" DROP EDGE "B"	LOAD SHIFTED SLIGHTLY TOWARD DROP EDGE. CENTER TIER WITH NO STRAP SHIFTED $\frac{1}{2}$ " MORE THAN REST OF LOAD.
6" DROP EDGE "D"	TIERS 2, 3 & 4 RETURNED TO CENTER. TOP TIER SHIFTED SLIGHTLY TOWARD DROP EDGE.
6" DROP EDGE "C"	LOAD SHIFTED SLIGHTLY TOWARD DROP EDGE. SOME CARTON SEPARATION IN ROWS 1 & 2.
6" DROP EDGE "A"	LOAD RETURNED TO CENTER. SOME SLIGHT MISALIGNMENT OF CARTONS IN 1ST TIER.
