NSWC TR 85-382

# IMPROVED DESIGNS FOR ISOCON CAMERAS IN HERTR SYSTEMS

BY JOSEPH J. STAFFORD  
J. STAFFORD ASSOCIATES FOR  
RESEARCH AND TECHNOLOGY DEPARTMENT

7 JUNE 1985

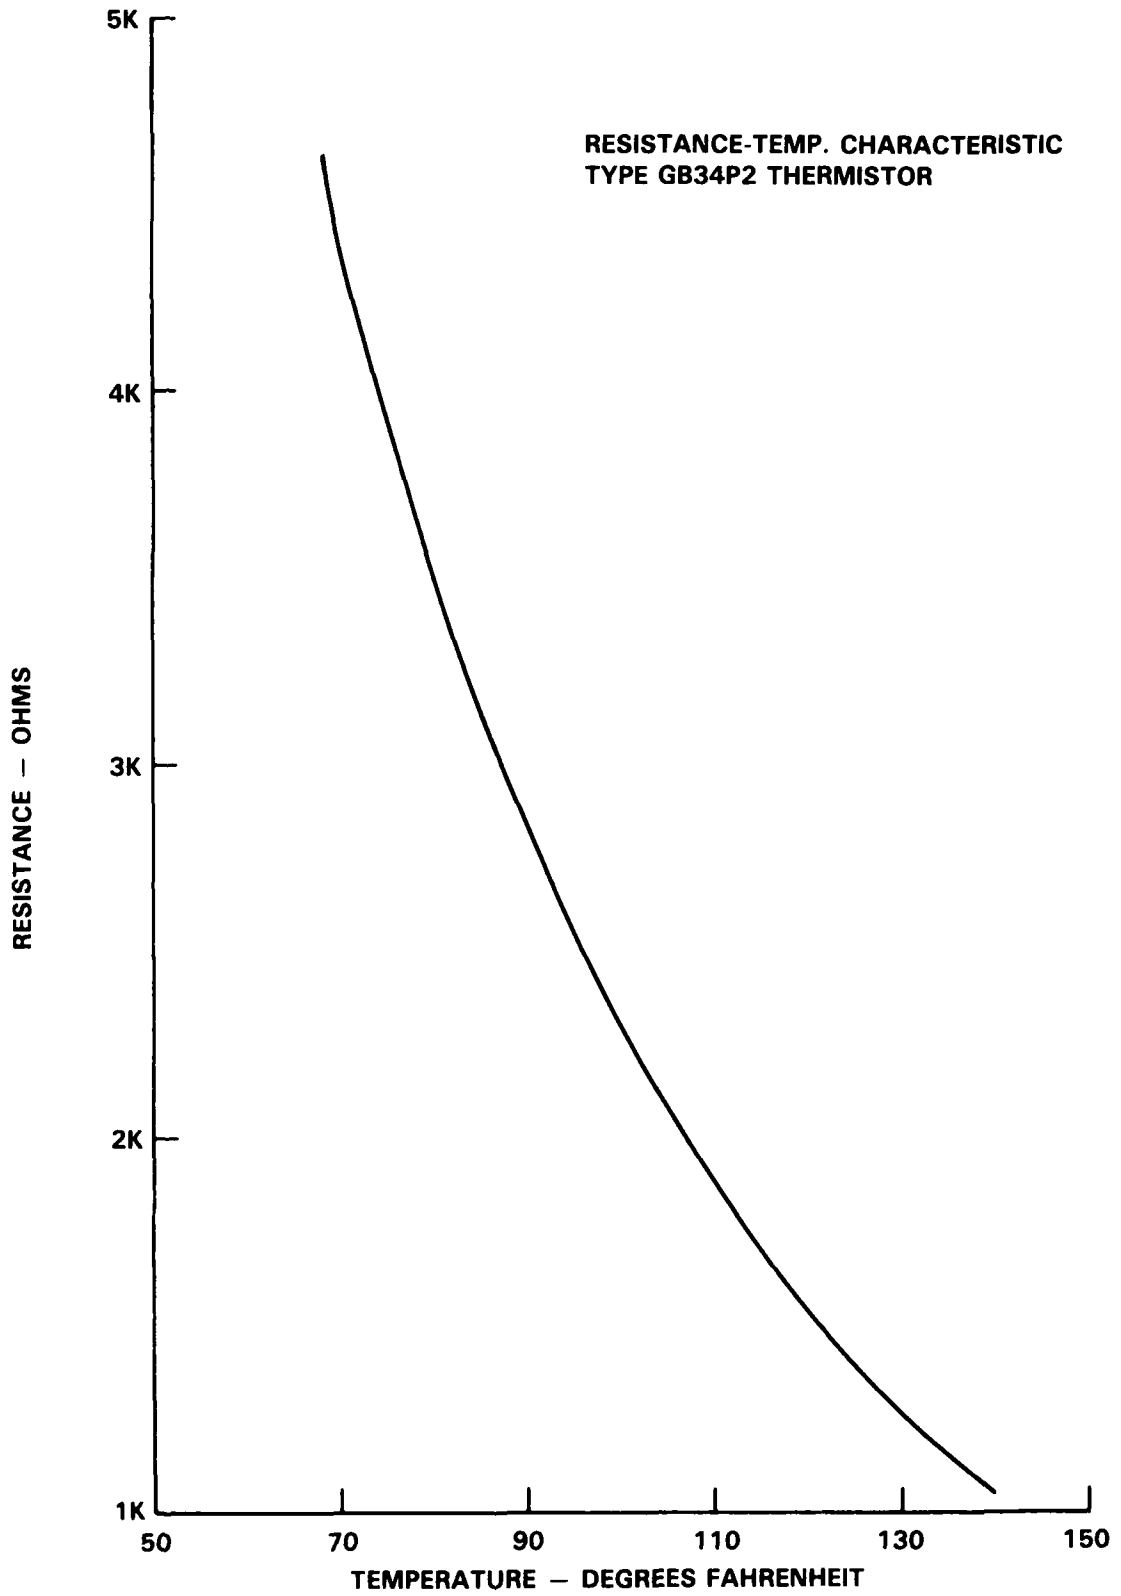
FIGURE 1. RESISTANCE/TEMPERATURE CHARACTERISTIC OF THERMISTOR

a. The deflection yoke, or deflection coil, lies immediately above the camera tube and provides the physical socket for the shoulder pins located on the rear of the head of the Isocon tube. In addition, the rear of the Isocon tube is supported on rubber snubbers located at the rear of the deflection yoke. In the region of the shoulder socket and extending into the space separating the socket from the tube, a thermistor is located. A thermistor is a thermally sensitive resistor having a negative temperature coefficient characteristic. The calibration curve for the thermistor type used in the Isocon yoke is shown in Figure 1.

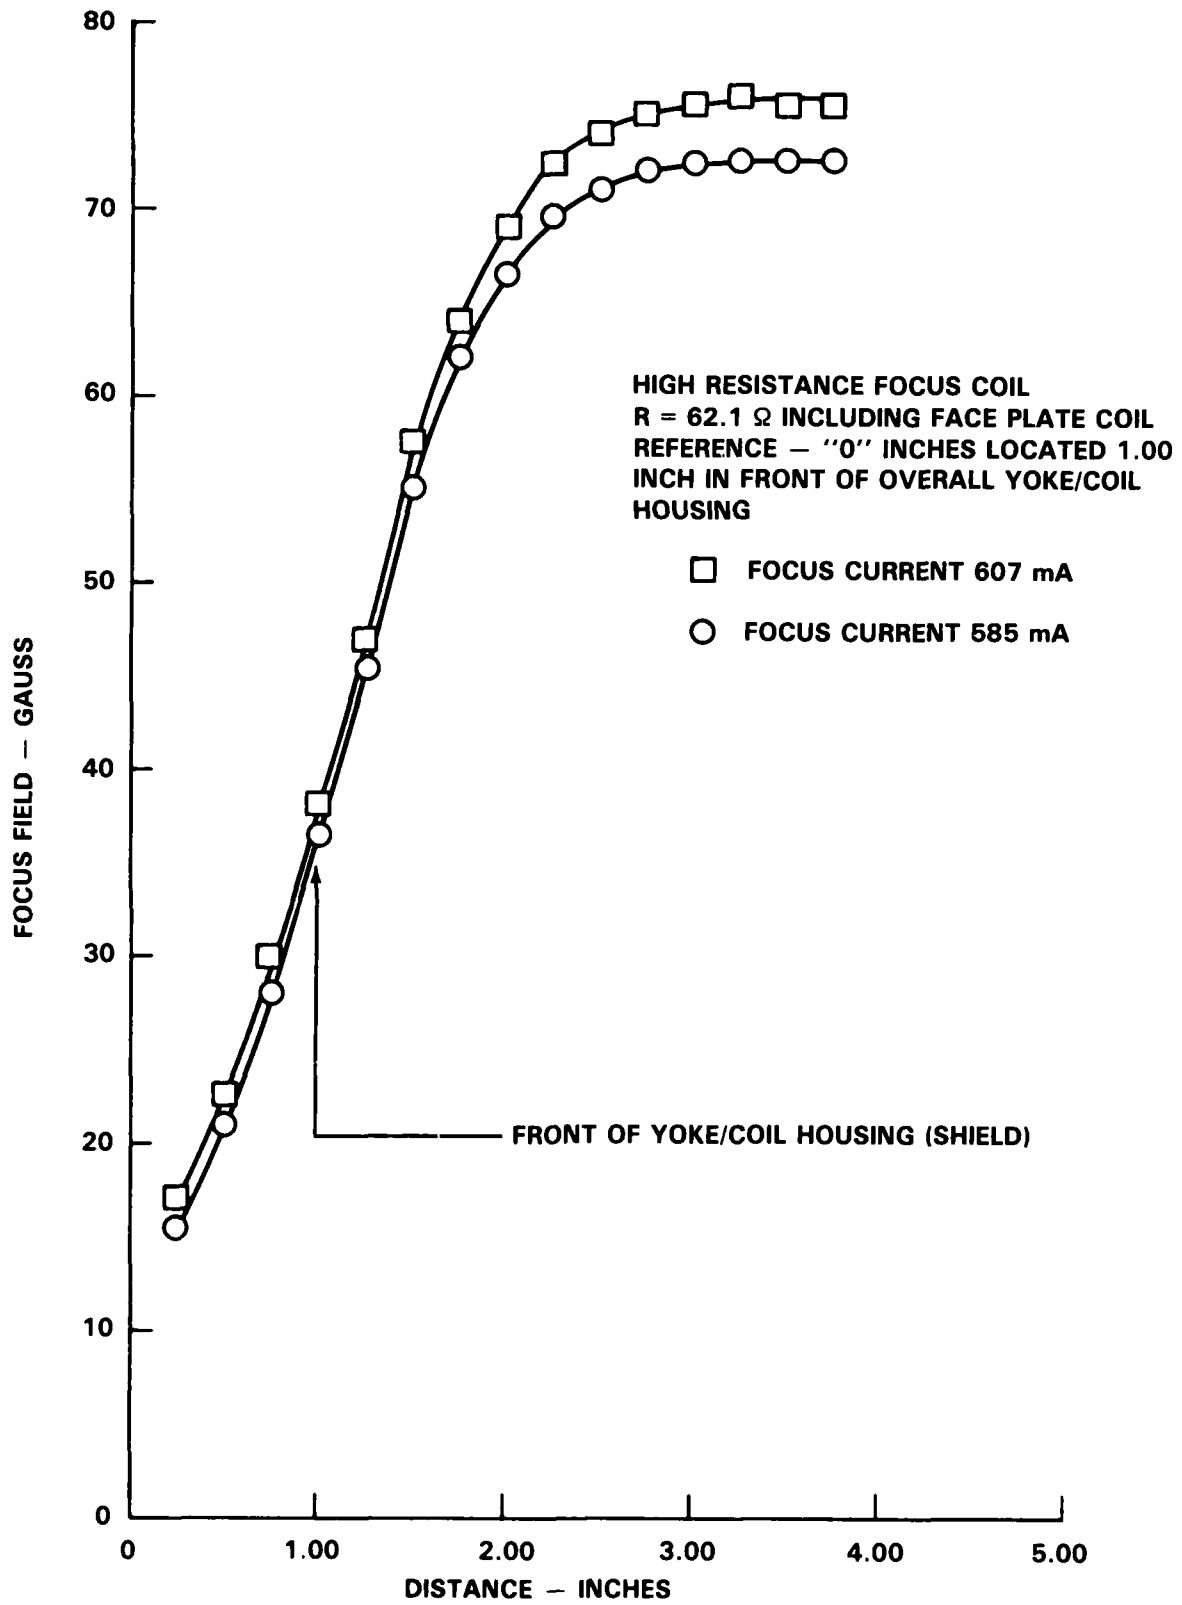
FIGURE 2. MAGNETIC FIELD FLUX PLOT - HIGH RESISTANCE FOCUS COIL

in the rear portion of the deflection yoke. The same faceplate coil was used in all measurements, shown in Figures 2 and 3, for both main focus coils. The resistance of the faceplate coil is typically 2 ohms.

- a. Remove the present focus coil assembly and replace it with a similar unit having a lower series resistance. As shown in Figures 2 and 3, they can be made magnetically equivalent.

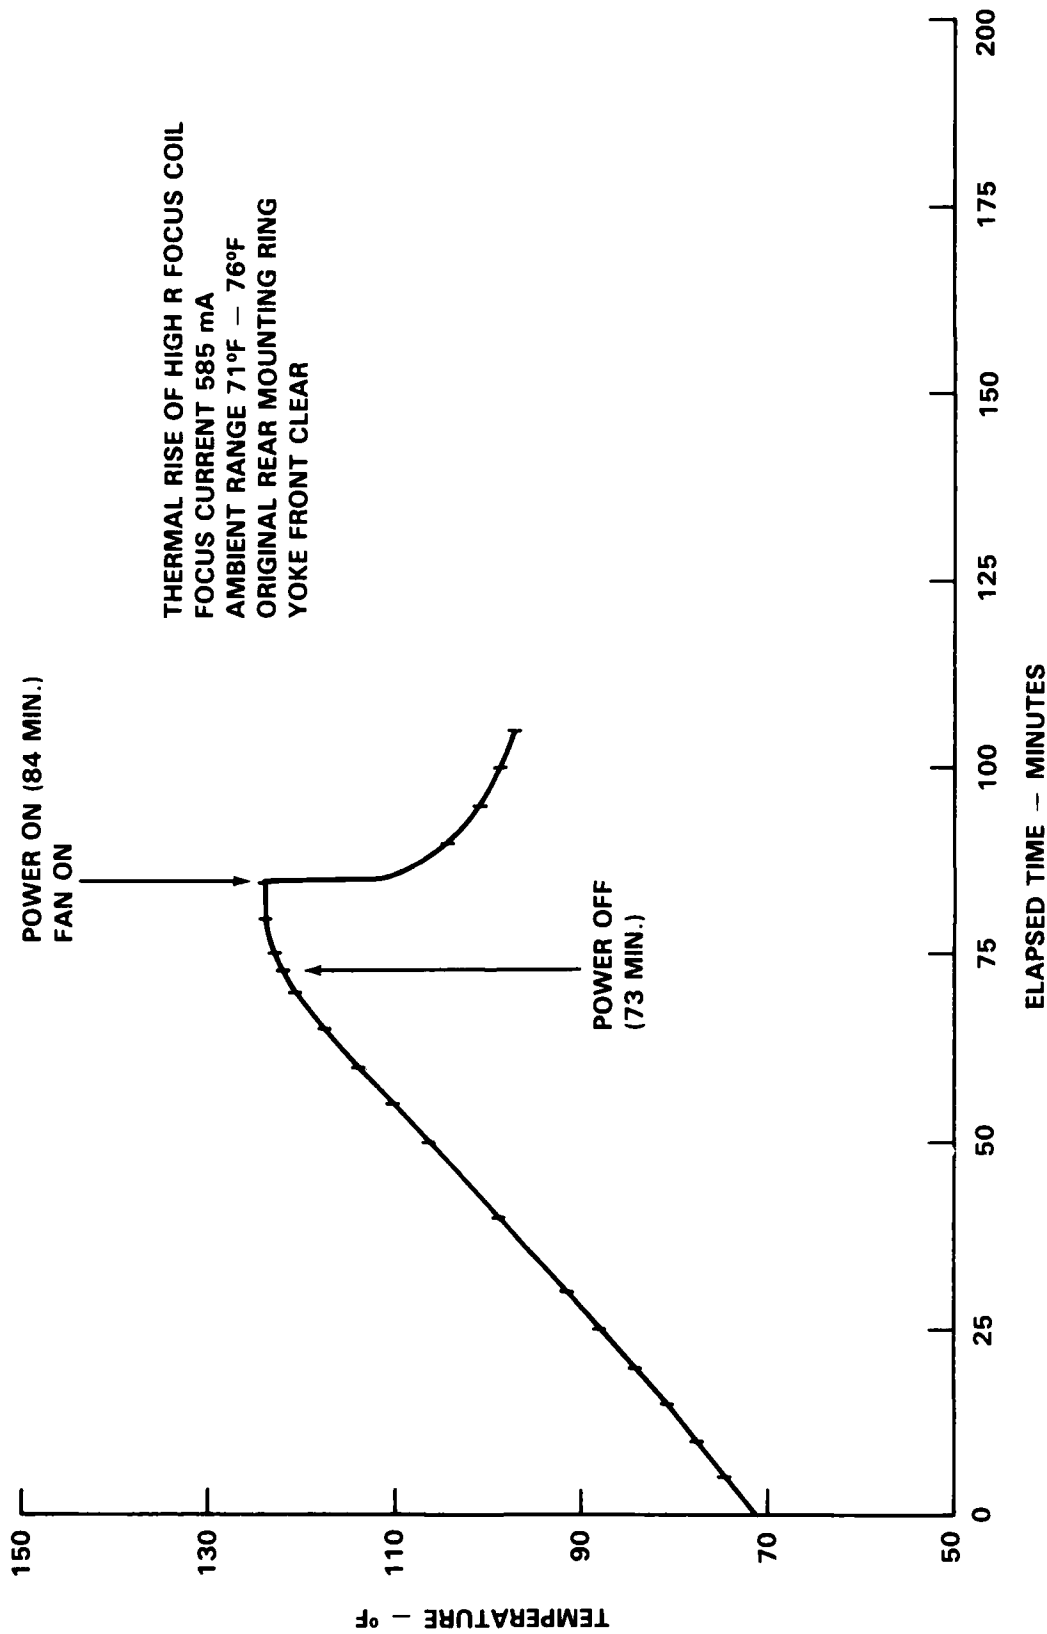
FIGURE 4. THERMAL CHARACTERISTIC - HIGH R COIL

Several characteristics are to be noted in the accompanying Figures 4,5,6,7,and 8. Comparisons of Figures 4 and 5 measure the effect of a slightly open and a very much open yoke assembly. The slightly open condition is established with the Canon lens. Optical focus with the high resistance focus coil allowed sufficient clearance to between the lens and the tube to allow cooling air to pass into the yoke in sufficient quantity to cool the thermistor. The setup in Figure 4 is representative of the current situation in the HERTR system. Note the approximately 70-80 minutes required to bring the thermistor to 122 degrees.

Compare Figures 4 and 6. Now the lens opening is setup very clear and the rear mounting ring is changed to a very open condition. Note the very much more rapid drop in temperature after application of cooling air and the narrower the difference between ambient and thermistor temperature. The ambient room temperature was actually lower for the test measurements shown in Figure 6

Compare Figures 4 and 8. Now the focus coils are different, and the rear mounting rings are different. The time required to heat the thermistor without the benefit of cooling is more than doubled, the rate of cooling is increased, and the asymptotic temperature is closer to room temperature. The configuration represented in Figure 8 is the appropriate design for this camera.

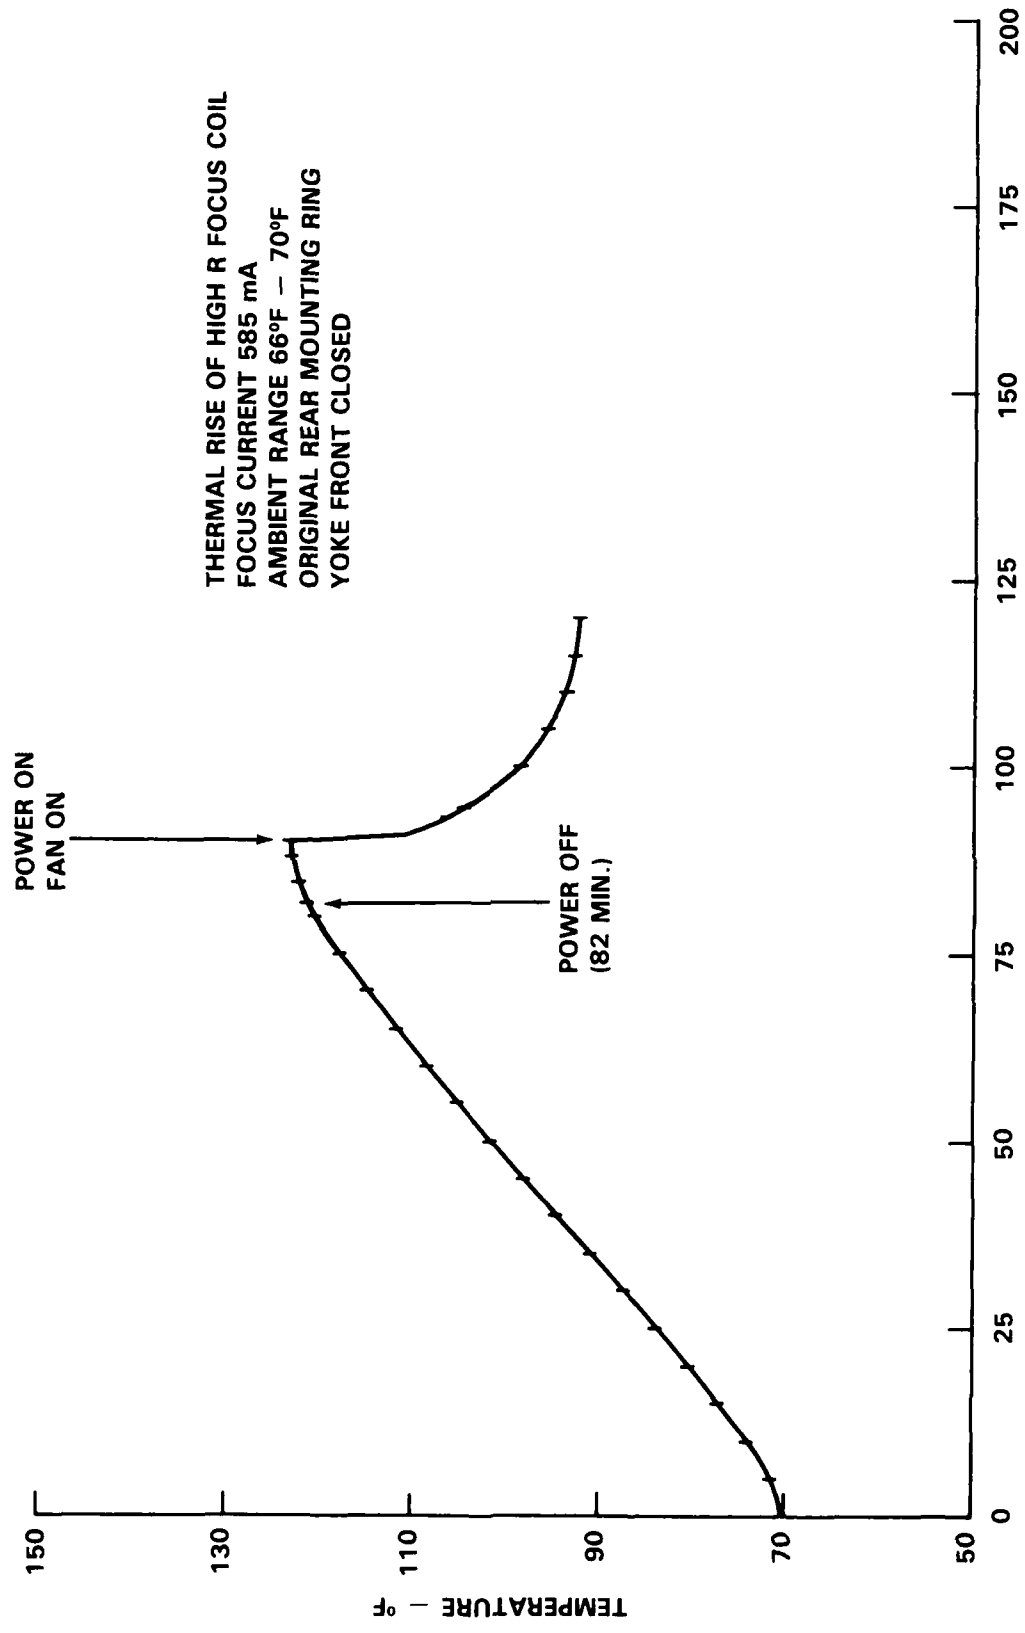
FIGURE 5. THERMAL CHARACTERISTIC - HIGH R COIL

Compare Figures 5 and 7. The lower resistance focus coil was used during the run described in Figure 7. This coil required that the lens, the Canon, completely block the deflection assembly front opening in order to achieve optical focus. The long, relatively slow cool down rate indicates that the air flow is partially blocked. This condition could be relieved if the lens was only slightly defocused. The camera assembly was designed in such a way that the lens focus was controlled with a differential screw. Differential screw action was such that the lens moved just under .015 inches per revolution or turn. Less than 1/2 turn would cause the temperature drop to increase significantly. From a just open condition as just described to a fully closed condition as was the initial condition, the temperature would actually rise rather than continue to fall. Now the heat input rate exceeded the cooling rate. Also note the longer period required to bring the thermistor to 122 degrees.

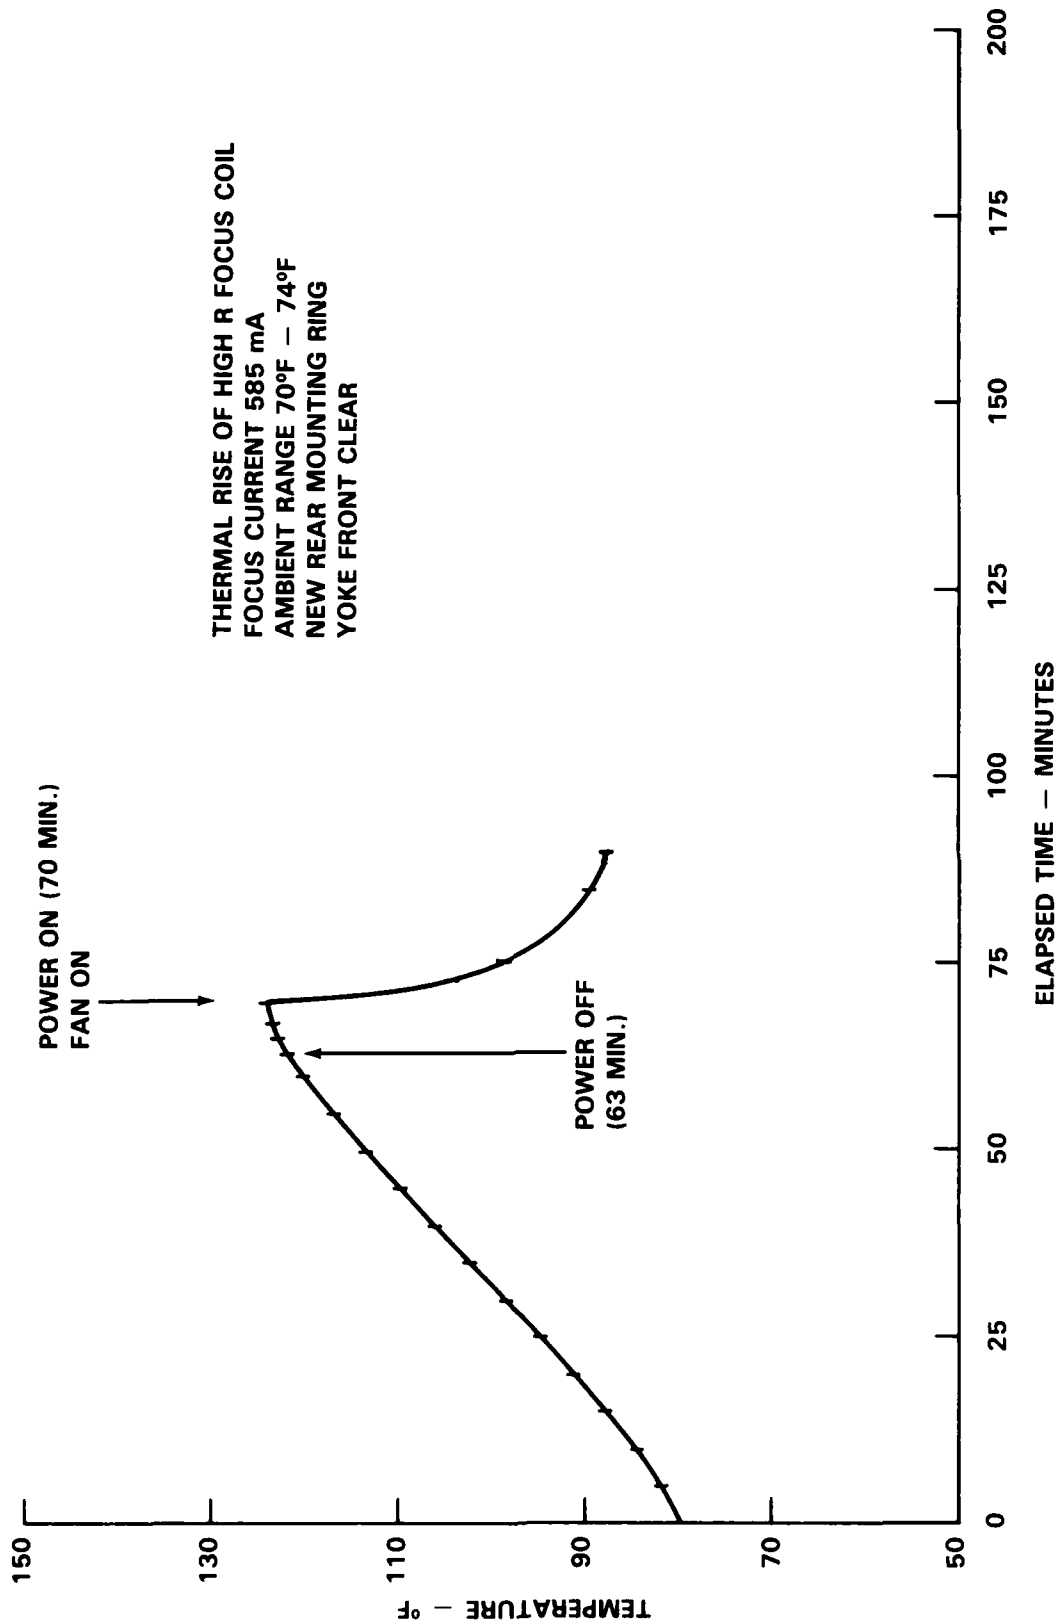
FIGURE 6. THERMAL CHARACTERISTIC - HIGH R COIL

than those shown in Figure 4. Other system measurements had been undertaken prior to the beginning of taking data for the run described in Figure 6 and the camera hadn't been allowed to come to a fully cooled down condition.
