BOMB CRATER REPAIR TECHNIQUES FOR PERMANENT AIRFIELDS

TECHNICAL REPORT GL-81-12

Report 3
SERIES 4 TESTS

October 1985

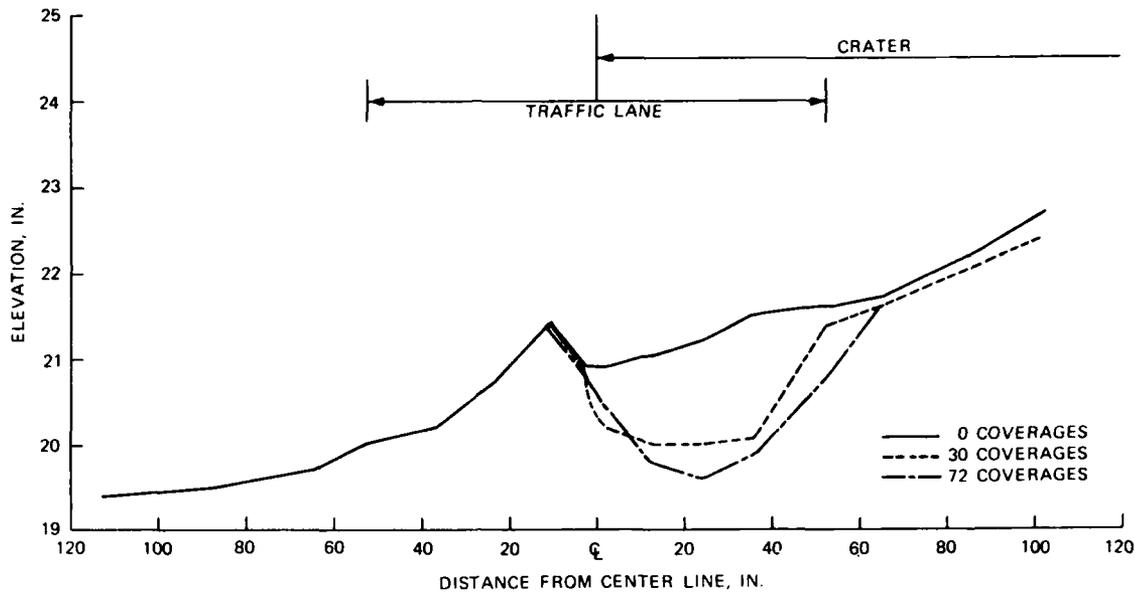
gravel in the rutted area. This material became unstable and shifted under the wheel. Photo 35 shows the surface condition after 550 passes or 72 coverages of the F-4. Figure 10 shows typical cross-section data of the rutted area. The loose material was removed from the rutted area and replaced with a well-graded crushed limestone and rolled 4 passes with the vibratory roller at 36-kip dynamic force. In repairing the rutted area it was found that the loose material was confined to the top 5 in., which was the last lift placed in the section. The stabilized sandy gravel under the rutted area was in excellent condition; this was the second lift placed in the repair. The rutted area was repaired to see if it was possible to patch a small area such as this with crushed limestone and continue traffic on craters 2 and 4. Photo 36 shows the traffic lane after 340 passes or 100 coverages of C-141 traffic, with no apparent damage. Note that the limestone repair is in the background. At 952 passes or 280 coverages a 1-in. rut had developed in the stabilized material at the edge of the patched area. This rut did not increase in depth as traffic continued. However, a 1-in. rut developed in the southwest corner and along the south edge of the crater repair after 1700 passes or 500 coverages. This rut increased in depth to 2 in. with the continuation of traffic to 3400 passes or 1000 coverages (Photo 37). Figure 11 shows cross-section data for the west end of the traffic lane.

Figure 10. Cross-section data of the rutted area, crater 3, lane 1, after F-4 traffic

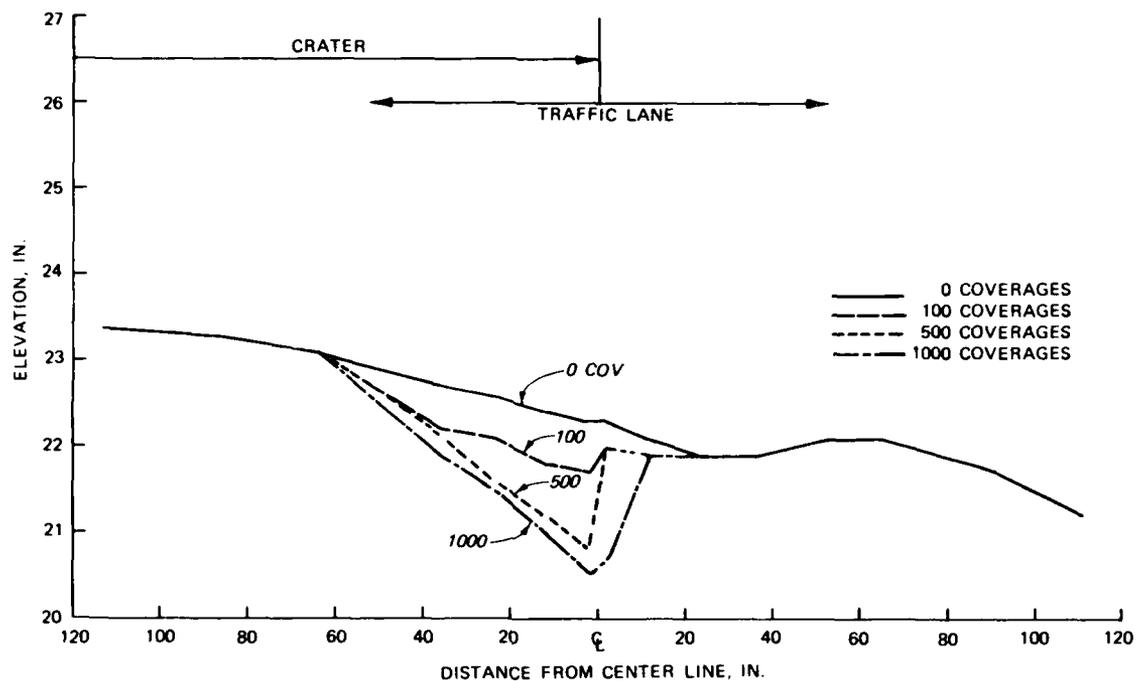
of the loose grout measuring 1 in.³ (Photo 47). After 1020 passes or 300 coverages, the spalling along the edges of the crater had progressed 13 in. back into the crater repair and there was spalling on some of the cracks inside the traffic lane. From 340 passes or 100 coverages to 3400 passes or 1000 coverages there was no noticeable increase in the number of cracks, only the continuation of the spalling. Photo 48 shows the surface conditions after 3400 passes or 1000 coverages. As in lane 1 there was consolidation of about 2 in. of the repair materials under traffic (Figure 14).

Figure 14. Cross-section data for crater 4, lane 2

- f. The consolidation of the crushed limestone in craters 4 and 5 showed that additional compaction, other than with a roller, is required along the edges on material placed below the surface of the crater repair. This could be accomplished with a gasoline-powered hand impactor compactor or vibratory plate compactor attached to a backhoe boom (Series 4, craters 4 and 5).
- g. The 18 in. of neat grout-large stone repair is recommended for the semipermanent crater repair where concrete transit mix trucks are not available.
- h. The asphalt caps are not recommended due to the difficulty in placement of correct temperatures and the question of availability of asphalt during wartime.

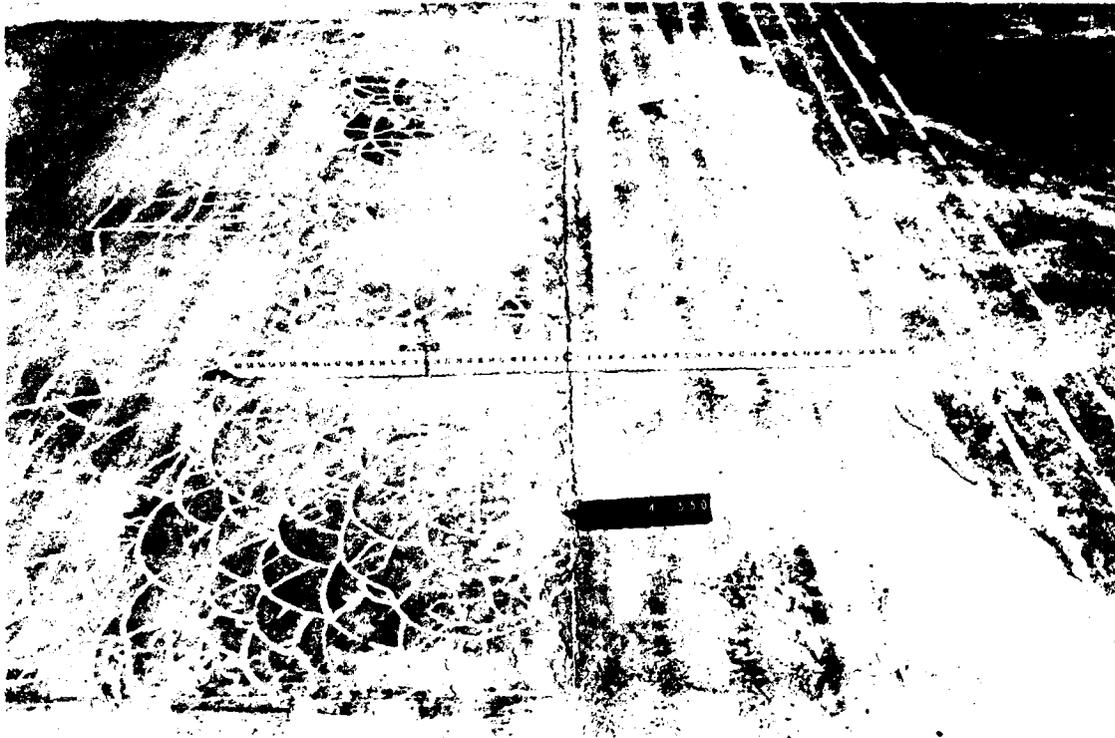
30. Photo 41 shows the traffic lane before traffic. F-4 traffic was started 10.5 hr after placement of the grout cap over the well-graded crushed limestone. Hairline cracks started in the grout cap after 15 passes or 2 coverages, and they ran the length and width of the traffic lane. After 45 passes or 6 coverages, minor spalling was noted along the edge of the crater repair. After 228 passes or 30 coverages a large number of cracks developed in a semicircular pattern (Photo 42). As the traffic continued, the number of cracks inside and outside of the traffic lane increased along with the spalling at the edges of the crater. Photo 43 shows the severity of the cracking and spalling after 550 passes or 72 coverages. C-141 traffic caused additional cracks and spalling after 340 passes or 100 coverages. Some of the cracks were 2 in. apart and the spalling had reached a depth of 1.5 in. along the edge of the crater (Photo 44). Traffic was continued to 3400 passes or 1000 coverages and there was no noticeable increase in the number of cracks; however, the spalling continued along the edges of the crater repair and some minor spalling was noted on the cracks inside the crater (Photo 45). Figure 13 shows that there was consolidation of the repair materials under C-141 traffic, with the maximum being 0.5 in. after 100 coverages, 1.5 in. after 500 coverages, and 2.0 in. after 1000 coverages.

Photo 43. Crater 4, lane 1, after 72 coverages of F-4 traffic

- d. The spalling of the grout cap caused a FOD problem of its own, while trying to eliminate the loose stone (FOD) problem encountered with the well-graded crushed limestone. The amount of spalling that occurred under traffic makes this crater repair method unacceptable (Series 4, crater 4).

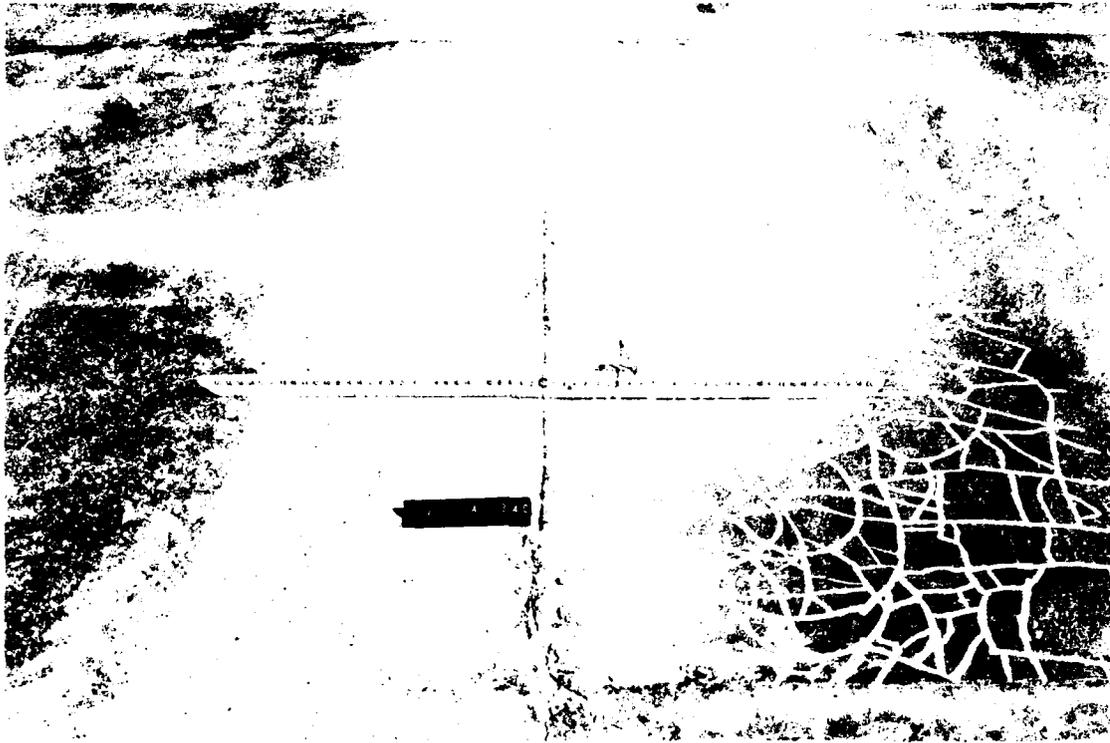
Photo 47. Crater 4, lane 2, after 100 coverages of C-141 traffic

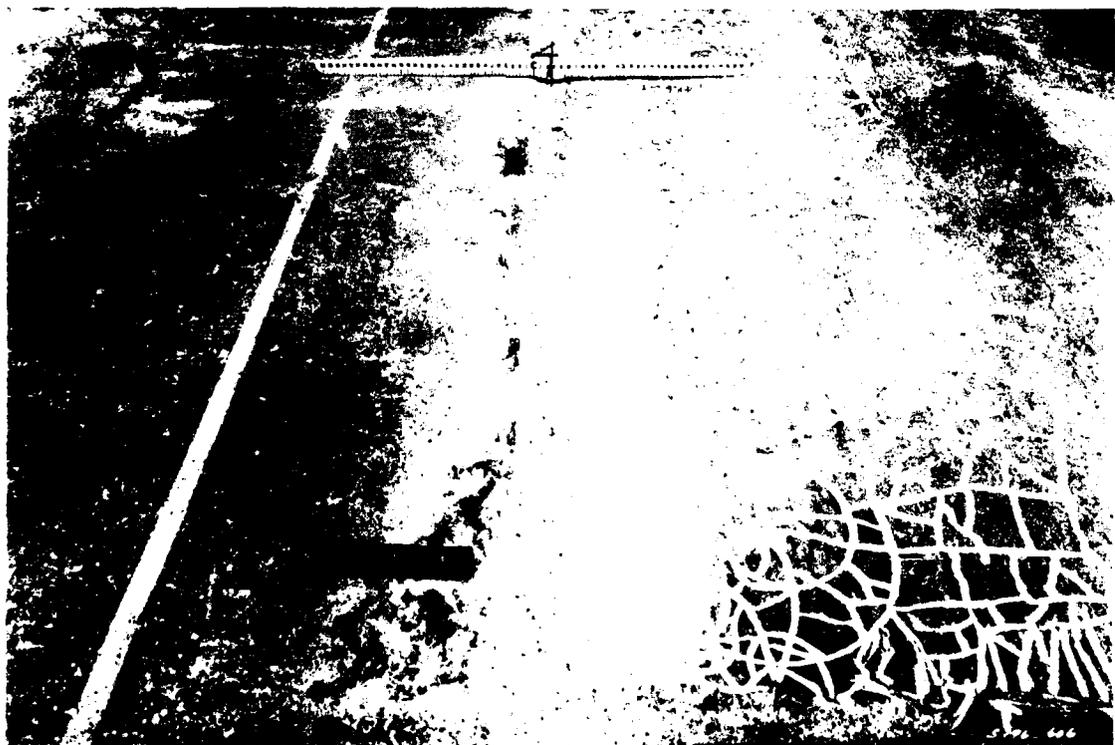
Photo 48. Crater 4, lane 2, after 1000 coverages of C-141 traffic

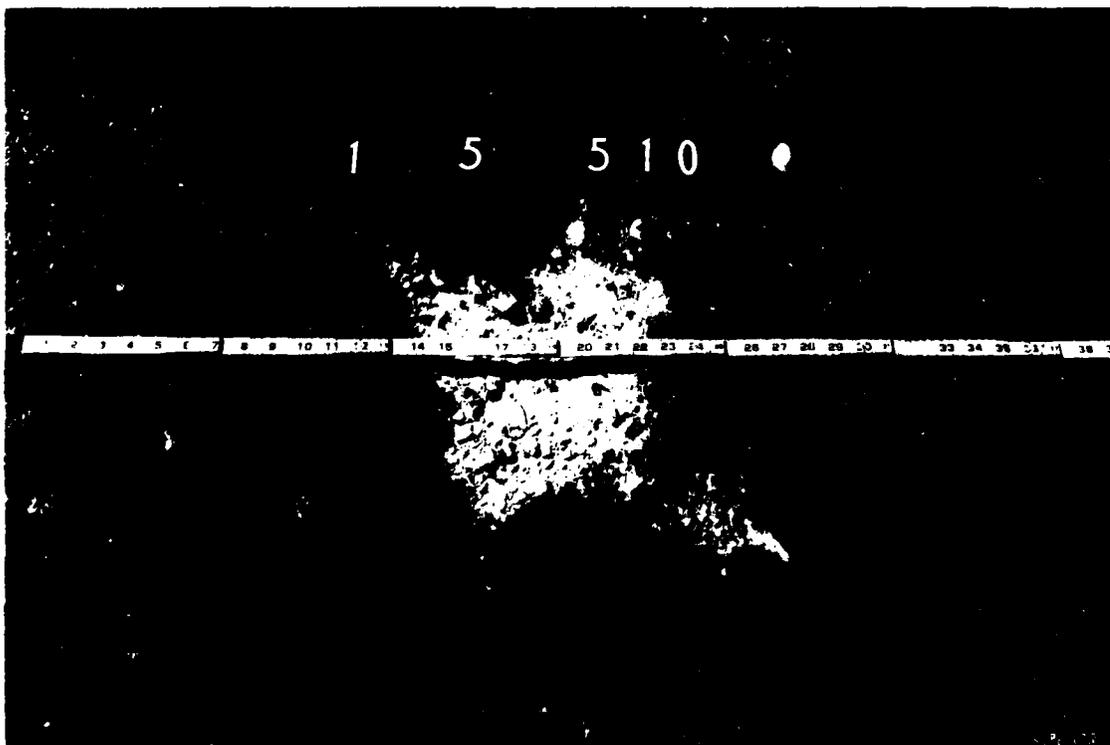
Photo 52. Crater 5, lane 1, one area of DBST which adhered to the tires of C-141 after 150 coverages

- e. Because of the ambient temperature of 65° to 70°F, the AC-20 cooled too quickly for proper seating of the aggregate into the binder. Also, the amount of asphalt used was somewhat higher than necessary--0.6 percent was used as compared to a design amount of 0.5 percent. As traffic was begun and the ambient temperature increased, the aggregate became embedde into the asphalt, resulting in a bleeding condition. If an AC is used for the binder in a DBST, it should be applied at the design amount or slightly less. Also, the DBST should not be placed if the ambient temperature is below 80°F or the surface to be treated is below 100°F. Even if these weather conditions are met, the aggregate may require preheating to ensure a good
