AFWAL-TR-84-3115

ACCELERATED CORROSION TESTING OF GRAPHITE/EPOXY COMPOSITES AND ALUMINUM ALLOY MECHANICALLY-FASTENED JOINTS

S. D. Thompson,
B. L. White
Survivability/Supportability Group
Structures and Dynamics Division

June 1985
Final Report for Period May 1980 - December 1984

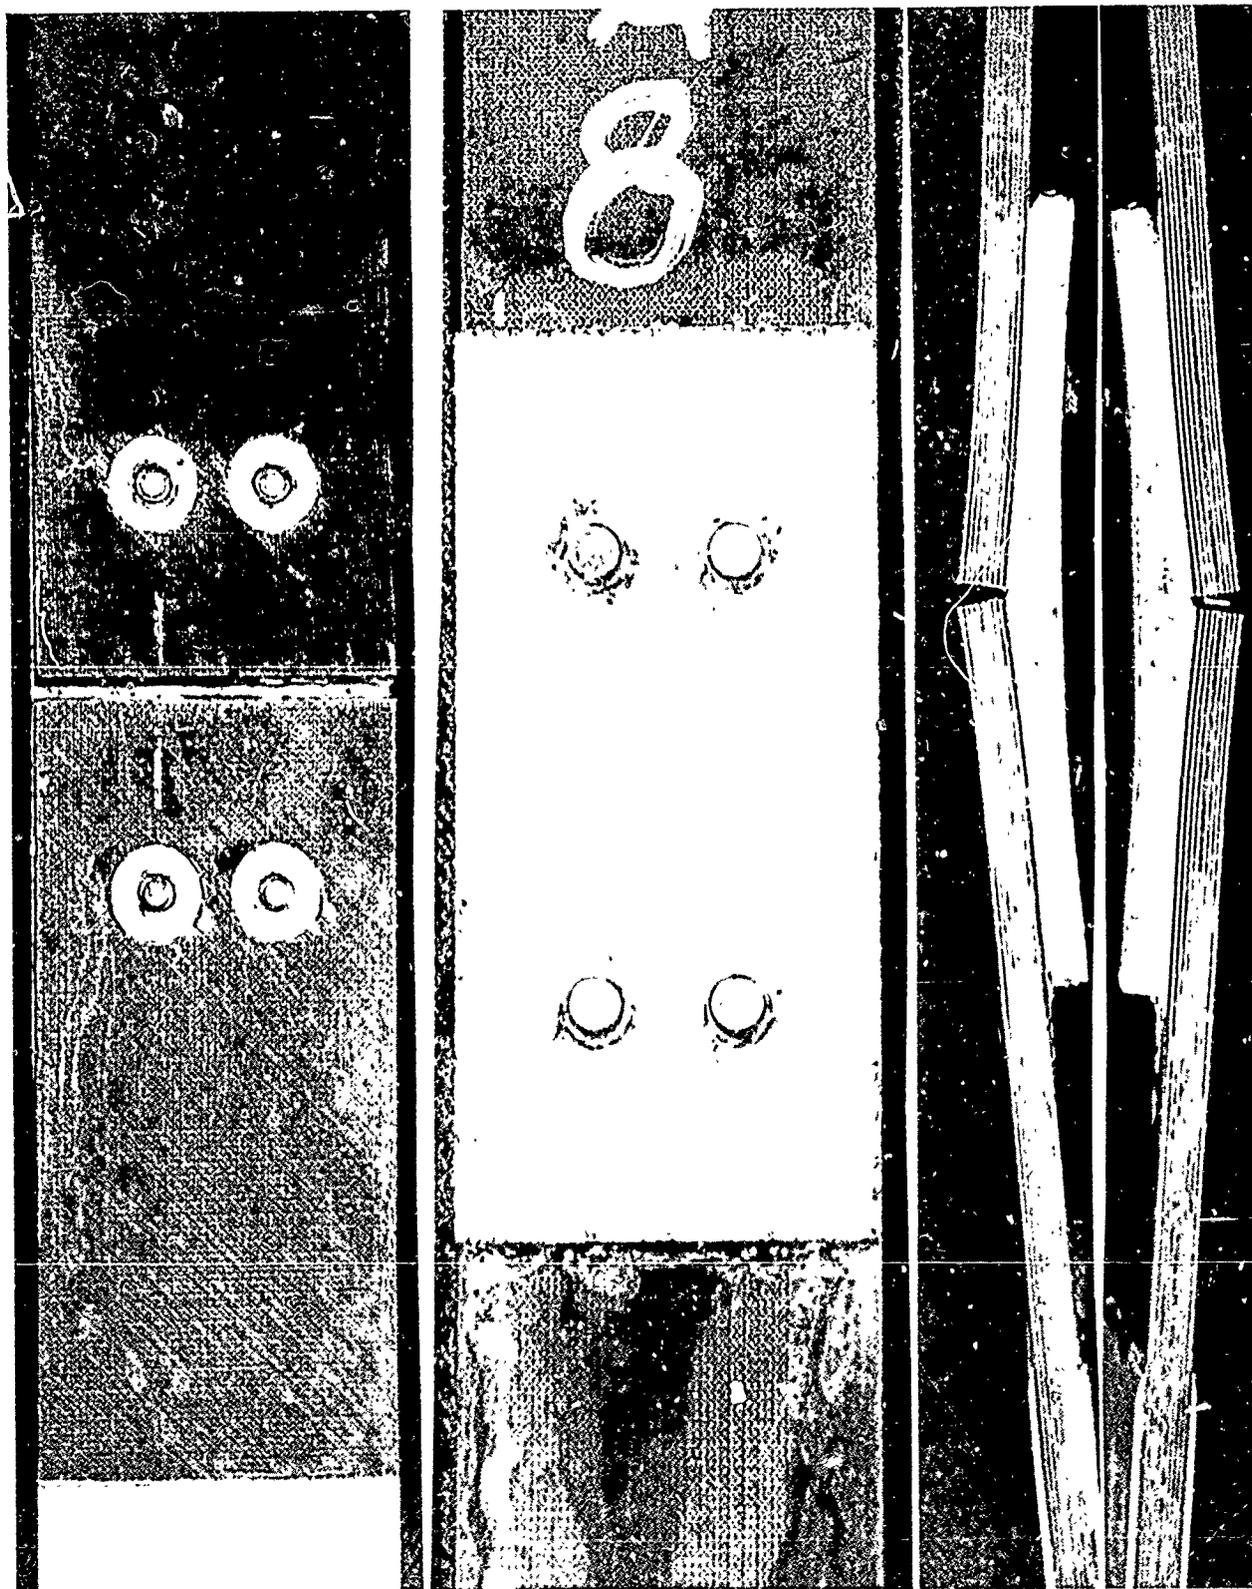
Figure 4. Unprotected Graphite/Epoxy and Aluminum Alloy Lap-Joint Fastened with A-286 CRES Fasteners After Two Corrosion Cycles

After a relatively short exposure time, the uncoated samples started to exhibit localized pitting along the edge of the aluminum plates. In all twenty cases, the aluminum was severely attacked at the edge where the two composite sections butt together. During the first twelve week corrosion testing period, corrosion and salt products began building up in the faying surface of the composite and aluminum section causing bending of the aluminum plate. These by-products can be seen in Figure 4 and Figure 5, C and D. The by-products resemble a fine whitish-gray salt wedged into the faying surface of the structure. After the second twelve week exposure the continued buildup of corrosion and salt products resulted in plastic deformation of the aluminum plate and substantial localized deformation of the graphite/epoxy composite.

The effect of the exposure to two corrosion cycles without the fatigue test sequence for the unprotected samples is shown in Figure 4 for the joints with A-286 CRES fasteners. The front and back of the test sample and two edge views are shown. In the front view (Figure 4a), the formation of red rust on the

A-286 CRES fastener around the center pin can be seen. In the view of the back of the sample (Figure 4b), the generalized corrosion attack on the surface of the aluminum and the more concentrated attack along the edge and adjacent to the fastener may be seen. The views of the joint area from either edge are shown in Figures 4c and 4d. The buildup of the corrosion and salt products between the composite and the aluminum plate may be seen. The deformation of the aluminum and the composite is quite evident.

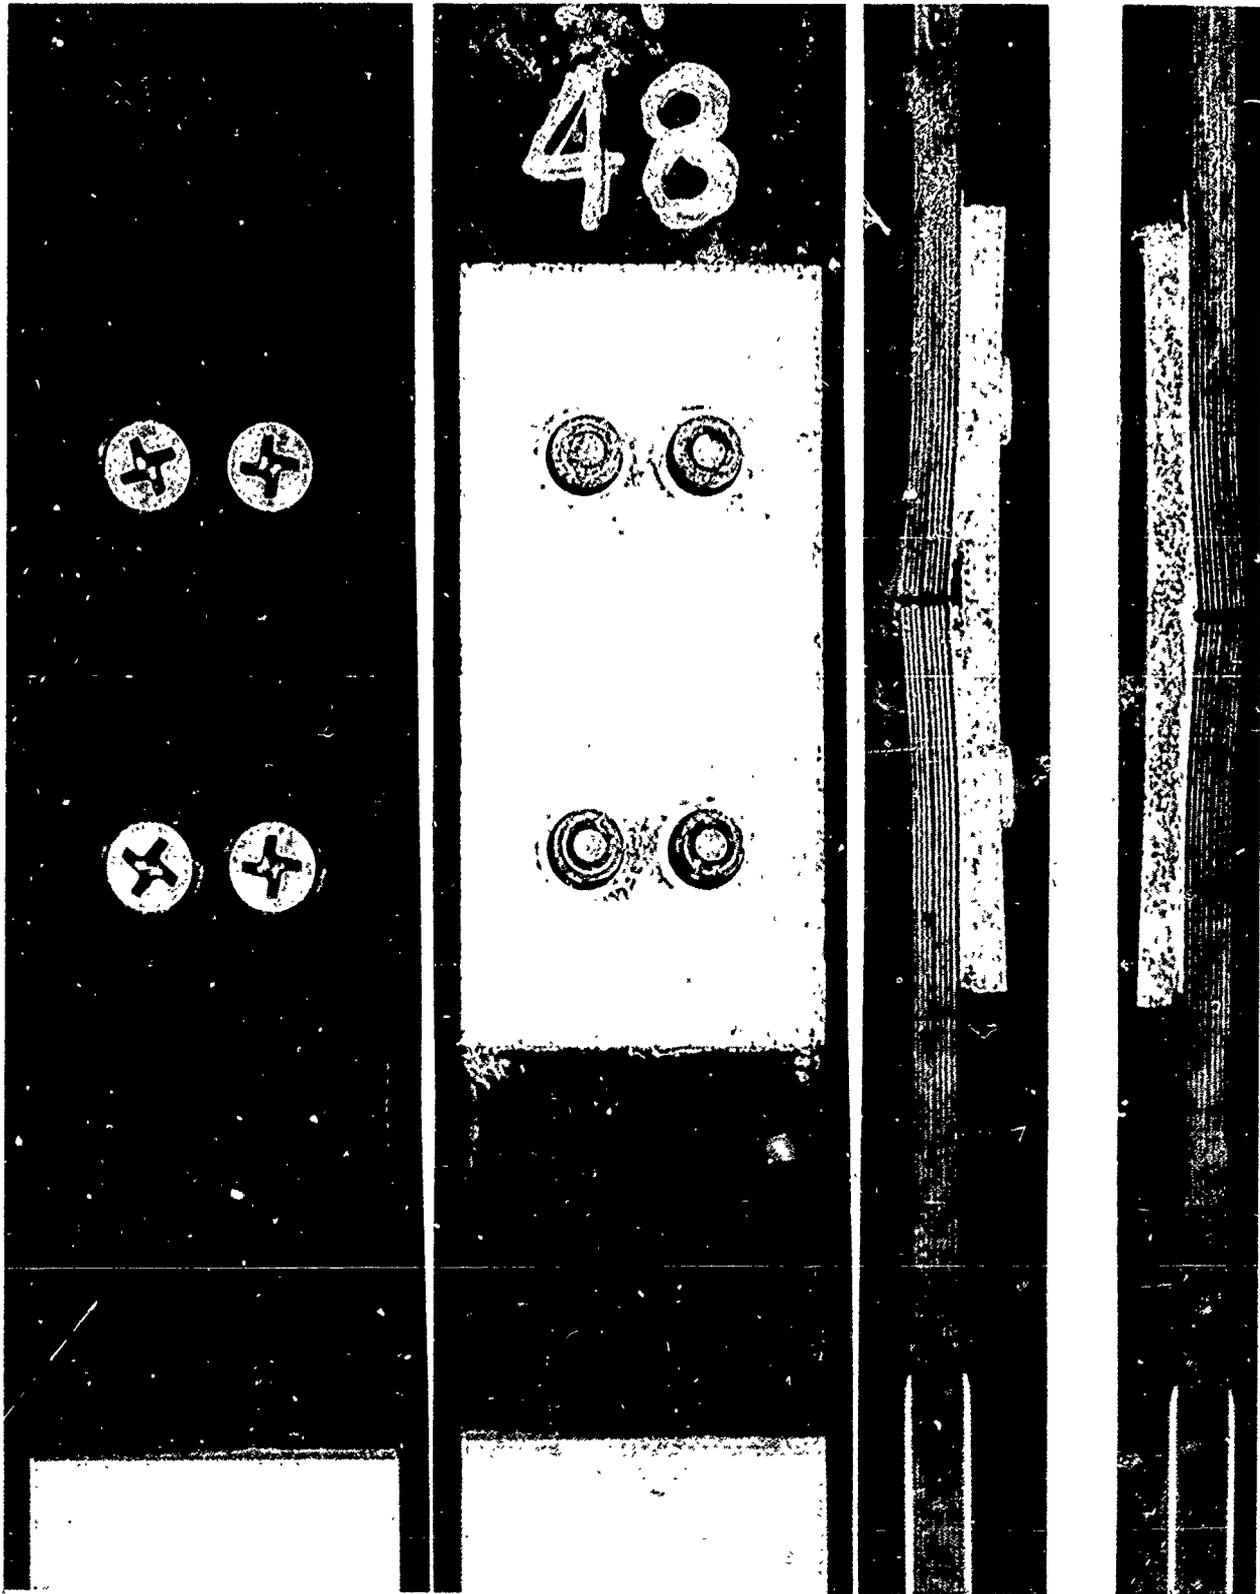
Figure 5. Unprotected Graphite/Epoxy and Aluminum Lap-Joint Fastened with Titanium Fasteners After Two Corrosion Cycles

The effect of the corrosive exposure on the unprotected composite joints with titanium fasteners is shown in Figure 5. In the front view (Figure 5a), the titanium fastener, as expected, showed little effect of the corrosive exposure. In the rear view (Figure 5b), the generalized corrosion of the aluminum may be seen. In the edge view (Figures 5c and 5d) the severe pitting of the edge of the aluminum may be seen. The buildup of the corrosion and salt products under the composite, in the area where the composite portions of the sample butt together, caused the ends of the graphite epoxy composite to bow up.

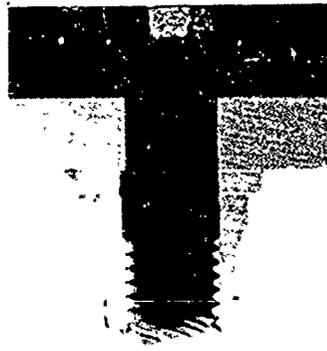
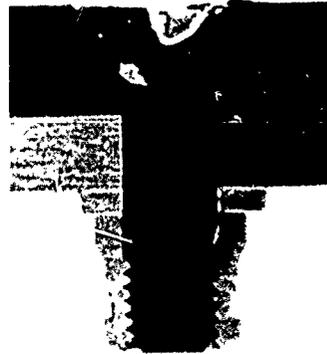
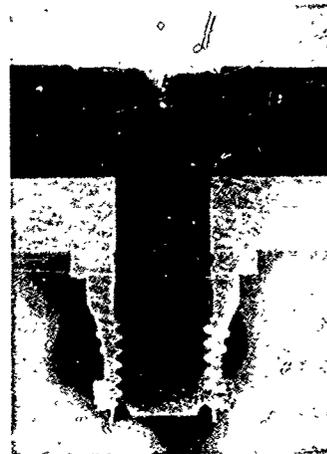
Figure 6. Protected Graphite Epoxy and Aluminum Samples, Fastener and Hole Condition After Two Accelerated Corrosion Cycles

In general, the fastener holes appear to be totally free of corrosion. The faying surface sealants adjacent to the fastener hole appear to be in good shape. Sealant is still visible in the countersunk area between the hole surface and the head of the fasteners. The dark area, which can be seen on the composite, adjacent to the fastener hole, on samples A-81, A-82, A-126, A-128, A-129, is a result of poor drilling technique. A discrepancy appearing in the photos in Figure 6 is the peeling of the top coat on the fastener heads. This did not occur during testing but was a result of the cutting process during pre-

Note, on samples A-82 and A-84 some signs of red rust are beginning to appear around the center pin of some of the CRES A-286 fasteners. This appears to result from either the paint chipping or the paint not covering a sharp corner on the fastener head.

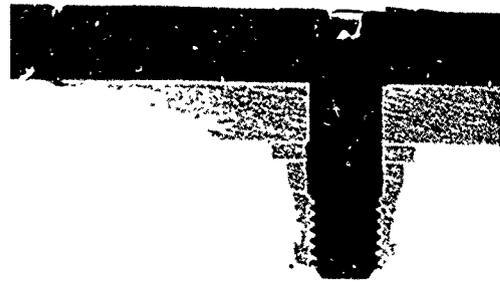
Figure 9. Protected Graphite/Epoxy and Aluminum Samples, Fastener and Butt Joint Conditions After Two Accelerated Corrosion Cycles

fastener hole and butt joint are both visible. Again, let it be emphasized that these six samples were chosen at random. Of the six samples, all six show little to no squeeze-out of sealant between the ends of the composite portion of the structure. As a result of this, three of the samples show slight to moderate pitting corrosion, the whitish area at the base of the joint, in this area of the structure.

Any faying surface disbond, samples A-81, A-84, A-128 and A-129, is a result of torque-up of the sample during fastener installation and lack of adequate faying surface sealant. This brings to light the importance of having proper sealant squeeze-out if the structure is to ever be protected from corrosion.

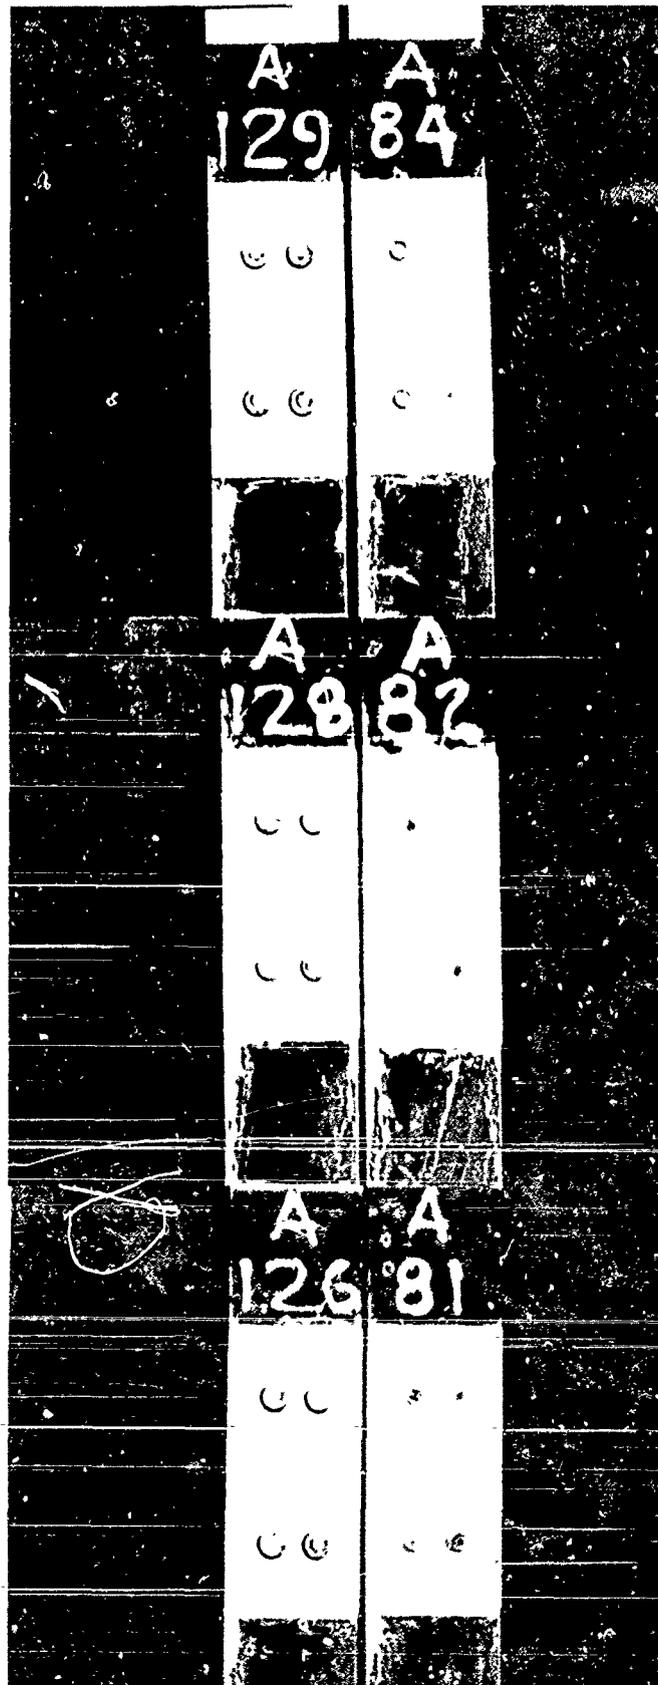
Figure 10. Protected Graphite/Epoxy Aluminum Samples, and Aluminum Structure Condition After Two Corrosion Cycles

Up to this point the defects which are similar on the two different types of samples have been discussed. The following is a discussion of defects which were unique to each design. A defect that was observed on just a single design was that of pitting around the crimped region of the A-286 fasteners. It can be seen in both Figure 6 and Figure 9 that there was an advanced stage of corrosion pitting in this area on sample A-81 and A-84. This same corrosion response was observed on practically all protected samples which used A-286 fasteners. Some possible reasons for this lie in the fact that 1) fastener holes in the substructure were drilled after the structure was anodized and primed, a typical fabrication process used by industry, which may allow for surface damage to occur during drilling, 2) microcracking of the primer resulting from loads

applied by the fastener during crimping, 3) no primer coating is 100% perfect, and 4) aluminum is very anodic to steel, thereby resulting in a large electrolytic dissimilarity producing the necessary driving force for the initiation of galvanic corrosion. Couple these possibilities with the fact that this area is ideally designed to hold salt and moisture, even after the sample is rinsed off, then this frequent occurrence of corrosion in this area is not surprising. Few such observations were seen on the sample which used titanium fasteners, probably because sealant was able to be squeezed out between the washers and aluminum structure during assembly. This would result in a well sealed interface and no damage to the protective primer on the aluminum. The above observations are better illustrated in Figure 9. This figure shows the substructure of all six samples, before they were cut into. Note the lack of corrosion products at the base of the titanium fasteners while every A-286 fastener shows some degree of corrosion pitting at and around the base of the fastener, at the substructure-fastener interface.

Another observation which can be made from Figure 10 is the presence of pitting corrosion on the aluminum collars used with the titanium fasteners. This was observed on every sample using titanium fasteners. The reason for this is due to the large electrolytic dissimilarity between titanium and aluminum. This dissimilarity produced a galvanic couple resulting in corrosion pitting.

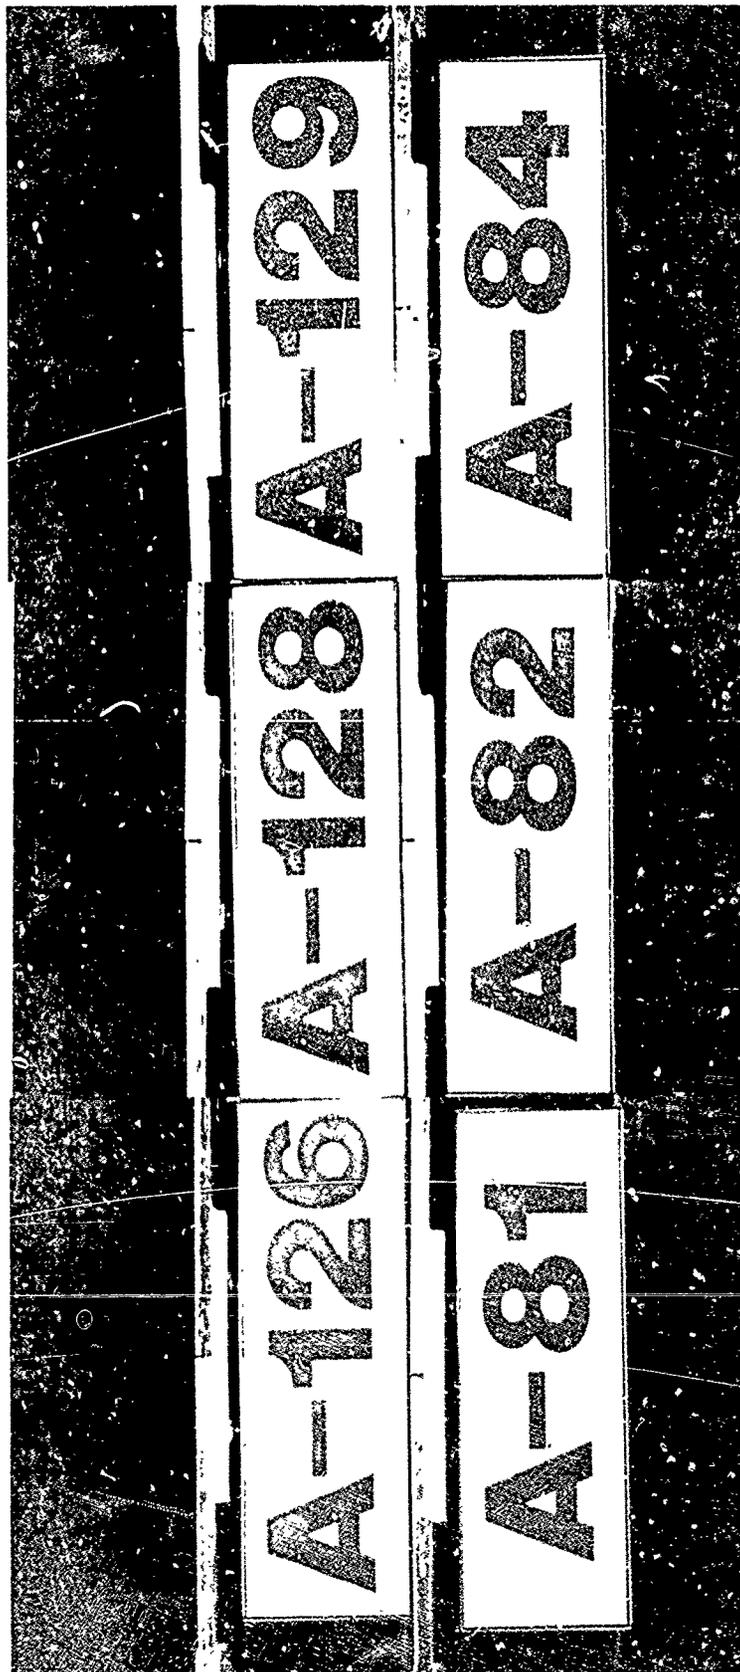
Figure 11. Protected Graphite/Epoxy and Aluminum Samples, Structure Edge Condition After Two Corrosion Cycles

Another significant observation made was the occurrence of moderate to severe pitting corrosion along the edge of the aluminum substructure. In this area it was obvious that the aluminum was going to be in very close proximity to graphite fiber ends, which were exposed along the end edge of the composite structure. It was felt at the start of this program that such an area as this would be very vulnerable to corrosion when subjected to a corrosive environment. It therefore was decided that the edges of the composite structure, on some of the samples, should be painted so that a comparison could be made. Figure 11 presents photos of the edge of the six samples which were selected from this group. It can be seen that all six samples experienced some degree of pitting along the edge of the aluminum. This was typical of all the samples tested. As can be seen A-129 was one of the samples which had the edge of the composite painted. This reduced, but did not prevent, corrosion from occurring. Another significant point to consider is the fact that the aluminum alloy used was 2124-T851, which is supposed to be a more corrosive resistant aluminum alloy than the 2024 series. Also the substructure was chromic acid anodized and covered with two coats of epoxy primer (MIL-P-23377). Such protective steps only reduce the chance of corrosion occurring. However, no paint, primer, or anodize layer can be 100% perfect; therefore, the chances of totally preventing corrosion are slim.

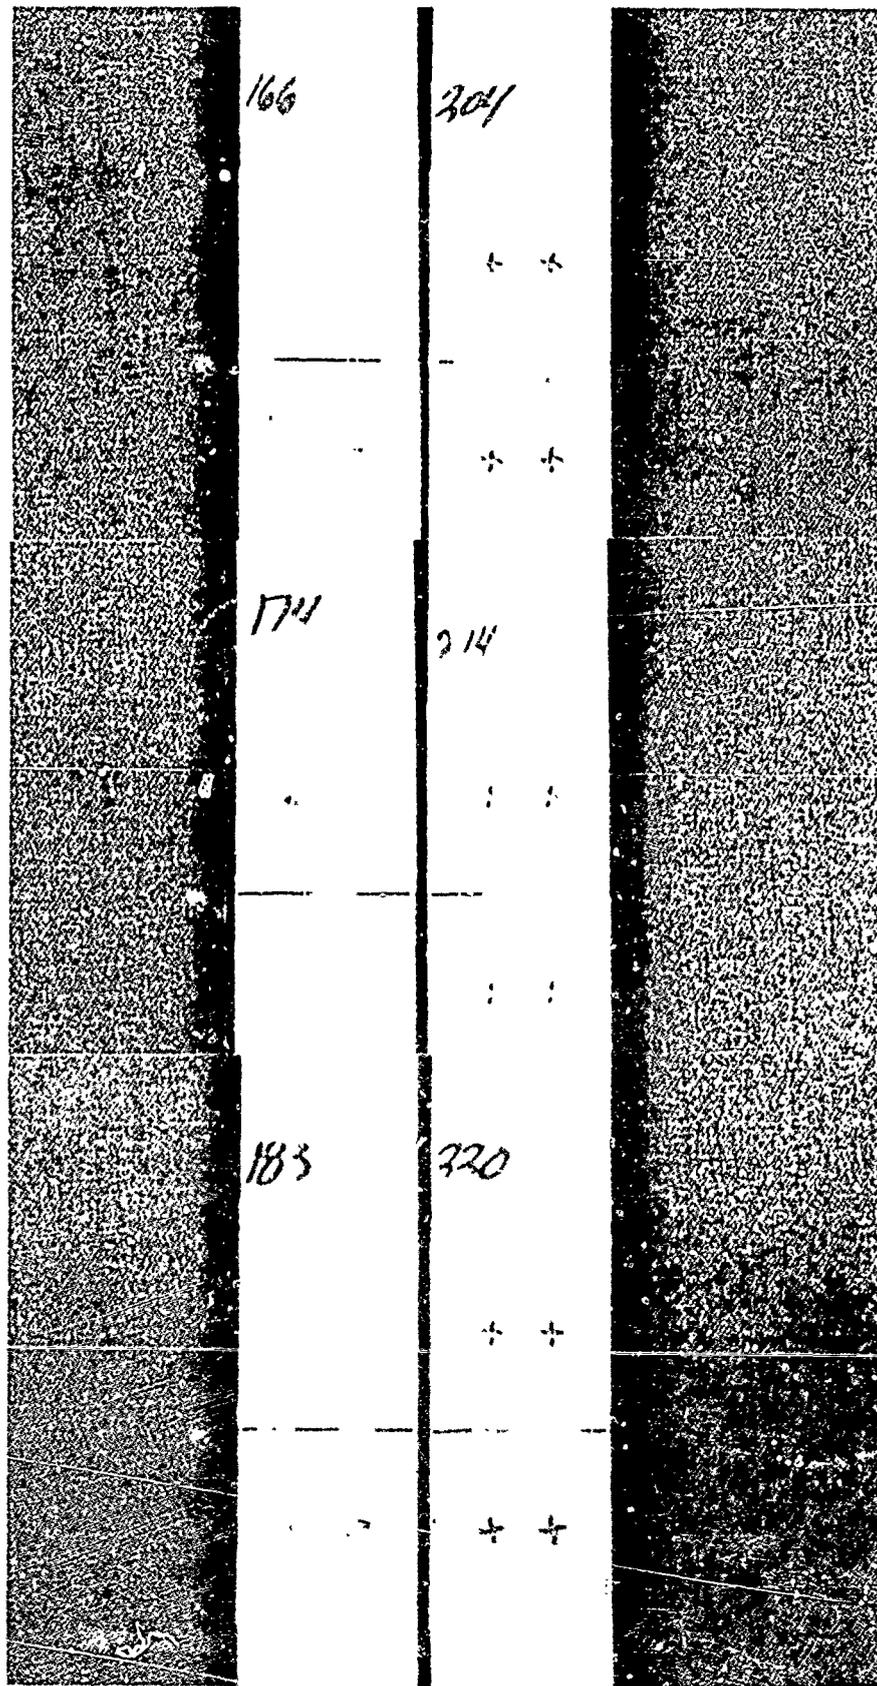
Figure 12. Protected Graphite/Epoxy and Aluminum Samples, Top Surface Condition After Two Accelerated Corrosion Cycles and One Fatigue Cycle

As can be seen in Figure 12, the upper surface of these samples, typical of all fifty samples, appear in good shape, except for the red rust products on some of the A-286 fasteners. The top coat appeared to have withstood the structural loading without cracking or peeling.

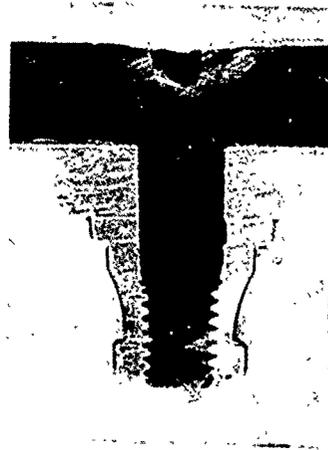
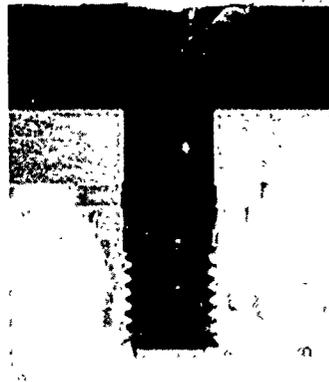
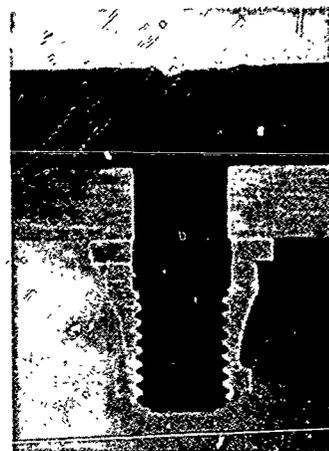
Figure 13. Protected Graphite/Epoxy and Aluminum Samples, Fastener and Hole Condition After Two Accelerated Corrosion Cycles and One Fatigue Cycle

samples, in this area, was identical to that seen in the samples which underwent accelerated corrosion testing only. It appears that the fatigue loading did not produce any cracks or deterioration in the protective coatings and sealants around the fasteners. Of course this is a function of load level and if the applied loads had been higher the response may have been different.

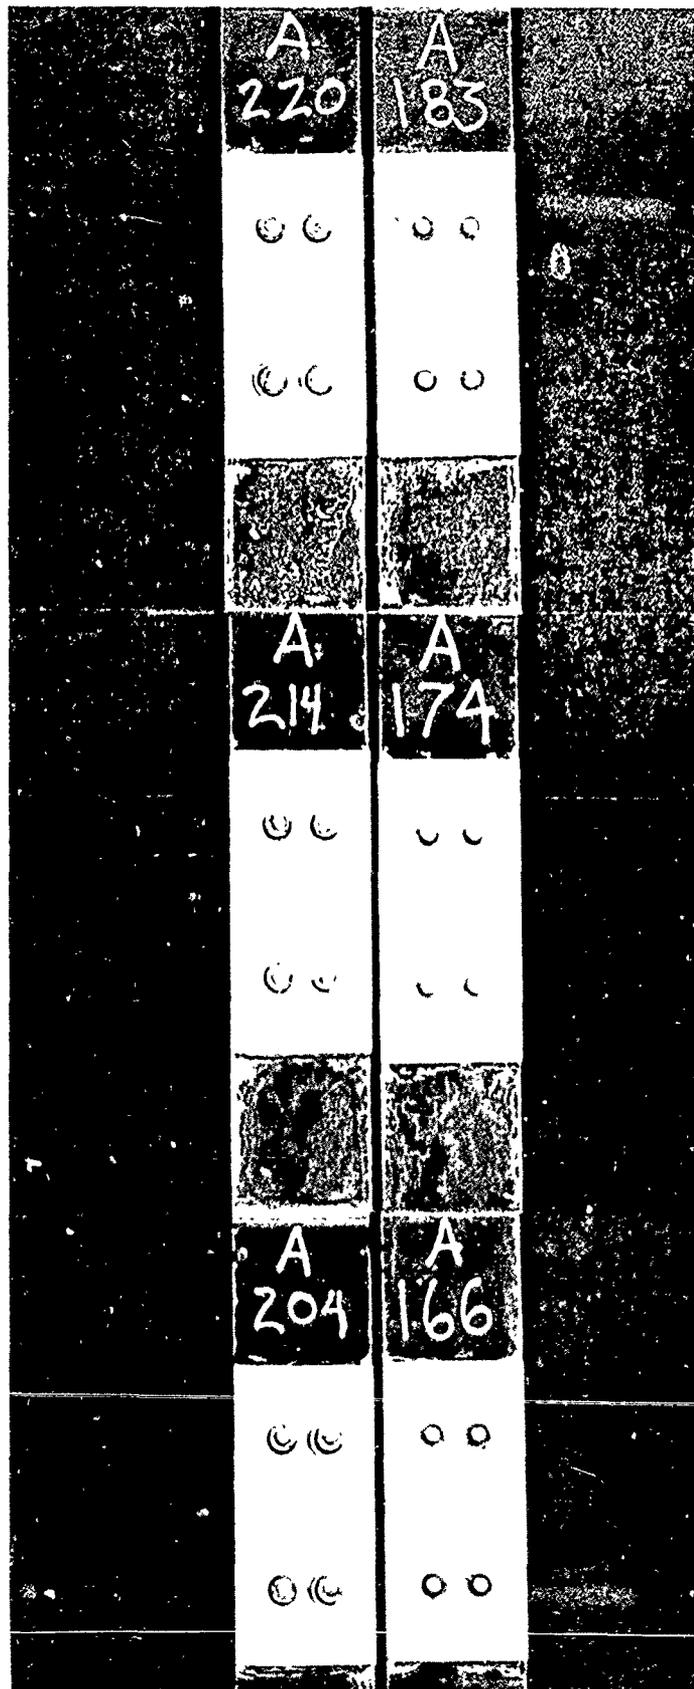
Figure 14. Protected Graphite/Epoxy and Aluminum Samples, Aluminum Structure Condition After Two Corrosion Cycles and One Fatigue Cycle

As noted before, these samples also showed severe pitting at the location of crimping on the samples using A-286 fasteners. Also, as noted before, the aluminum collars used on the titanium fasteners show signs of severe pitting. Figure 14 presents a series of photos which show the backside of these six samples showing these areas of corrosion. Figure 15 shows enlarged views of the same fasteners shown in Figure 13 but the butt joint area and faying surface bondline are also shown. As can be seen in these photos, samples A-174, A-183, A-204, A-214, and A-220 show that there was more than adequate squeeze-out of sealant in the butt joint area. However, sample A-166 had very little squeeze-out and, as can be seen, all samples show no signs of corrosion in this area.

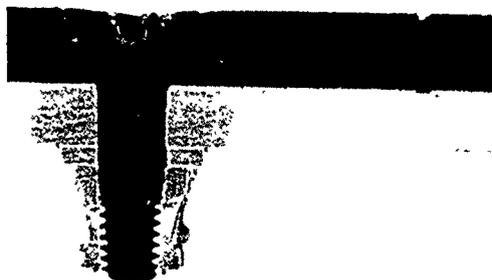
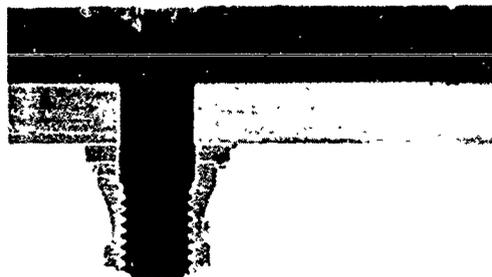
Figure 15. Protected Graphite/Epoxy and Aluminum Samples, Fastener and Butt Joint Condition After Two Accelerated Corrosion Cycles and One Fatigue Cycle

Note the large cracks appearing in the sealant in the joint area. These cracks appear to have resulted due to sealant curing then aggravated by the structural loads which were applied during fatigue cycling. This is evident by the smaller cracks in the sealant adjacent to the aluminum substructure and the corner of the composite skin structure. This appears on all six samples

and if left undetected on actual aircraft structure could result in increasing the structure's vulnerability to corrosion. The sealant (MIL-S-83430) is the type presently being used on the faying surface on many aircraft which have composite-aluminum structure.

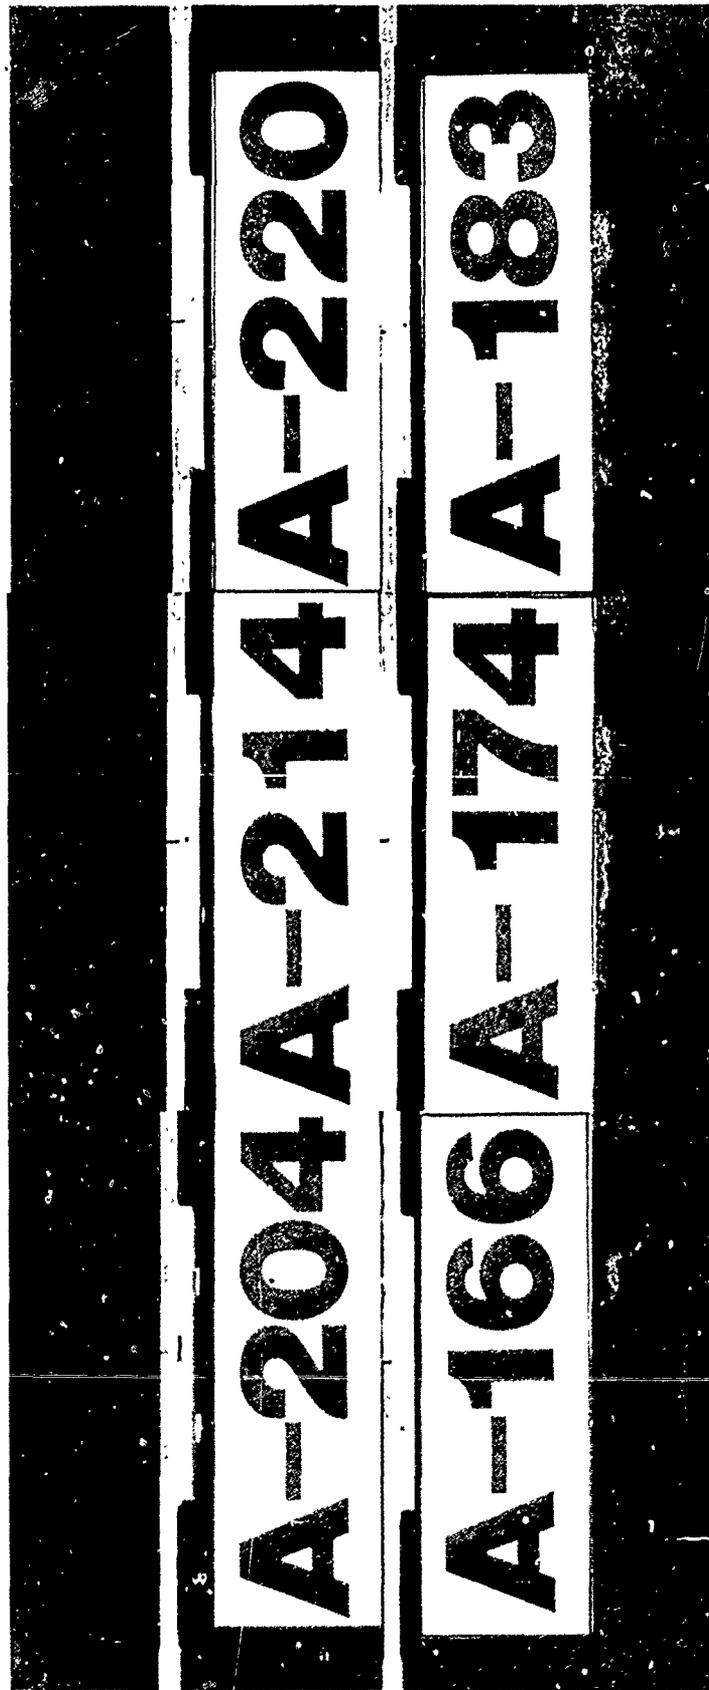
Figure 18. Protected Graphite/Epoxy and Aluminum Samples, Structure Edge Condition After Two Corrosion Cycles and One Fatigue Cycle

Figure 18 is a series of macrographs showing the edges of the six samples: A-166, A-174, A-183, -204, -214, and A-220. As can be seen in these photos, the edges of the composite structure were covered with polyurethane top coat. However, this did not prevent the occurrence of corrosion. The corrosion response of this portion of these test samples was very similar to that of the samples which did not undergo load cycling.
