N-1742

January 1986

Technical Note

Experimental Polyurethane Foam (PUF) Roofing Systems- III: Naval Station, Roosevelt Roads, Puerto Rico, and Naval Facility, Cape Hatteras, North Carolina

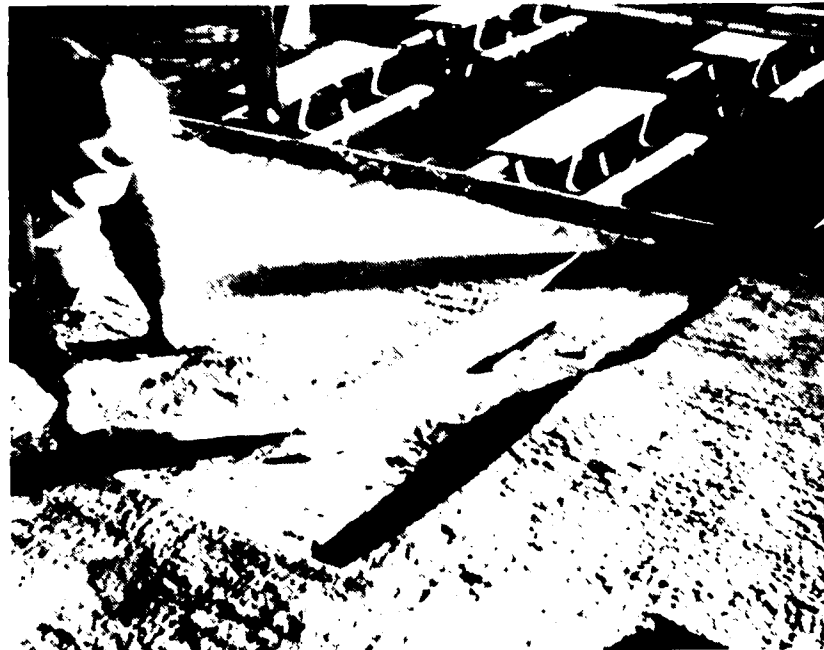
When the old roof was torn off, the insulation was attached to a poured gypsum concrete roof deck rather than gypsum plank. Because of this, the SAM was adhered directly to the poured gypsum concrete and the foam stop rather than the gypsum plank and the foam stop (Figure 3). The western portion of the gypsum concrete deck was subjected to an unexpected rain storm after the BUR was removed and before the SAM was attached. This caused substantial leaking and wetting of the gypsum concrete. The SAM did not adhere well to the gypsum concrete in one area because it was damp. Figure 4 shows a workman removing the SAM (with PUF attached) from the gypsum concrete in the area before the repairs.

Figure 4. Workman remove PUF and SAM from damp area of Galley's roof where SAM did not adhere to gypsum concrete fill. Naval Facility, Cape Hatteras N.C.

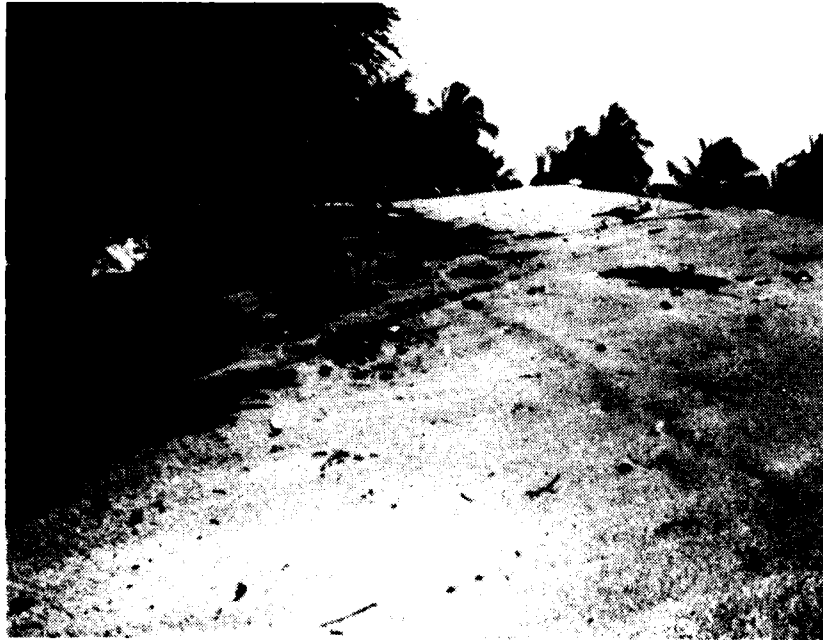
Figure 11. System 2 - Silicone with fungicidal granules. In good condition despite accumulation of leaves and tree limb erosion. Naval Station, Roosevelt Roads, P.R.

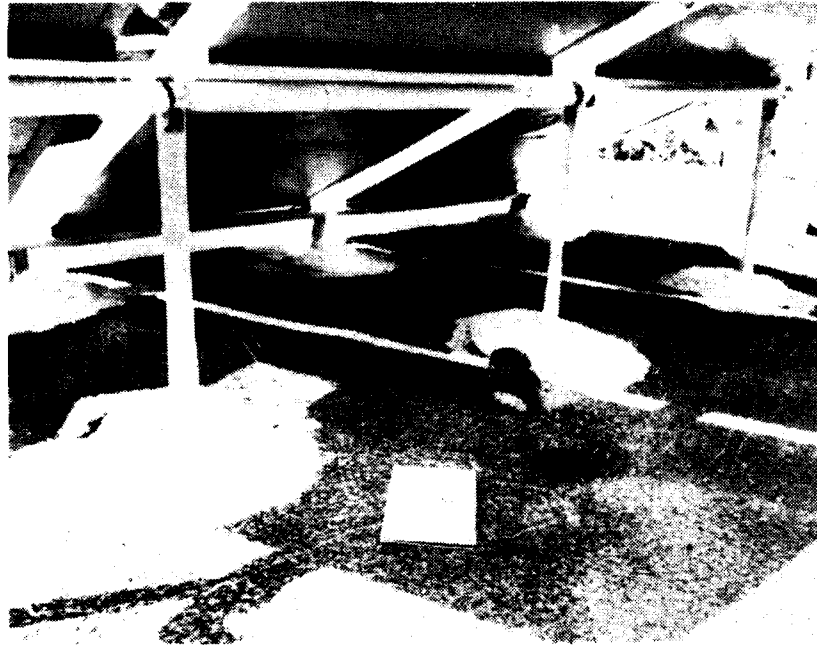
Physical abuse of the silicone coatings was more severe than with the acrylic systems. Palm tree abrasion, such as that shown in Figure 12, occurred on 10 of the 21 roofs, again somewhat higher than with the acrylics. Bird pecking, although not a serious problem, was observed on six of the units. The silicone-coated PUF flashing seals around legs of solar collector supports were in excellent condition, which again shows that the system will perform very satisfactorily when properly coated (see Figure 15).

Figure 15. System 2 - Silicone with regular granules. Typical PUF flashings coated with heavy coat of silicone are in excellent condition. Naval Station, Roosevelt Roads, P.R.

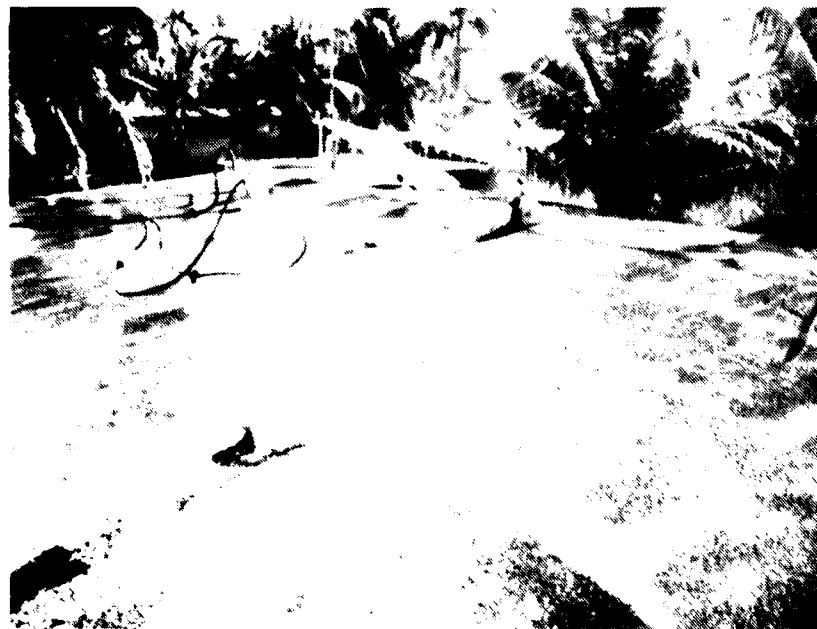
By contrast, most PUF flashings around other vertical projections or penetrations (pedestals for electric service drops, pipes, etc.) were defective as shown in Figures 9, 16, and 17. The foam was not properly applied to form a smooth transition from the roof deck up and around the projections or penetrations. In addition, the rougher foam surface was not coated to a proper dry film thickness to provide adequate protection. The foam around penetrations should be coated with at least two additional coats of elastomeric base coat or with a compatible caulking compound in order to protect the PUF from weathering. This was done around the angles of the solar units but not around the other penetrations or projections.

Figure 16. System 2 - Silicone with regular granules. Poor performance due to coating being applied too thin. Note pedestal for incoming electrical service and loss of granules because of inadequate coating thickness and improper granule embedment. Naval Station, Roosevelt Roads, P.R.

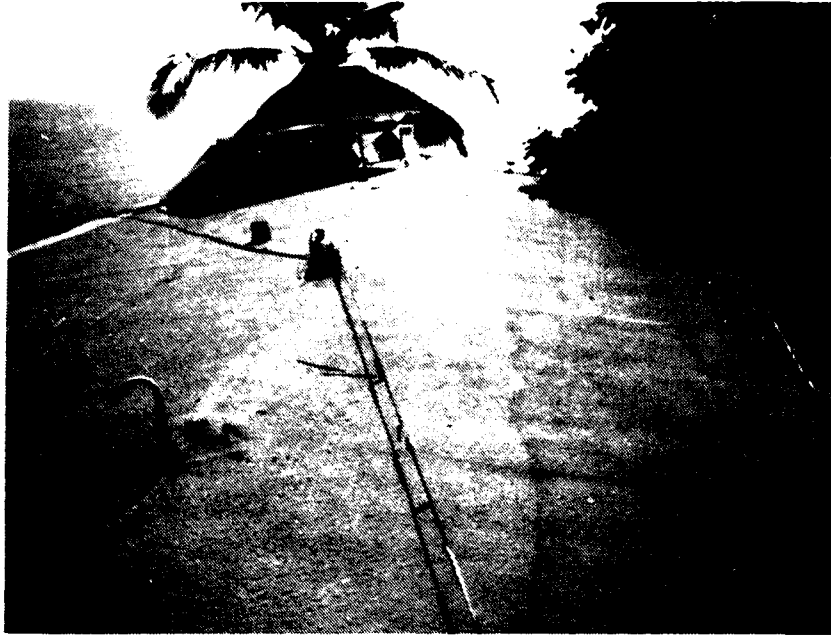
Figure 19. System 1 - Acrylic elastomer with fungicidal granules. Condition very good except for punctures near pipe. Note wires laying on or near coated surface. Naval Station, Roosevelt Roads, P.R.
