## MARINE CASUALTY REPORT

### TANKSHIP PUERTO RICAN

EXPLOSION AND FIRE  
IN THE PACIFIC OCEAN,  
ON 31 OCTOBER 1984

MARINE BOARD OF INVESTIGATION REPORT

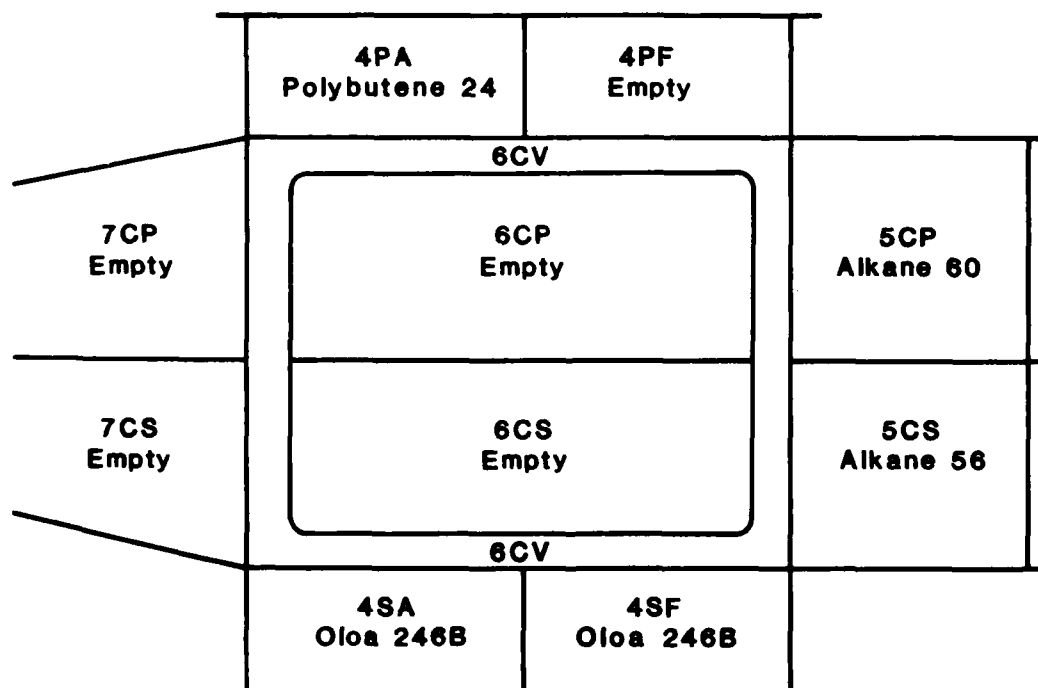
Figure 2. Cargoes in the tanks adjacent to 6CV, at the time of the casualty.
