MTL TR 85-36

# CAUSES OF DELAMINATION FAILURES OF KEVLAR/EPOXY LAMINATES USED IN HARDENED ARMY TACTICAL SHELTERS

WILLIAM W. HOUGHTON and MARGARET E. ROYLANCE  
COMPOSITES DEVELOPMENT DIVISION

December 1985

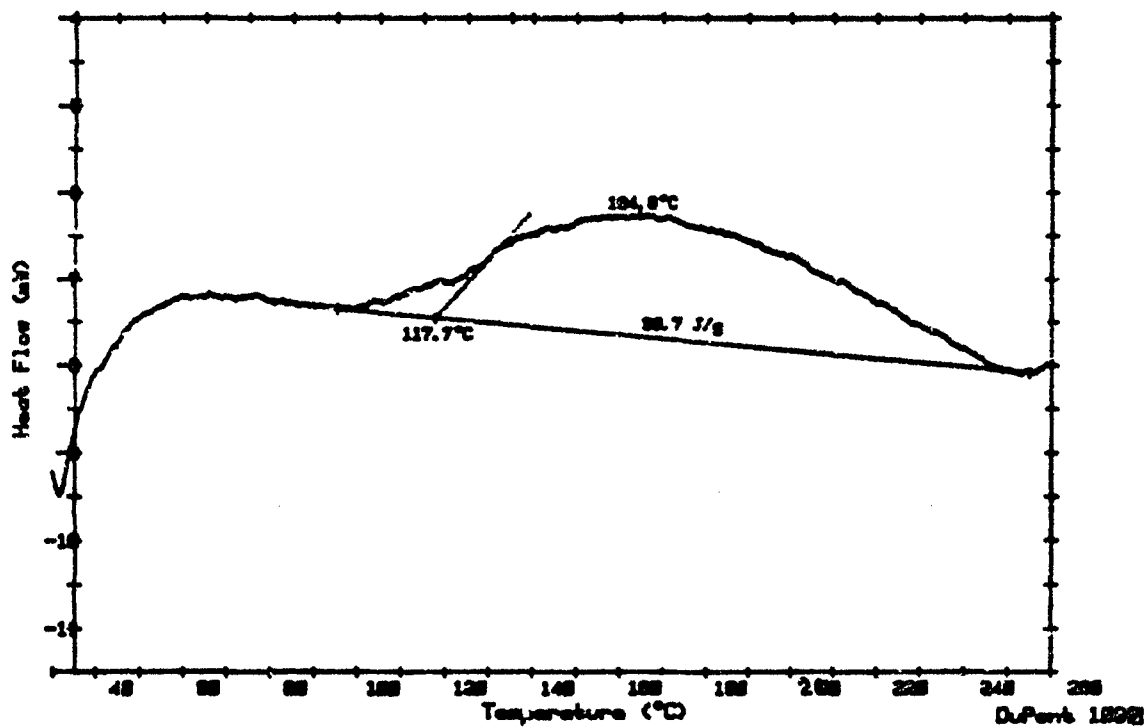
Figure 15. DSC measurement of the residual exotherm in cured Kevlar/epoxy material from shelter A2.

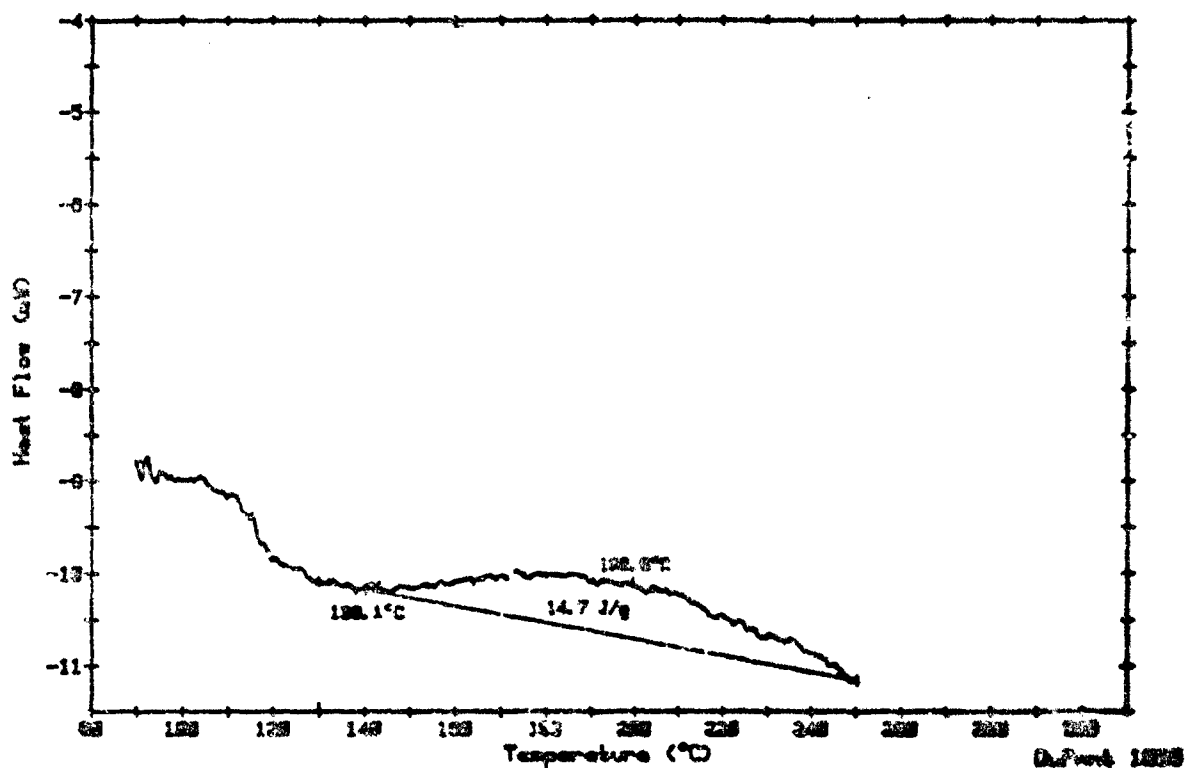
These recommendations were followed during the fabrication of shelter A5, and DSC measurements of test specimens from shelter A5 (Figure 16) indicate a residual resin exotherm of about 30 joule/gram compared to a resin exotherm of 80 joule/gram in A2. This represents a considerable improvement in the extent of cure. Elimination of acetone from the resin, and thorough drying of the Kevlar fabric, as discussed below, may also have contributed to a higher degree of cure in shelter A5.

Figure 16. DSC measurement of the residual exotherm in cured Kevlar/epoxy material from shelter A5.

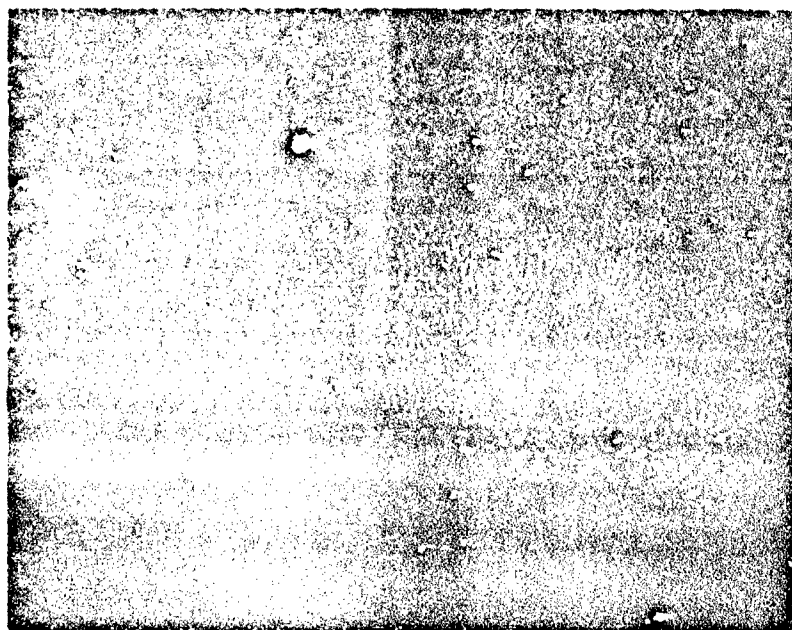
Delaminated Edge

Figure 17 shows a micrograph of an A2 specimen along the environmentally delaminated edge from the region shown in Figures 11 and 12. Figure 18 shows micrographs at two different magnifications of specimens from shelter A2 (labeled "bad") and micrographs at the same magnifications of specimens from the B shelter (labeled "good"). Figures 17 and 18 show that, in addition to the actual delamination, the

A2 material contains many small cracks which run along the fiber-matrix interface. The delaminations themselves appear to be the result of coalescence of these cracks at ply surfaces.

Figure 17. Photomicrograph at 80X of the edge of an environmentally induced delamination from shelter A2. Delamination is also shown in Figures 10 through 12. Figure shows fiber-matrix cracks coalescing at next ply boundary.

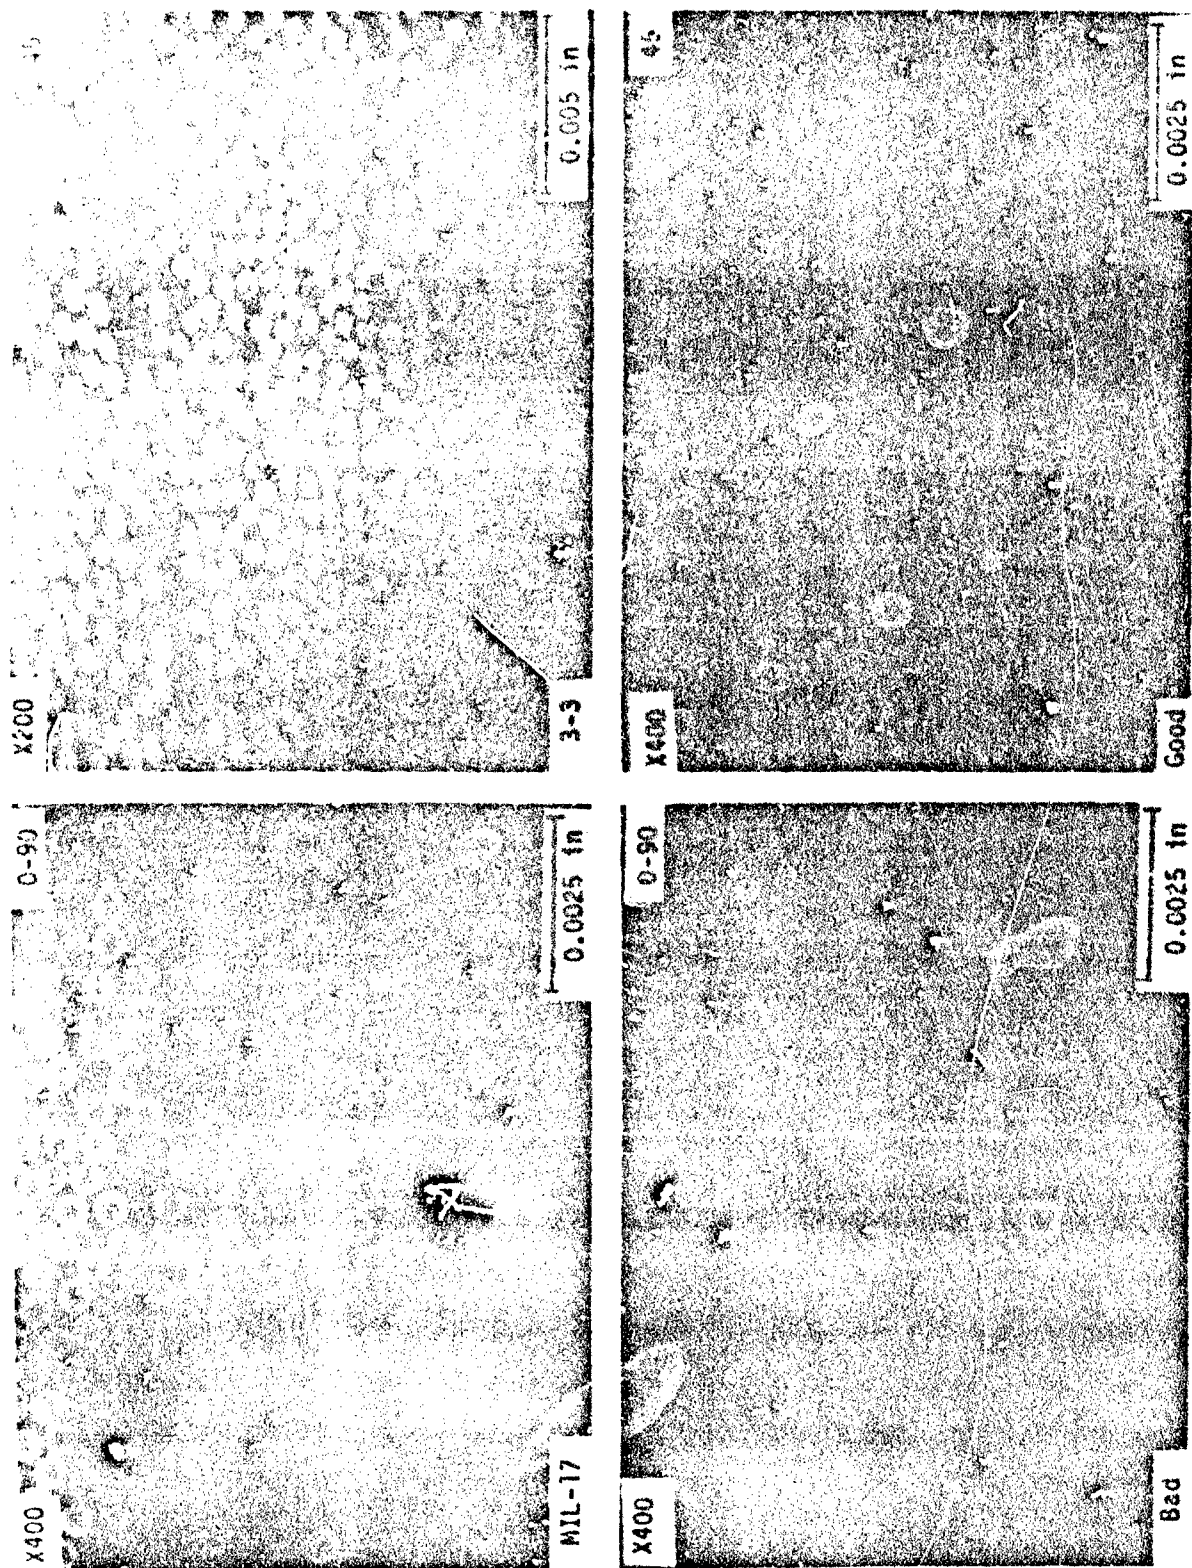
Care was taken during the processing of the Mil Handbook 17 material to ensure that the Kevlar prepreg was dry before laminate fabrication. Manufacturers generally dry the Kevlar fabric adequately before prepegging. The fabric should be dried at temperatures above 100°C for several hours. This procedure was not followed by MIKI during fabrication of the earlier shelters. If environmental moisture is not removed from the Kevlar fabric prior to cure, the elevated temperature will drive

it from the fibers into the fiber-matrix interface. This would be expected to cause the type of damage which was observed in the shelter materials. The correct drying procedure was incorporated into the fabrication of shelter A5, and a microscopic examination of the A5 material showed no such damage.

Figure 19. Photomicrographs at 400X of specimens from shelters A2 and B3 compared with a specimen from a Mil Handbook 17 Kevlar/epoxy laminate. Mil Handbook 17 material does not exhibit fiber-matrix cracking.

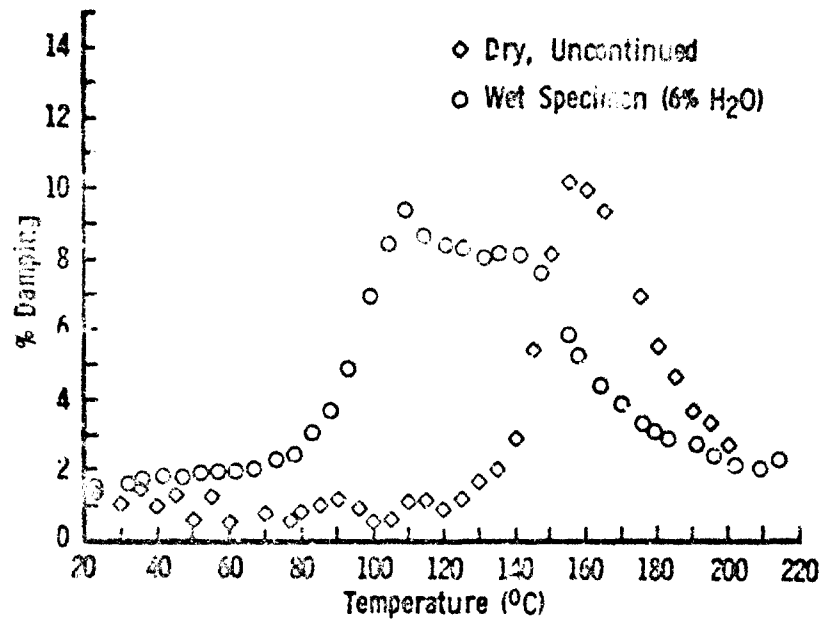
Figure 20b. Torsional pendulum data showing the effect of absorbed moisture on the % damping of Kevlar/epoxy HATS material as a function of temperature. Data indicate approximately 50°C depression of  $T_g$ .

Figure 20 shows that the onset of the glass transition occurs at a significantly lower temperature (about 50°C) in the wet material. This lowering of the glass transition temperature could seriously degrade the performance of the material at the upper use temperature, and suggests that design properties for the laminates should be determined at these temperatures after appropriate environmental conditioning. Saturation by moisture is unlikely to occur in use, but several percent moisture uptake could take place in high humidity environments, and even a few percent absorbed moisture could lead to significant depression of the glass transition temperature in highly cross-linked materials such as this epoxy.
