N-1744

January 1986

Blistering of Asphalt Pavement Overlay on Runway 14-32 at MCAS Beaufort, South Carolina

NAVAL CIVIL ENGINEERING LABORATORY PORT HUENEME CALIFORNIA 93043

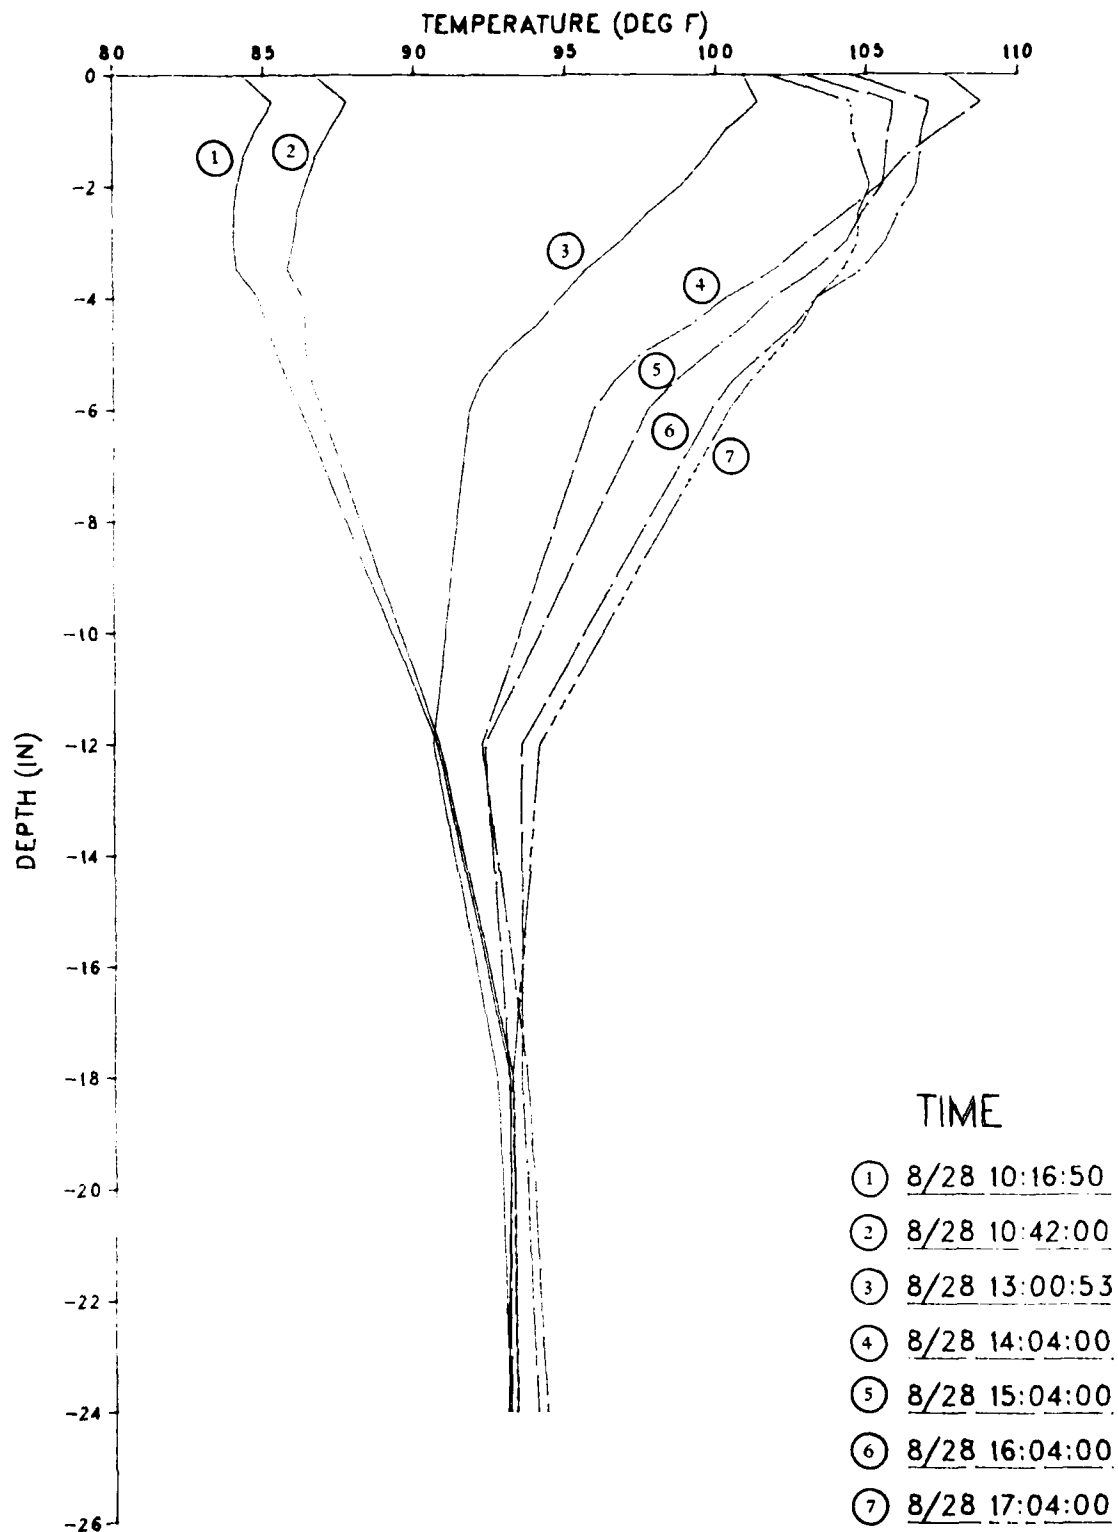
It is unlikely that gas pressures originating from ground water or moisture in the soil could be the cause of the diurnal blister behavior. As can be seen in the measured temperature profiles of Figures 13 and 14, the large diurnal pavement surface temperature variation dissipates into a steady state condition below about the 1-foot depth. Thus, since diurnal temperature effects are minimal beyond this depth, the blister behavior cannot be attributed to gas originating from deeper depths on a diurnal basis. Since the ground water table is located much deeper than 1 foot (10-foot deep inspection wells were dry), this eliminates gas originating on a diurnal basis from the groundwater as the cause of the blisters. Gas originating from moisture in the soil at shallower depths above the water table can also be eliminated as the cause of the blisters because of two reasons: (1) the soil, which is sandy, is much more permeable to gases than the dense asphalt pavement layers and thus any pressure buildup will dissipate through the soil and not through the pavement structure, and (2) gases present in the soil moisture, if they were to migrate into the blisters, would with time become depleted and blisters would cease to form. Since the blisters continue to form diurnally, blister formation cannot be attributed to gas pressure buildup in the soil layers beneath the pavement structure. An additional indication

Figure 13. Temperature profiles at Site 1 near blisters 1 and 2.

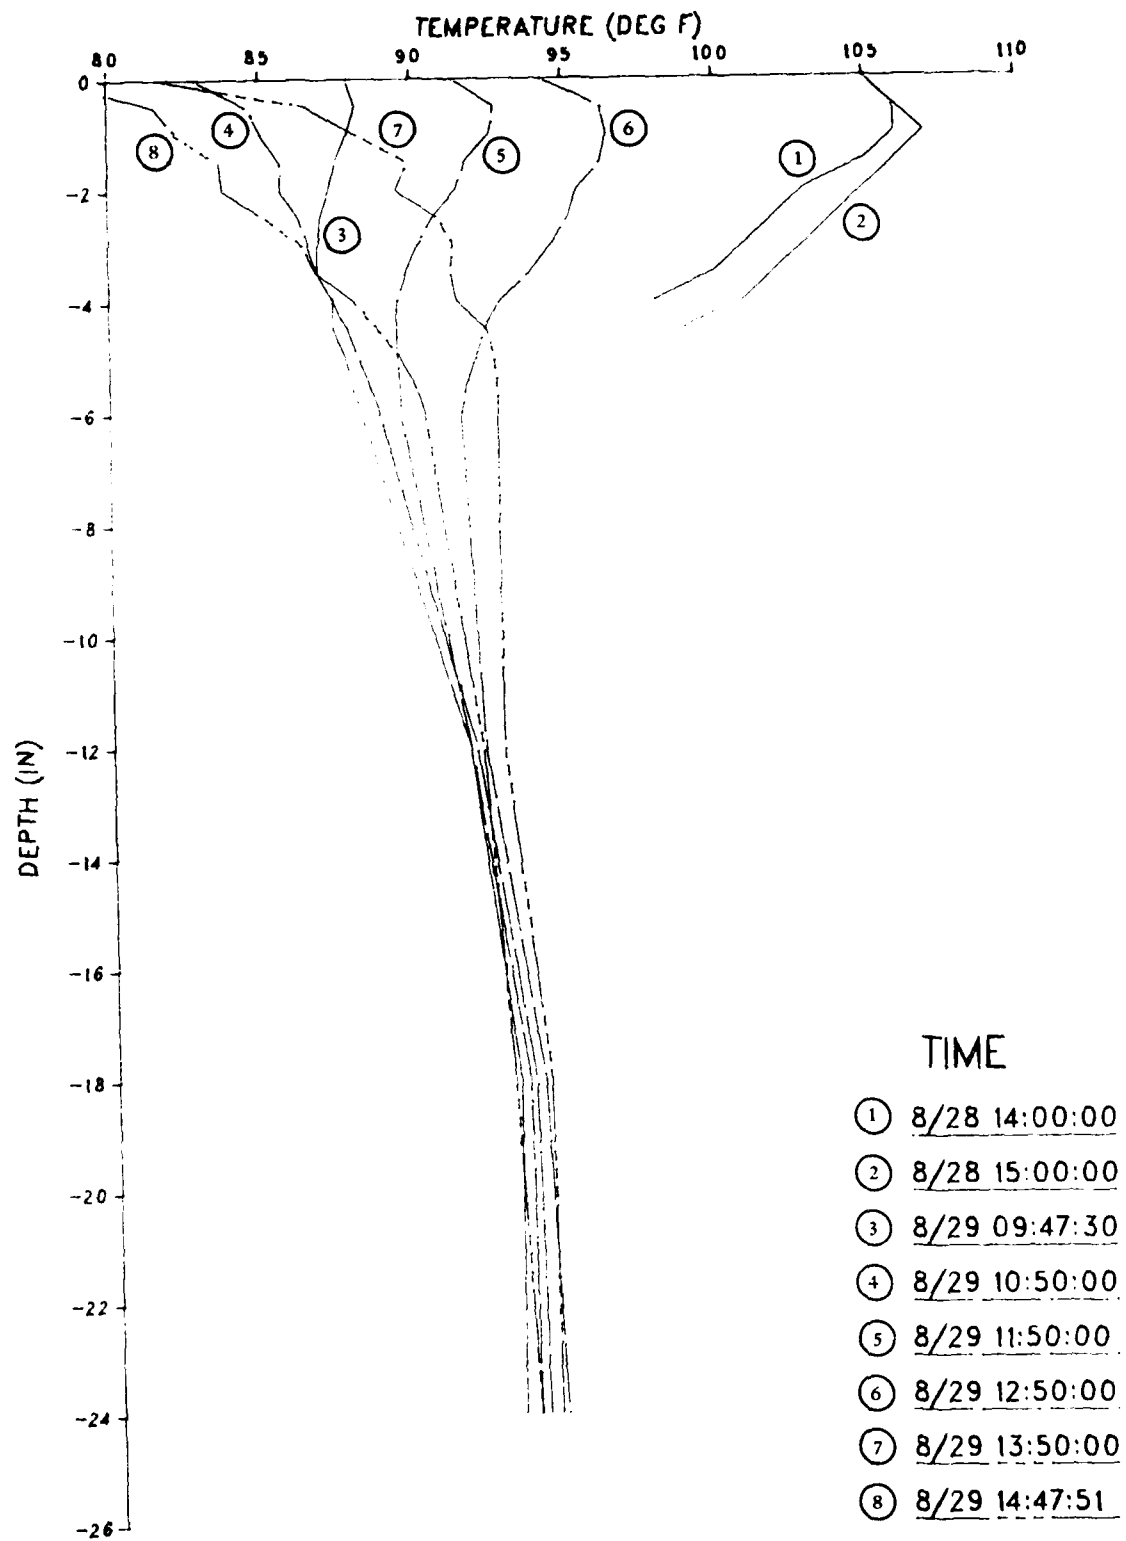
Figure 14. Temperature profiles at Site 2 near blisters 3 and 4.

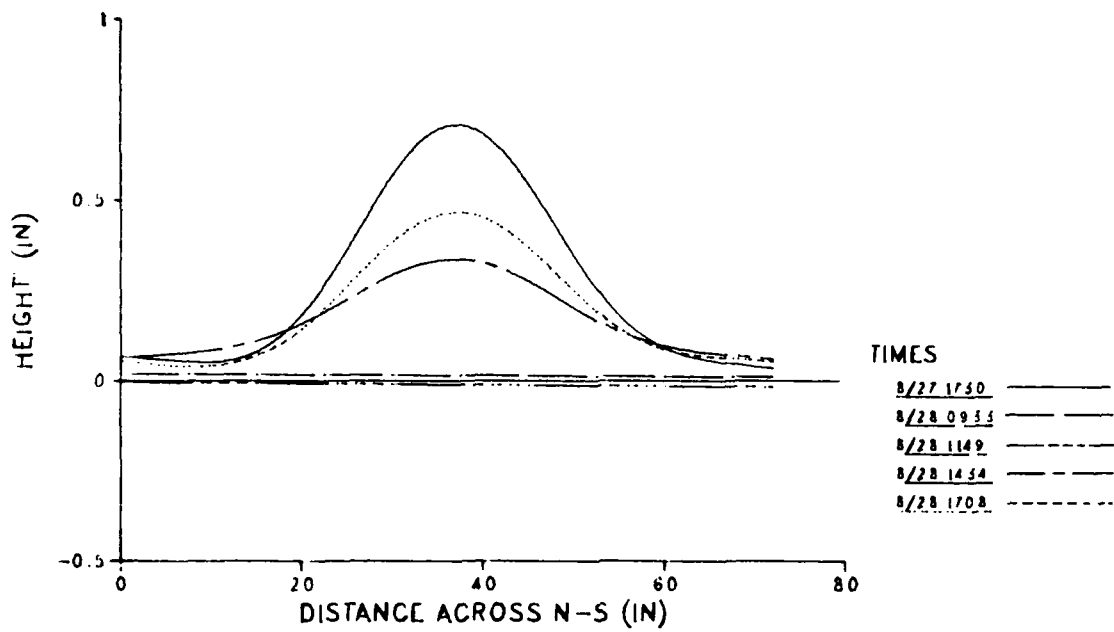
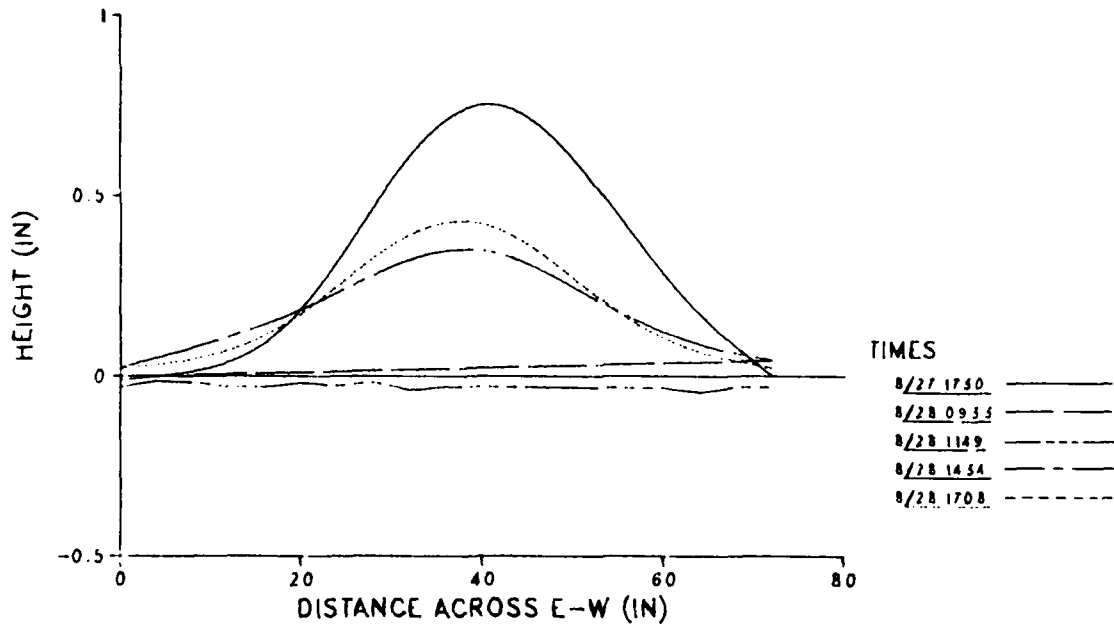
Figure 15. Profile changes of blister 1.

The blisters rise and fall throughout each day with changes in ambient pavement temperatures as shown in Figures 15 through 18. During the cool morning hours, the blisters are absent. As the pavement temperature increases, the blisters begin to rise. Subsequently, as the temperature decreases, the blisters recede. When they are punctured, the blisters deflate. This implies that they are caused by internal pressure buildup. The blister volume changes calculated with the blister surface elevation data are shown in Table 4.

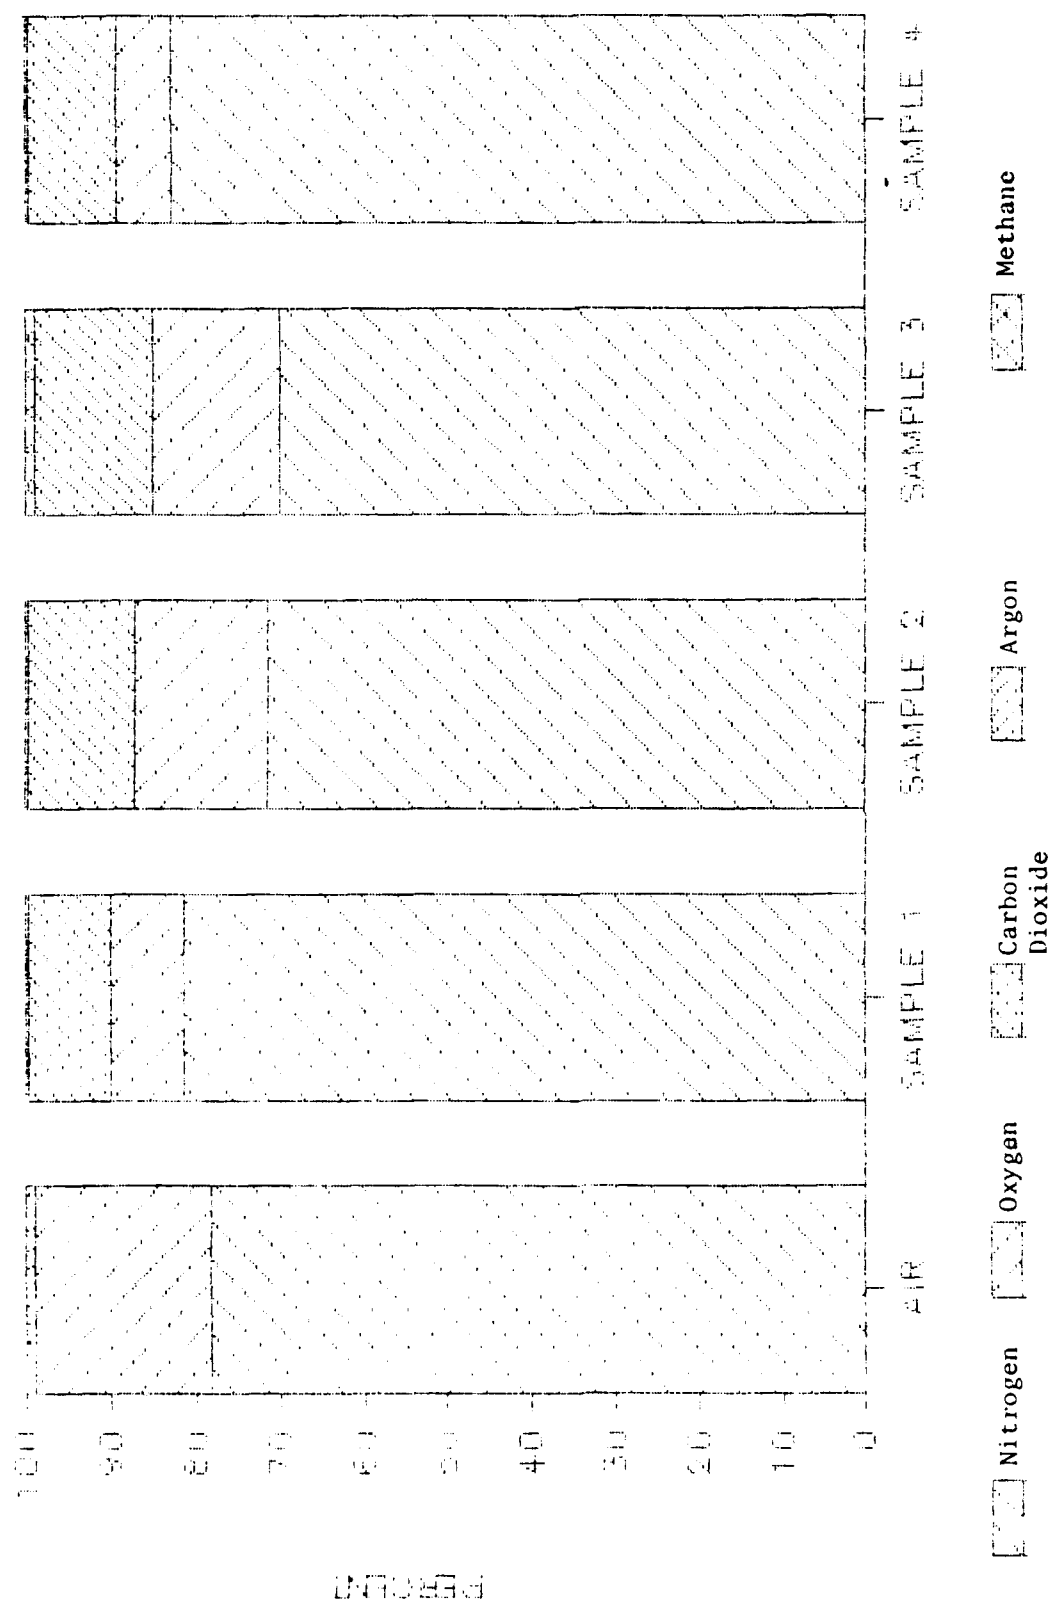
The gas samples from the four blisters were analyzed for saturates, unsaturates, and normal gases in a Hewlett-Packard Gas Chromatograph (Model 5880). The results of the analyses are shown in Appendix C. Figure 19 summarizes all of the detected constituents of the gas samples as compared to the constituents contained in air. The constituents of the blister gas are the same as those found in normal air. The deviation of the amounts of each constituent from the norm is explained later in this report.

The analysis of the gas contained in the blisters suggests that biological activity, if present, is primarily aerobic and that the activity level is low. Aerobic activity is substantiated by the fact that there is a high concentration of carbon dioxide and a low methane content (methane is produced by anaerobic organisms). The abundant supply of oxygen is indicative of low biological activity. The high carbon dioxide content of the blisters suggest that the blister gases are not able to dissipate to ambient values; this indicates that the gases are contained in a sealed environment. In addition to biological activity, the excess carbon dioxide could have originated from that dissolved in rain water that percolated through the pavement overlay.

Figure 19. Composition of air compared to measured values from gas samples.

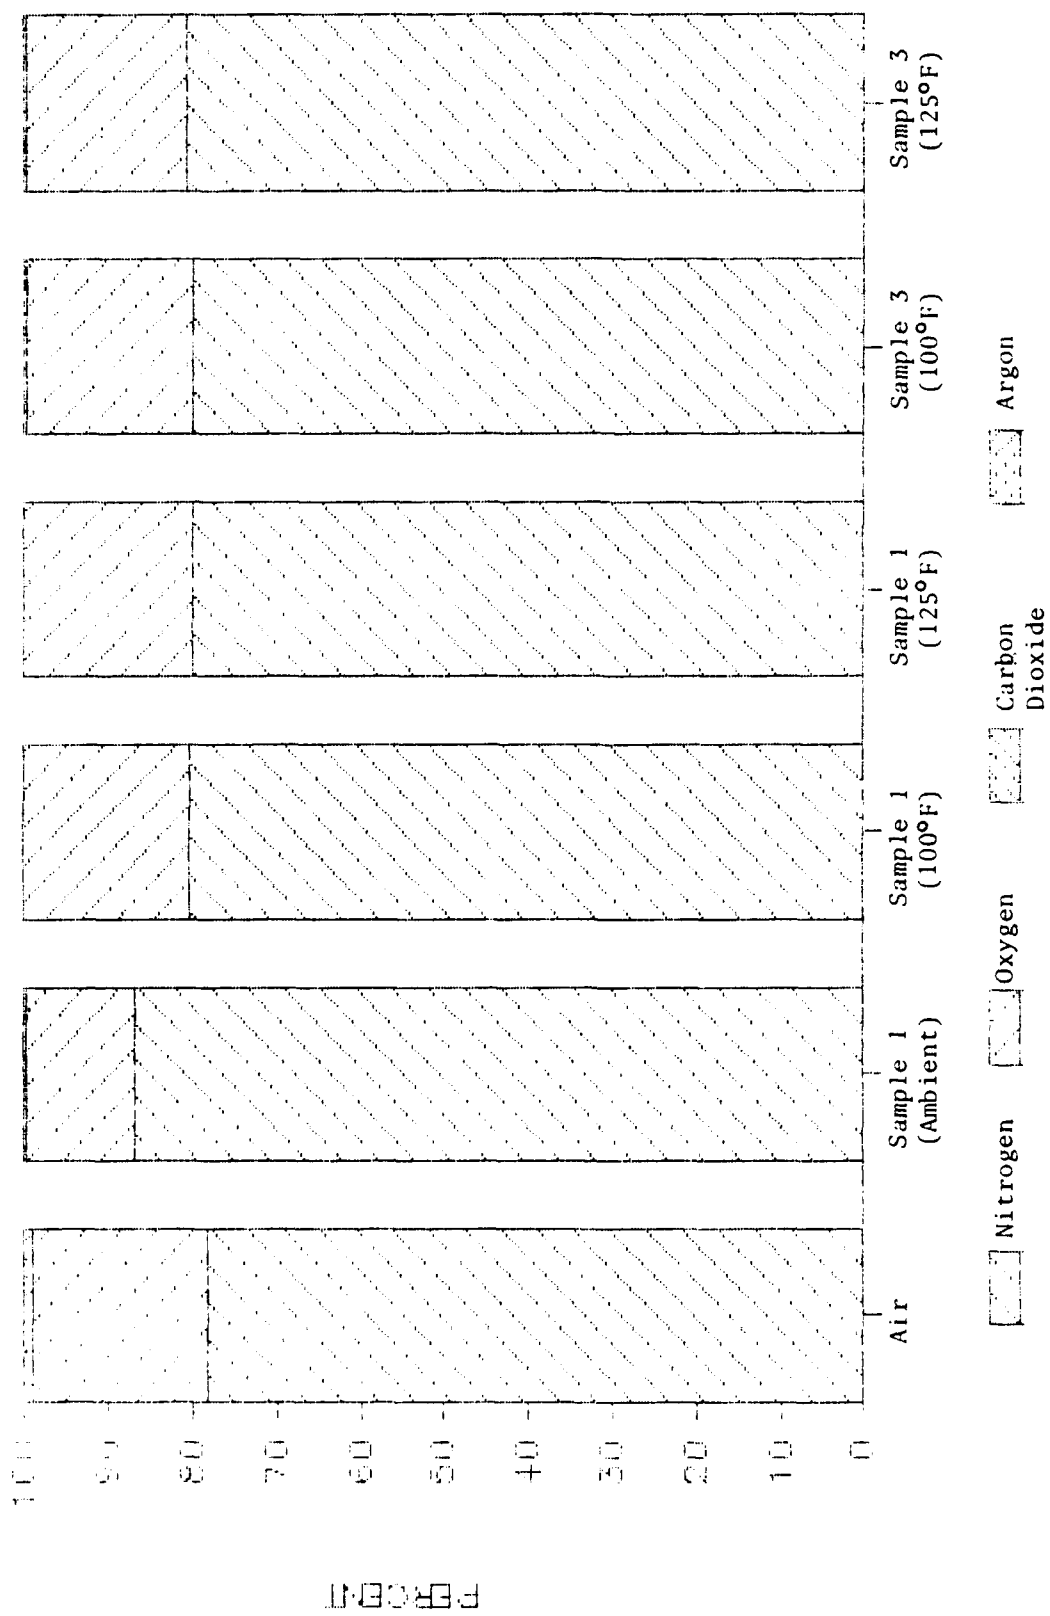
Gas samples collected from the AC pavement overlay itself at various laboratory temperatures are shown in Appendix D. The gas samples were collected from the AC pavement samples that were obtained during the saw cutting operation. Emitted gases were collected at ambient laboratory temperature and at 100 and 125°F. The collected samples were then analyzed using the same chromatograph as was used for the blister gases. Figure 20 summarizes the test results. These results show that the gas contained in the pavement itself is principally air and that there were no other gases emitted in any measurable amount that could be responsible for the pavement blistering.

Figure 20. Composition of air compared to measured emitted gas from asphalt pavement samples at various temperature conditions.

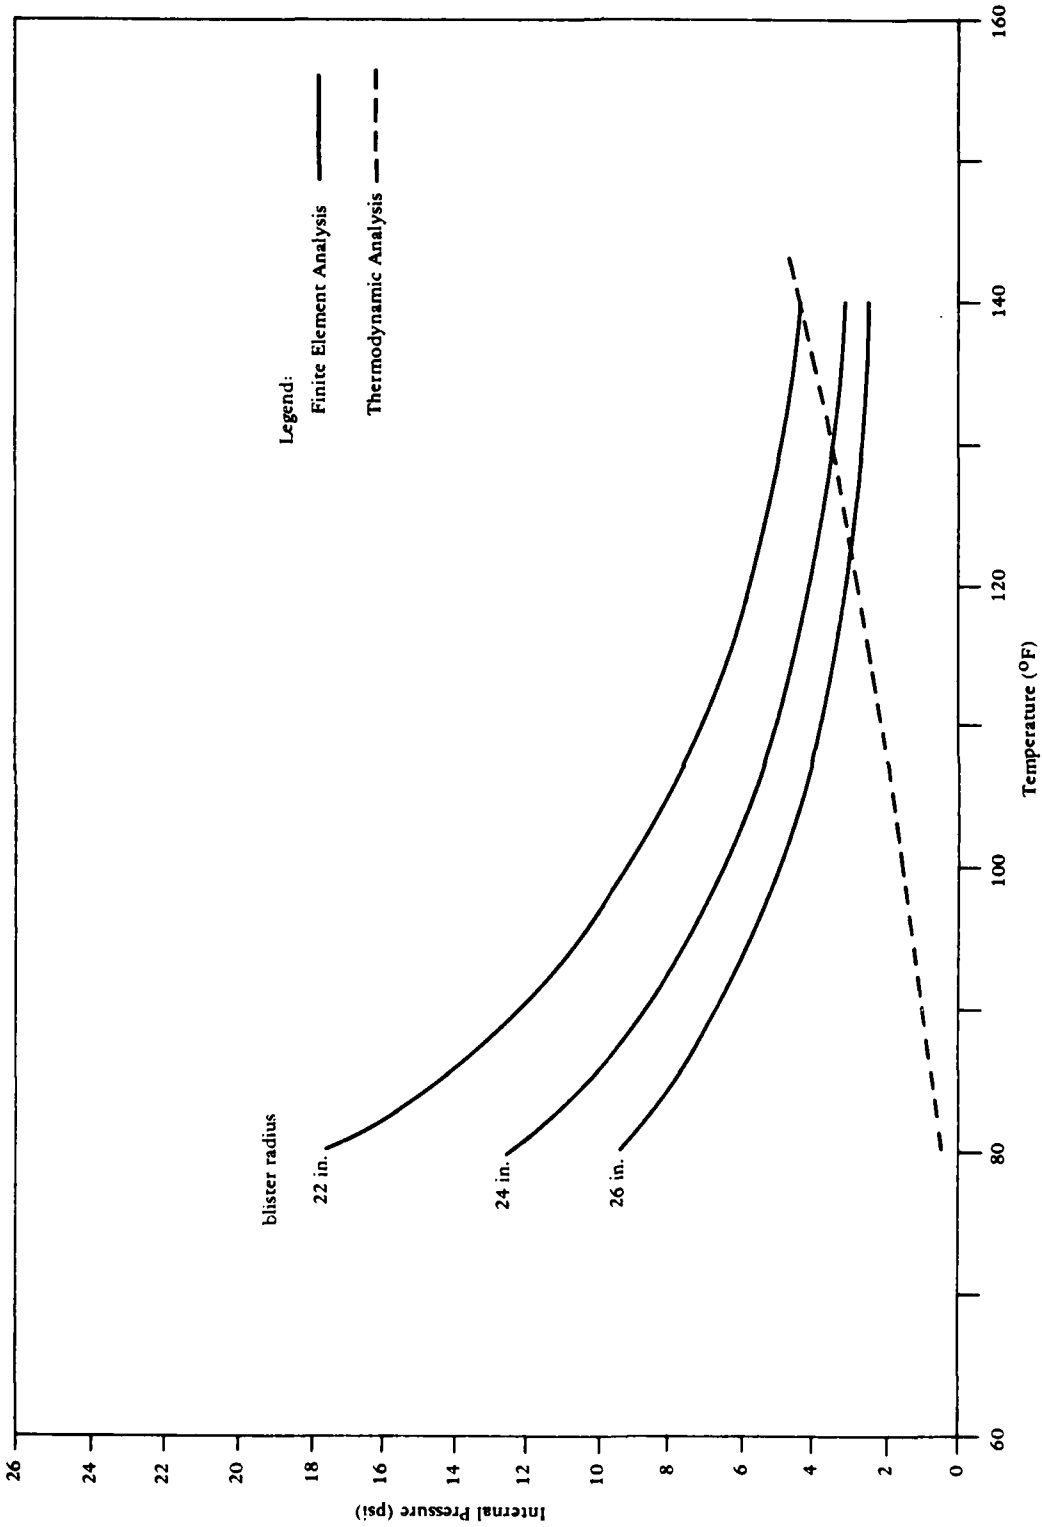
8. The finite element analysis simulating the behavior of blister 1 resulted in the calculation of pressures that were higher than those obtained in the thermodynamic analysis. The difference in the calculated pressures can be explained by the following reasons: (1) the finite element program treats the asphalt overlay as a homogeneous material (it is not), (2) cracks are present in the blistered overlay which reduces the bending stiffness, (3) the actual temperature could be several degrees higher than that measured because of the insulating effect of the trapped gases (i.e., the subsurface layers act as a heat sink), and (4) the initial starting point of 80°F used in the thermodynamic analysis may be higher than actual field conditions.

Figure 23. Internal pressures required for a crown deflection of 0.69 inch for various size blisters computed by the finite element method compared to pressures computed in the thermodynamic analysis of blister gases and water vapor.

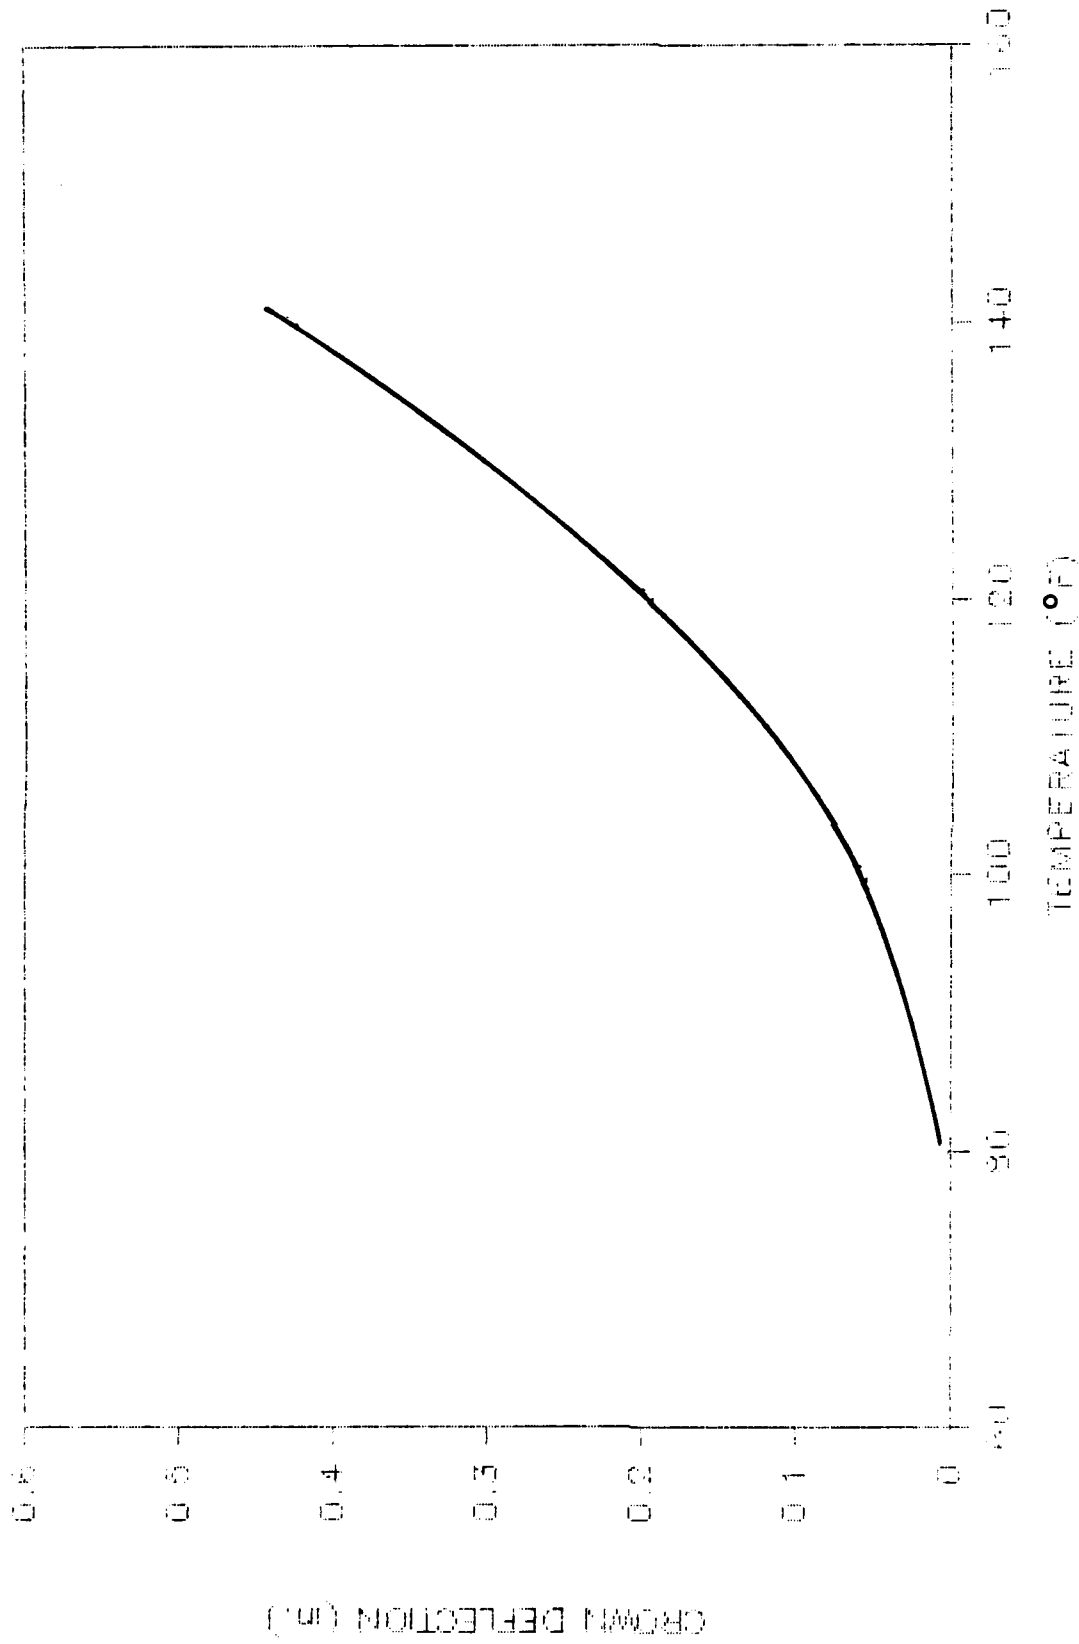
An analysis was made to determine the effect of a 2-inch overlay on the pavement in its present condition with the 1-1/2-inch overlay in place. The finite element model was modified to analyze a 2-inch overlay. Although not entirely correct, it was assumed that the new overlay provided resistance to all of the bending and membrane stresses and that the present overlay was cracked. The results of this analysis are summarized in Figure 24 where it can be seen that significant blister crown deflections were calculated. Thus, although not entirely conclusive with the above limited information, the possibilities are good that blistering will occur even with the added 2-inch overlay.

Figure 24. Crown deflections at various temperatures for a 24-inch radius blister in a new 2-inch thick overlay over the existing pavement.

The three alternatives available relative to the present overlay are: (1) do nothing, (2) add another overlay, or (3) remove and replace the overlay. We recommend that alternative (3) be pursued because if properly installed, the possibility of blisters forming will be eliminated. In alternative (1), blisters will continue to form and the possibility of FOD to aircraft engines due to pavement fragments from the breakup of the blisters exists. We do not recommend alternative (2) because the probability of blisters forming exists because air and water can be trapped in void spaces of the present debonded areas at the time the new overlay is applied. Also, with time the same cracking, healing, and blistering phenomena as now exists could occur with the new overlay, because debonded areas exist under the present overlay.
