①
UNDERWATER FACILITIES
INSPECTIONS
AND
ASSESSMENTS
AT

NAVAL AIR STATION
WHIDBEY ISLAND,
OAK HARBOR, WA

FPO-1-83-(41)

SEPTEMBER 1983

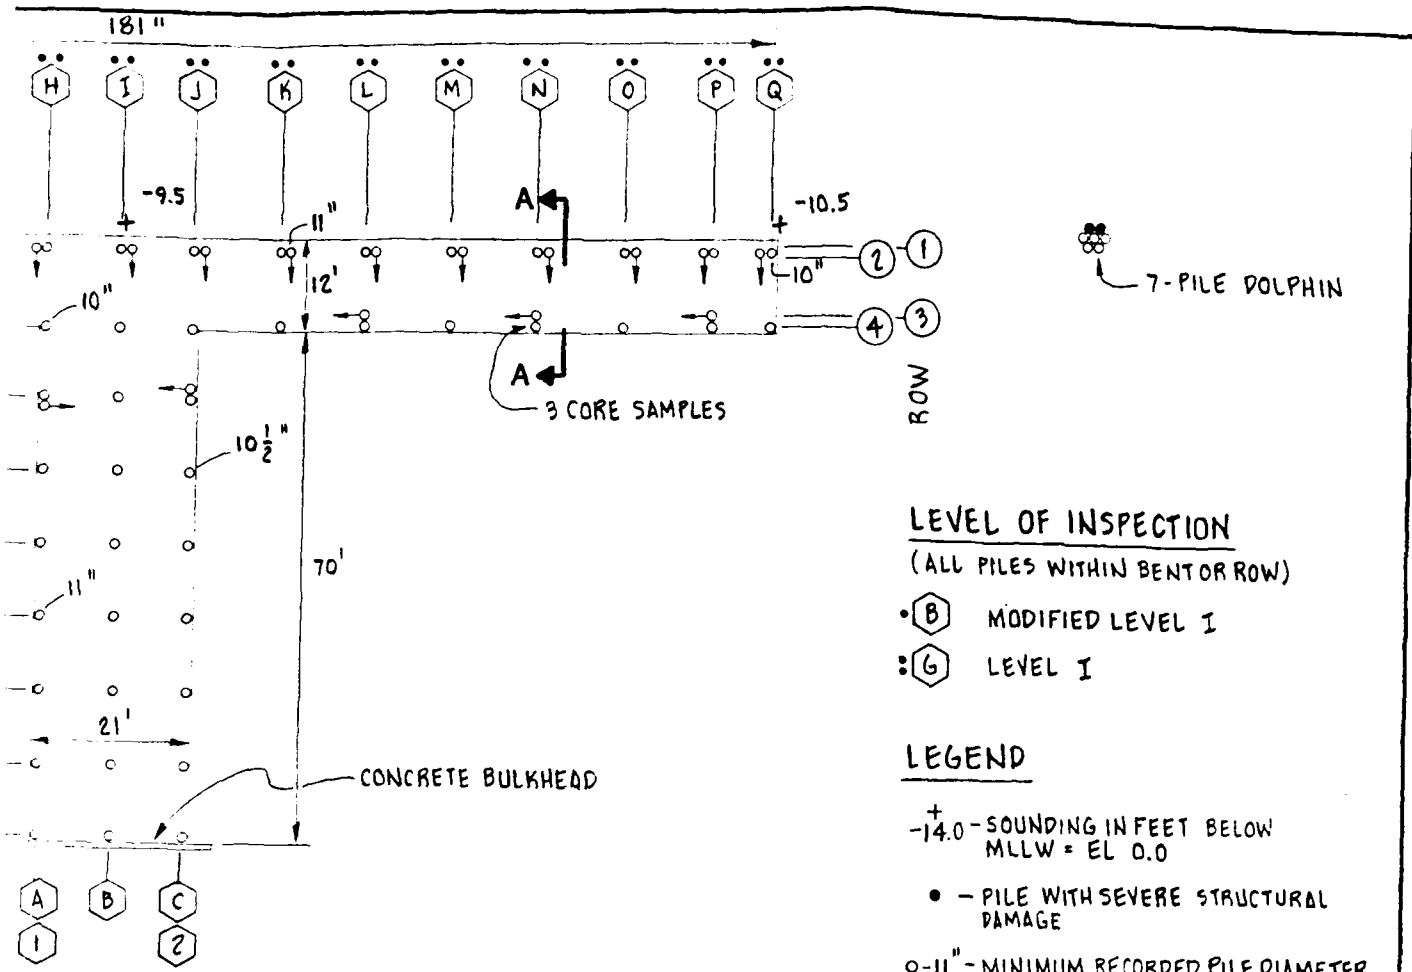
GRAPHIC SCALE	CHILDS ENGINEERING CORPORATION 801 333 WEDFIELD MA	CHESAPEAKE DIVISION NAVAL FACILITIES ENGINEERING COMMAND WASHINGTON D C	
AS SHOWN		NAVAL AIR STATION FUEL PIER	WHIDBEY ISLAND, WA FIG NO 6

The major structural anomaly was observed on two (2) of the piles associated with the 7-pile dolphin. The two (2) northern piles

are broken approximately 3' below MLLW. It appears the breaks are the result of impact from a berthing vessel (for location see Figure 6.

The two (2) broken piles found in the 7-pile dolphin have seriously reduced this structure's capacity to resist berthing loads. If these piles are not repaired, it is possible that the dolphin will fail if it is subjected to a significant impact.

To return the 7-pile dolphin to design capacity, the two (2) broken piles should be replaced. It is estimated that the cost of this repair is approximately \$8,400.00.
