COMMANDER FLEET ACTIVITIES SASEBO FLEET MOORINGS UNDERWATER INSPECTION REPORT

SEPTEMBER 1983

OCEAN ENGINEERING
AND CONSTRUCTION PROJECT OFFICE
CHESAPEAKE DIVISION
NAVAL FACILITIES ENGINEERING COMMAND
WASHINGTON, D.C. 20374

FPO-1-83(28)

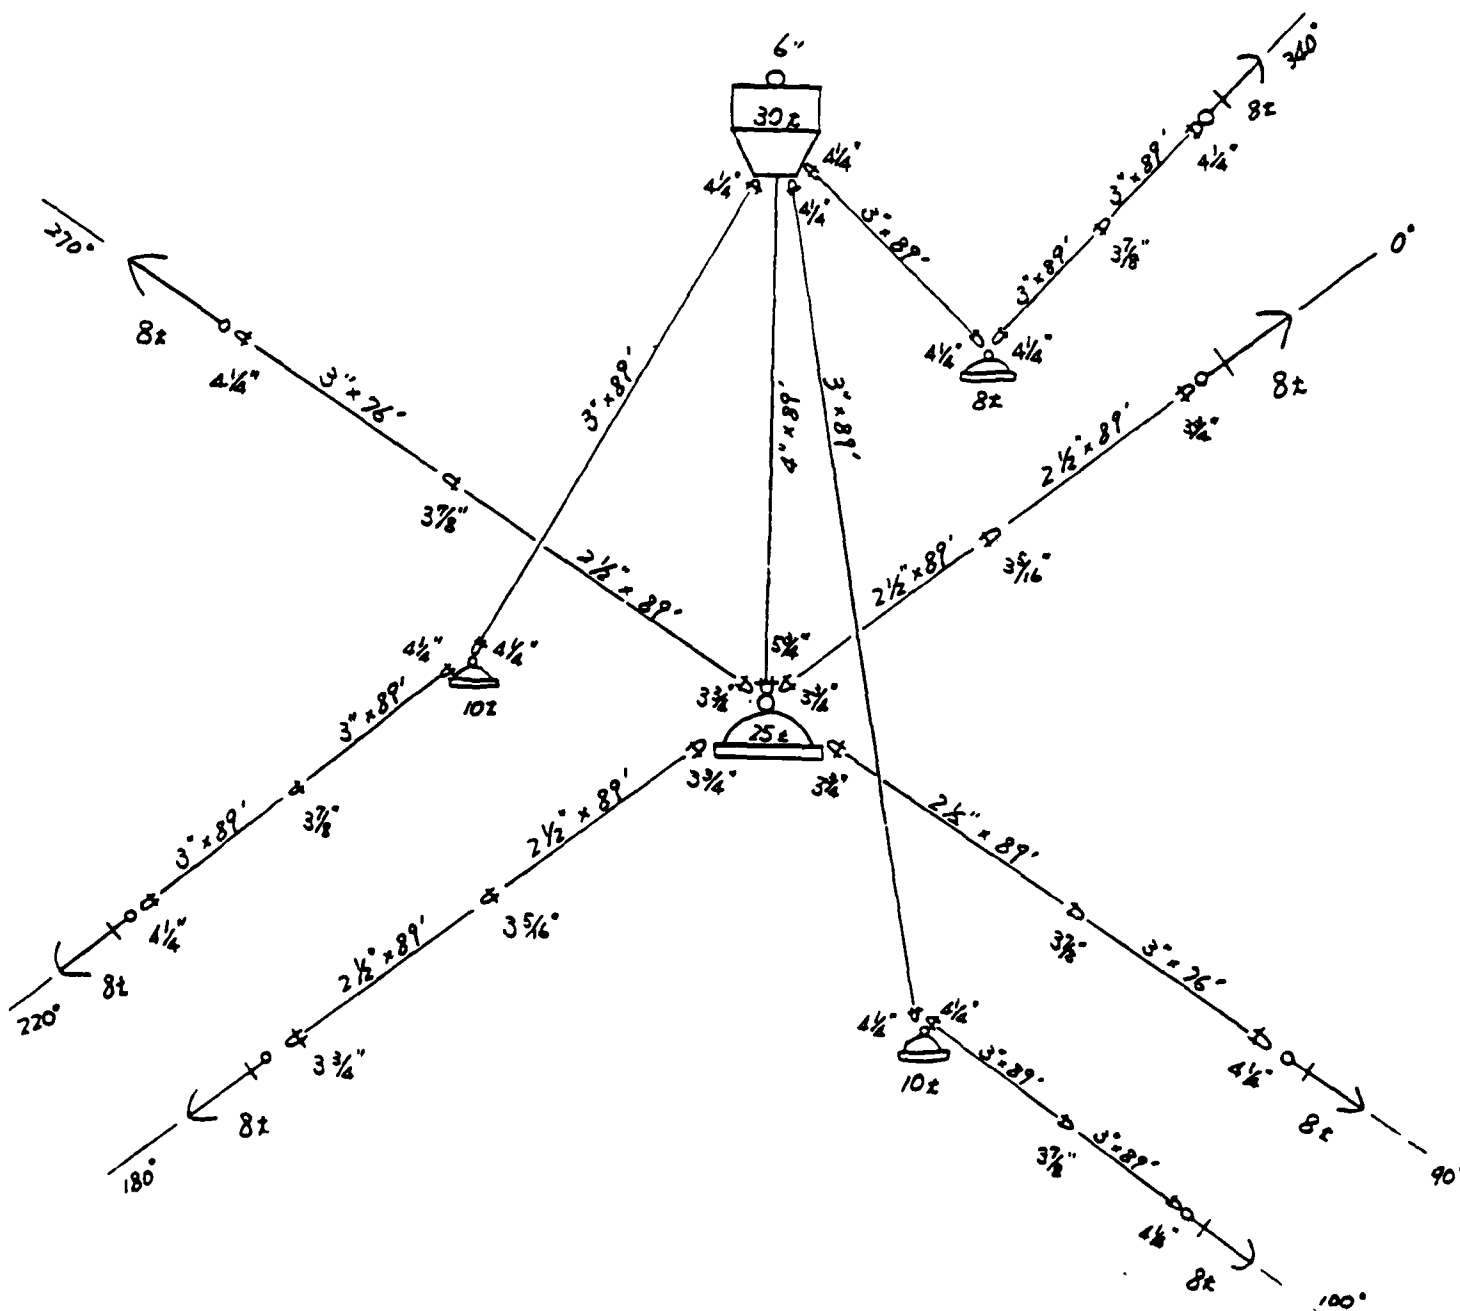
MOORING I-S

This is a Japanese-designed 11.5-foot-diameter drum-type buoy with a hawse-pipe. It has a freeboard of 38 inches, and its topside jewelry consists of 3 1/4- and 5 1/4-inch shackles. The buoy is in good condition.

This mooring is in good condition and satisfactory for continued use as a class B mooring. It is uncertain that the leg/sinker/anchor arrangement shown in the as-built drawing can adequately resist the 125,000 lb. design load of a class B mooring. Recommend a review of the forces on the moored vessel(s) and the design of the mooring.

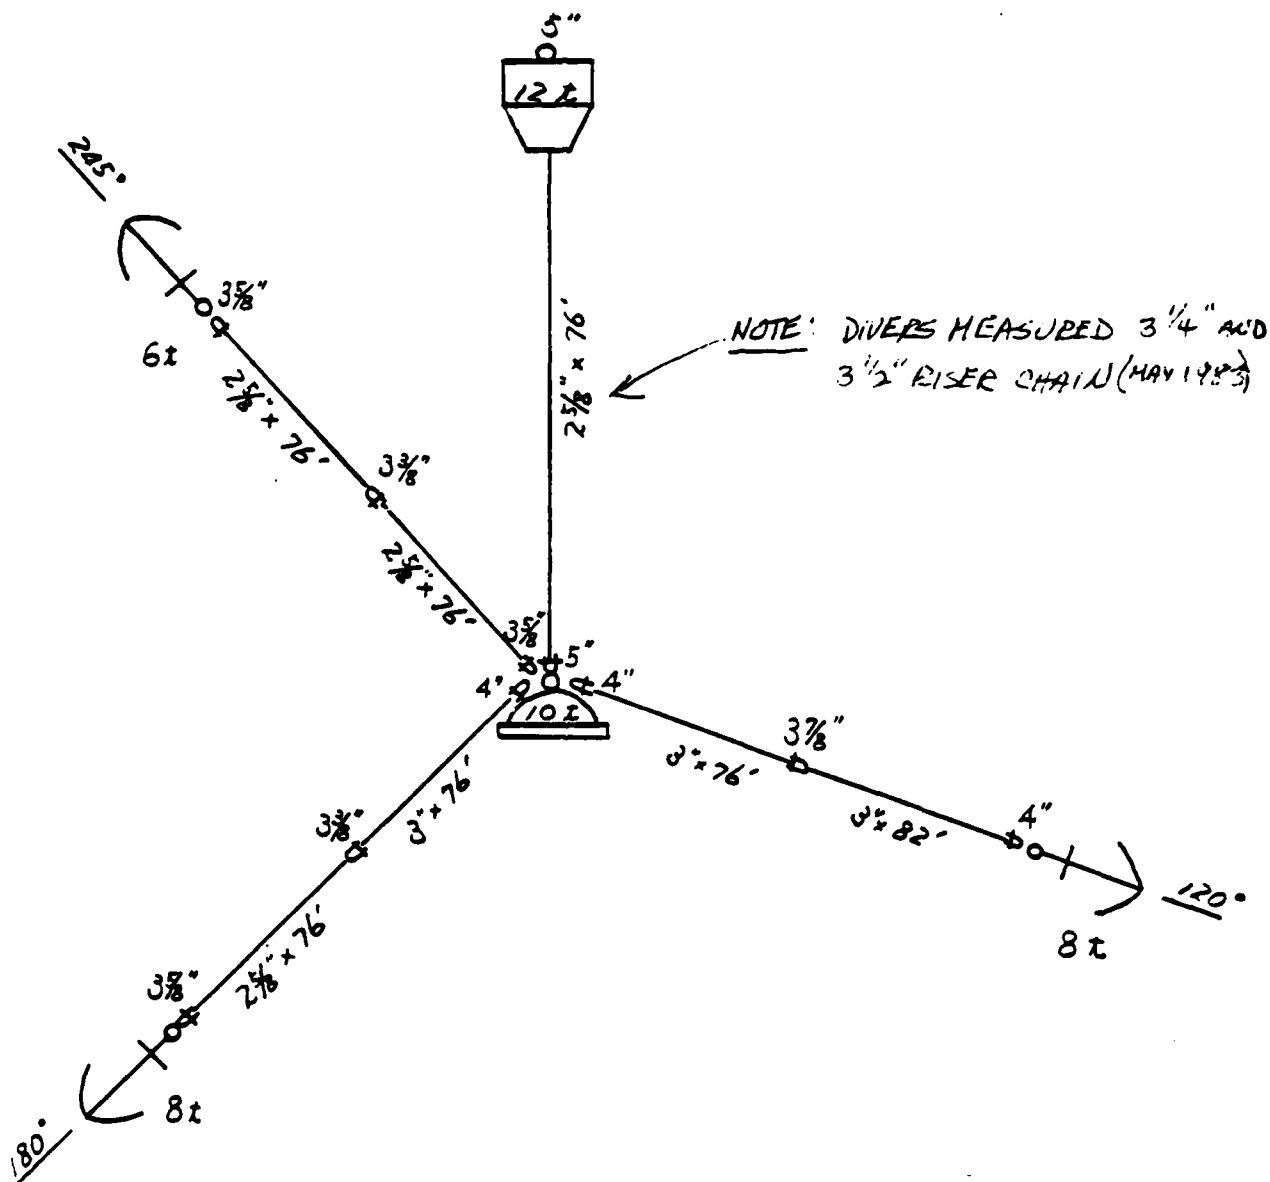
MOORING 61

This is a 12-foot-diameter Japanese designed drum-type buoy with a hawsepipe. The buoy has a 38-inch freeboard, and its chafing rail is badly dented. The top jewelry is heavily rusted, and the bottom of the buoy's hull is covered with about 2 inches of marine growth.

This mooring is in fair condition.

A measurement between 80 and 90 percent of any mooring component is normally cause for a mooring to be downgraded to the next lower class of mooring. However, in this case, the larger-than-required original wire diameter of the riser chain allows it to still be capable of withstanding class B mooring loads. It is uncertain that the leg/sinker/anchor arrangement shown in the as-built drawing can adequately resist the 125,000 lb. design load of a class B mooring. Recommend a review of the forces on the moored vessel(s) and the design of the mooring.

COMPONENTS	NI	CONDITION						COMMENT	
		NEW	SINGLE LINK %		DOUBLE LINK %		D		
			90+	80+	80-	90+			80+
BUOY HARDWARE									13' DIAMETER, 38" FREEBOARD, CHAFING
5 1/4" SHACKLE									RAIL DELETED, HEAVY ROST AND FLAKING
									OF TOPSIDE SHACKLE, 2" GROWTH
									ON BOTTOM
									CHAPER MEASUREMENTS
NEAR BUOY		3 1/2"	✓✓			✓✓		<10'	6 1/2" D.L. (X3) 3 1/2" S.L.
MIDDLE		↓	✓✓			✓✓		30'	6 1/2" D.L. (X2) 6 3/4" D.L. 3 1/2" S.L.
NEAR GRD RG		↓	✓✓	✓		✓✓		63'	6 1/2" D.L. (X3) 3" (S.L.)
GROUND RING	↓								2" MARINE GROWTH ON RISER EXCEPT
UPPER END									FOR BOTTOM 5 FEET WHICH ARE
MIDDLE									CLEAN, RISER ENTERS BOTTOM AT
ENTERS BOTTOM									62 FEET.
UPPER END									
MIDDLE									
ENTERS BOTTOM									
UPPER END									
MIDDLE									
ENTERS BOTTOM									
UPPER END									
MIDDLE									
ENTERS BOTTOM									
UPPER END									
MIDDLE									
ENTERS BOTTOM

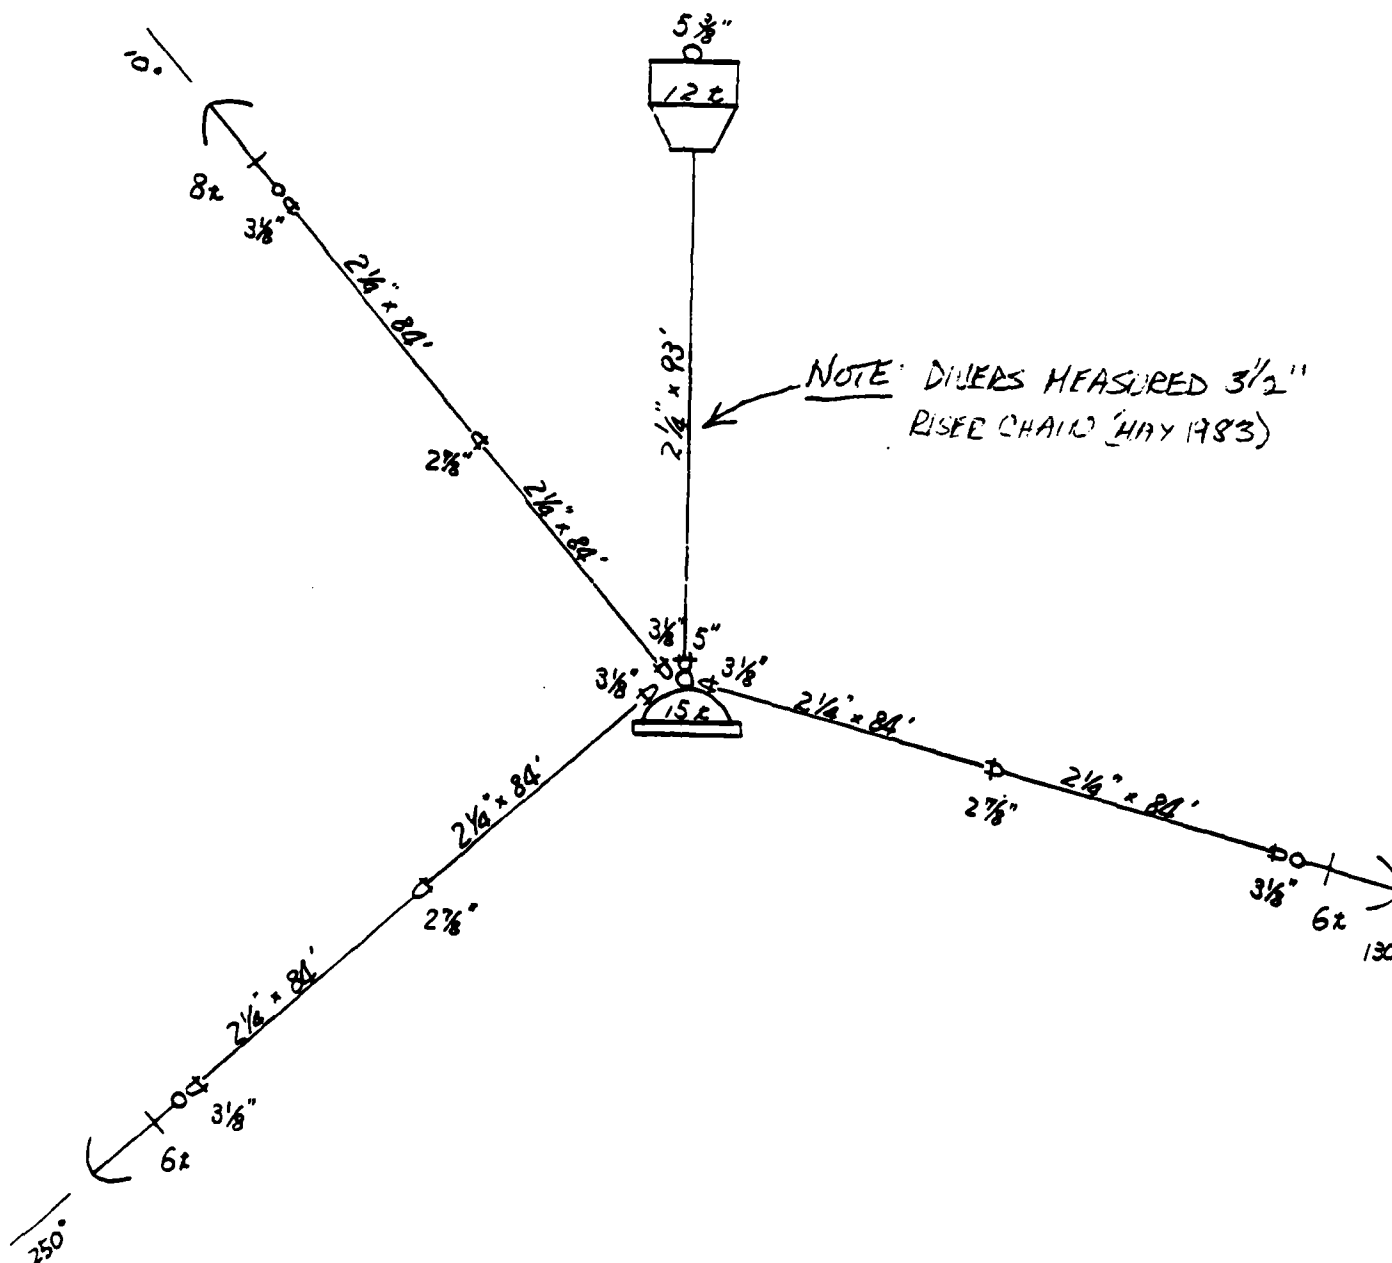
MOORING A-II

This is an 8-foot-diameter Japanese designed and built drum-type buoy with a hawsepipe. The buoy has a 30-inch freeboard and is fiberglass coated. The fenders are in good condition but the underwater portion of the buoy's hull is covered with about 3 inches of marine growth.

This mooring is in fair condition.

A measurement between 80 and 90 percent of any mooring component is normally cause for a mooring to be downgraded to the next lower class of mooring. However, in this case, the larger-than-required original wire diameter of the riser chain allows it to still be capable of withstanding class E mooring loads. It is uncertain that the leg/sinker/anchor arrangement and sizes shown in the as-built drawing can adequately resist the 50,000 lb. design load of a class E mooring. Recommend a review of the forces on the moored vessel(s) and the design of the mooring.

COMPONENTS	NI	CONDITION							COMMENT	
		NEW	SINGLE LINK %			DOUBLE LINK %				D
			90+	80+	80-	90+	80+	80-		
BUOY HARDWARE									8' DIAMETER. 30" FREEBOARD.	
3" SHACKLE									FIBERGLASS / FENDERS GOOD	
									CONDITION. 3" MARINE GROWTH ON BUOY BOTTOM.	
RISER		2"	✓		✓✓				6' RISER TO 2 1/4" SHACKLE TO 3 1/16"	
		↓	✓		✓✓				20' END LINK IN THE MUD BOTTOM	
			✓			✓✓			39' LOWER FIVE FEET OF CHAIN CLEAN	
GROUND RING										
GROUND LEG NO. A	NO LEGS	UPPER END								
		MIDDLE								
		ENTERS BOTTOM								
GROUND LEG NO. B	NO LEGS	UPPER END								
		MIDDLE								
		ENTERS BOTTOM								
GROUND LEG NO. C		UPPER END								
		MIDDLE								
		ENTERS BOTTOM								
GROUND LEG NO. D		UPPER END								
		MIDDLE								
		ENTERS BOTTOM

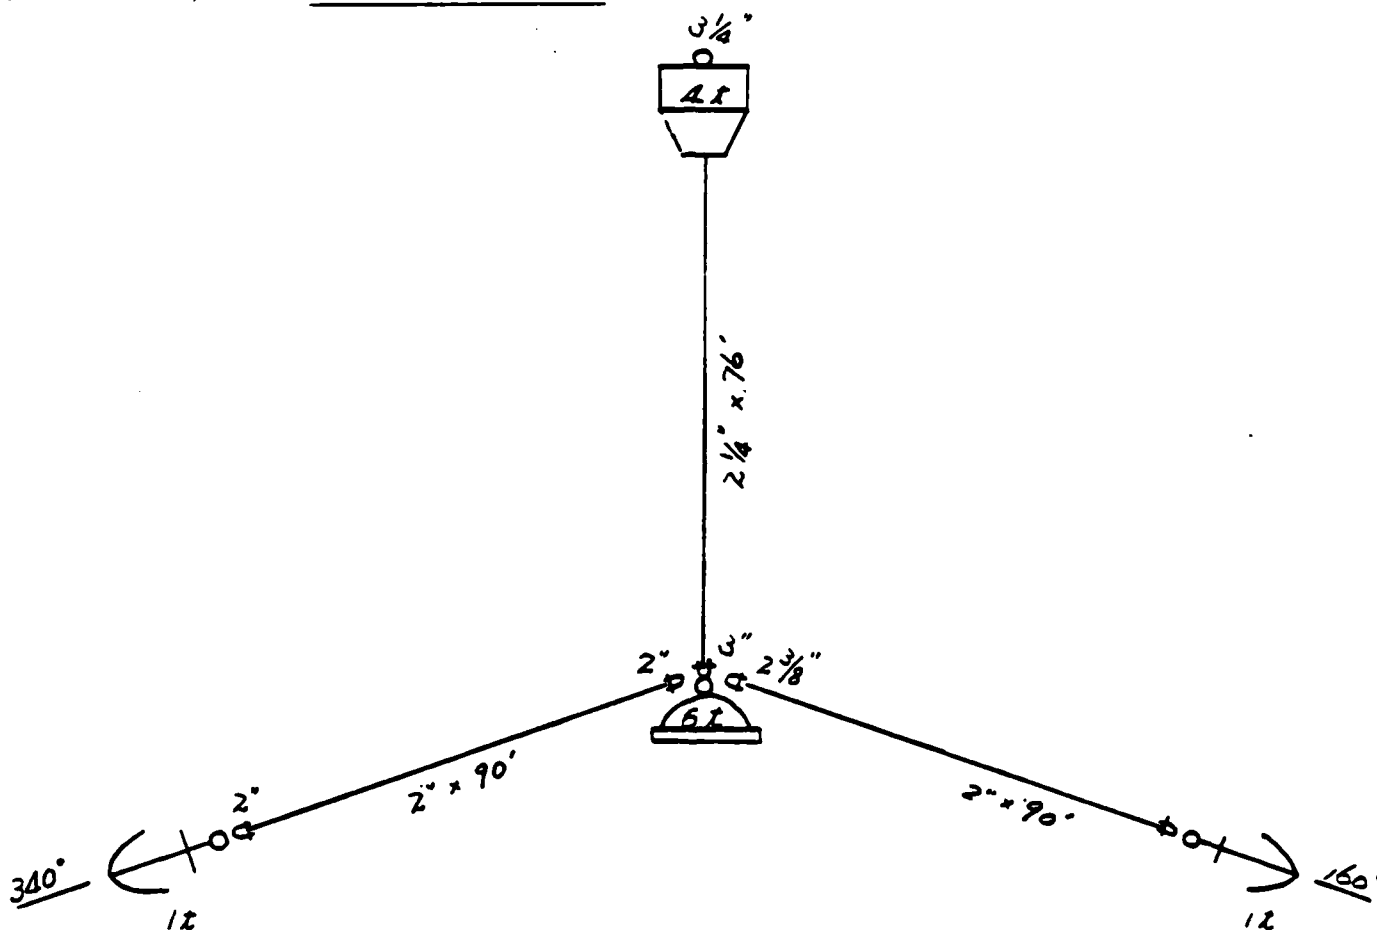
MOORING A-15

This Japanese designed and built drum-type buoy has a diameter of 7 feet 10 inches. The buoy is fiberglass coated and has a 30-inch freeboard. The top of the buoy is slightly rusted at the base of the chafing rail. Overall, the buoy is in good condition.

This mooring is in good condition and satisfactory for continued use as a class E mooring.

It is uncertain that the leg/sinker/anchor arrangement and sizes shown in the as-built drawing can adequately resist the 50,000 lb. design load of a class E mooring. Recommend a review of the forces on the moored vessel(s) and the design of the mooring.

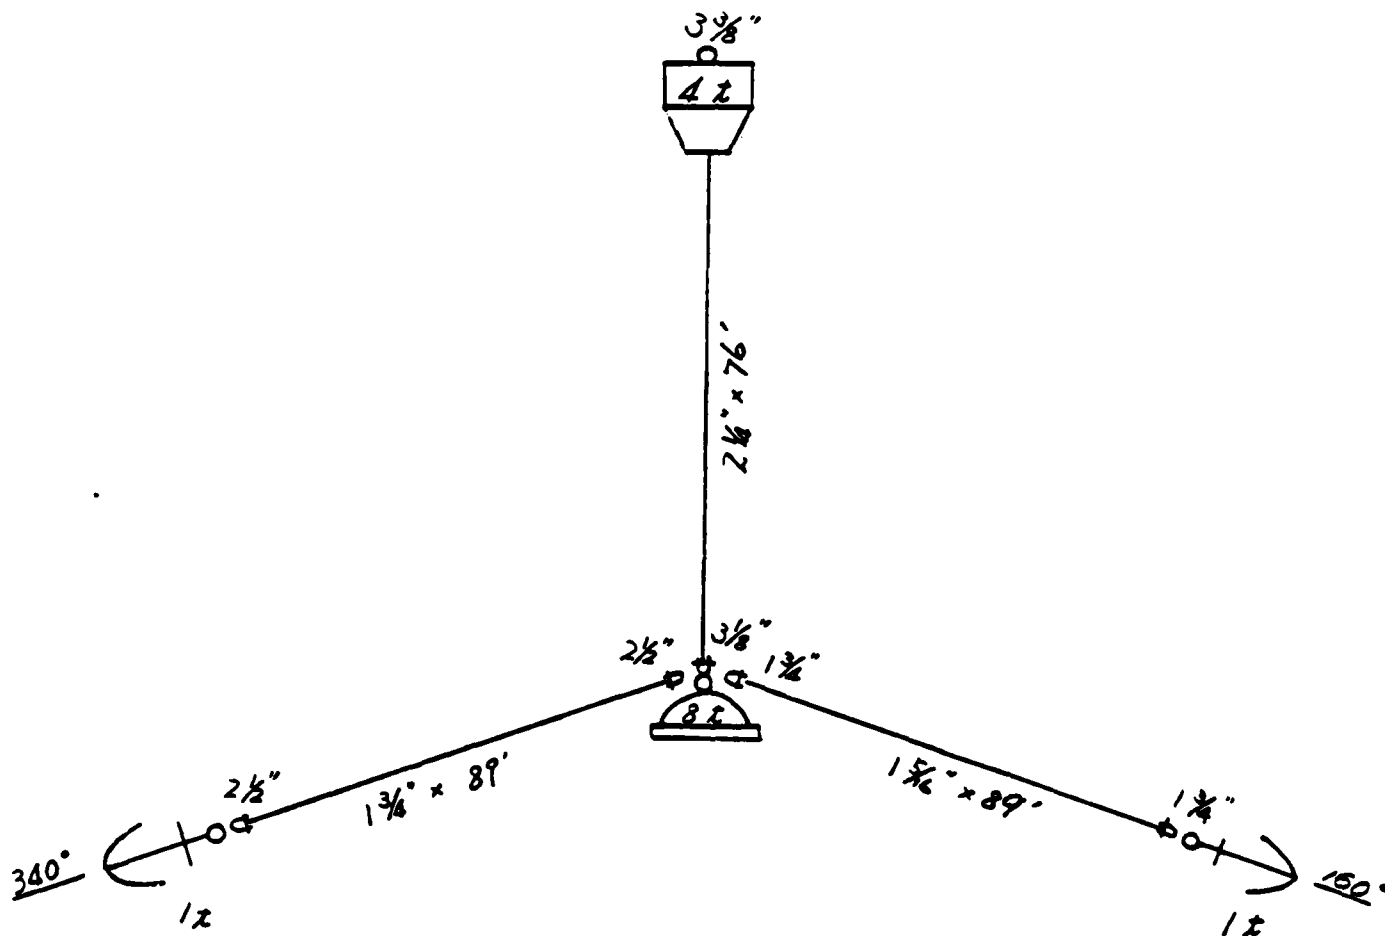
MOORING A-16

This is an 8-foot-diameter Japanese-built drum-type buoy with a hawsepipe. The buoy is fiberglass coated and has a 31-inch freeboard. There is some rust on the top deck padeyes and in the hawsepipe. In addition there is some light rust on the top plate at the base of the chafing rail.

This mooring is in fair condition.

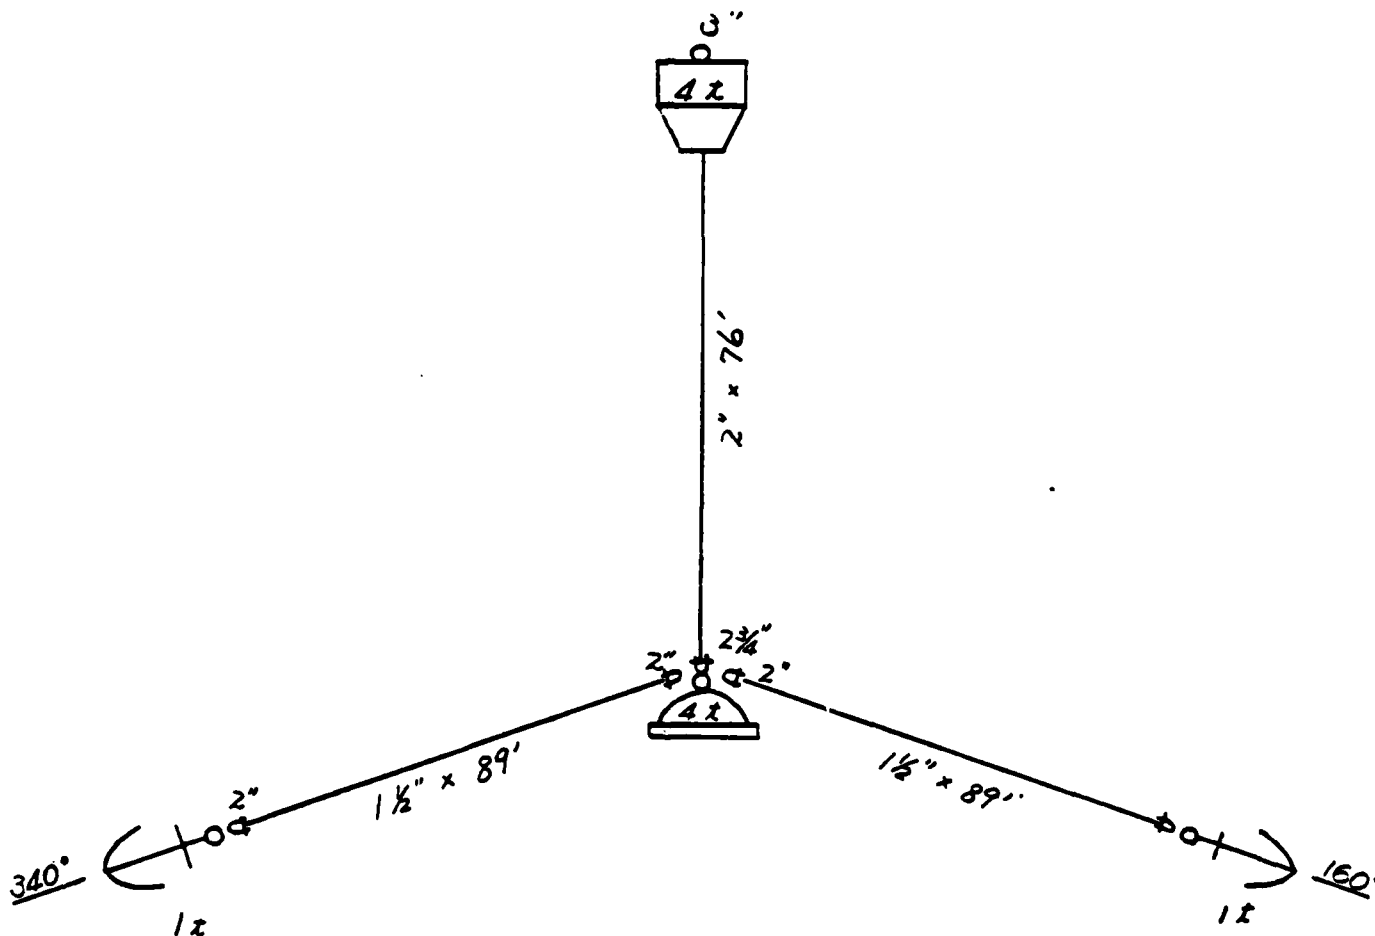
MOORING A-18

NOTE: DIVERS FOUND A SHACKLE AT
A DEPTH OF 25'. THIS INDICATES
THAT THE RISER HAS PROBABLY
BEEN REVERSED (MAY 1983)
