UNDERWATER FACILITIES
INSPECTION AND ASSESSMENT
AT

NAVAL SUPPLY CENTER
SAN DIEGO,
CALIFORNIA

F P O - 1 - 83 - (43)

Sept., 1983

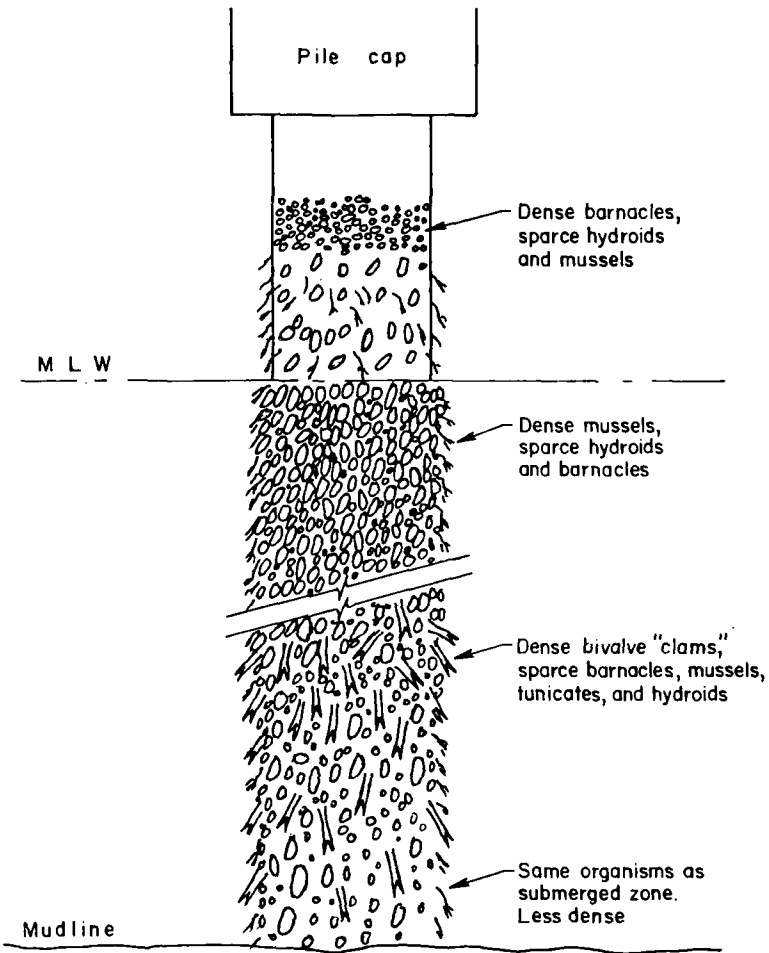
Marine growth or fouling profiles were found to be similar throughout the structure. Organisms found on or near the structure include barnacles, mussels, bivalve clams, hydroids and tunicates. In addition, several species of fish, crabs and lobsters were observed. The fouling organisms attached to the piles or concrete bulkhead were found to range from the upper intertidal zone to the mudline. Specifically they were found to range as follows:

Upper Intertidal Zone:	Dense barnacles, sparse hydroids and mussels
Mid - Lower Intertidal Zone:	Dense mussels, sparse hydroids and barnacles
Submerged Zone to Mudline:	Dense bivalve "clams", sparse barnacles, mussels, tunicates and hydroids

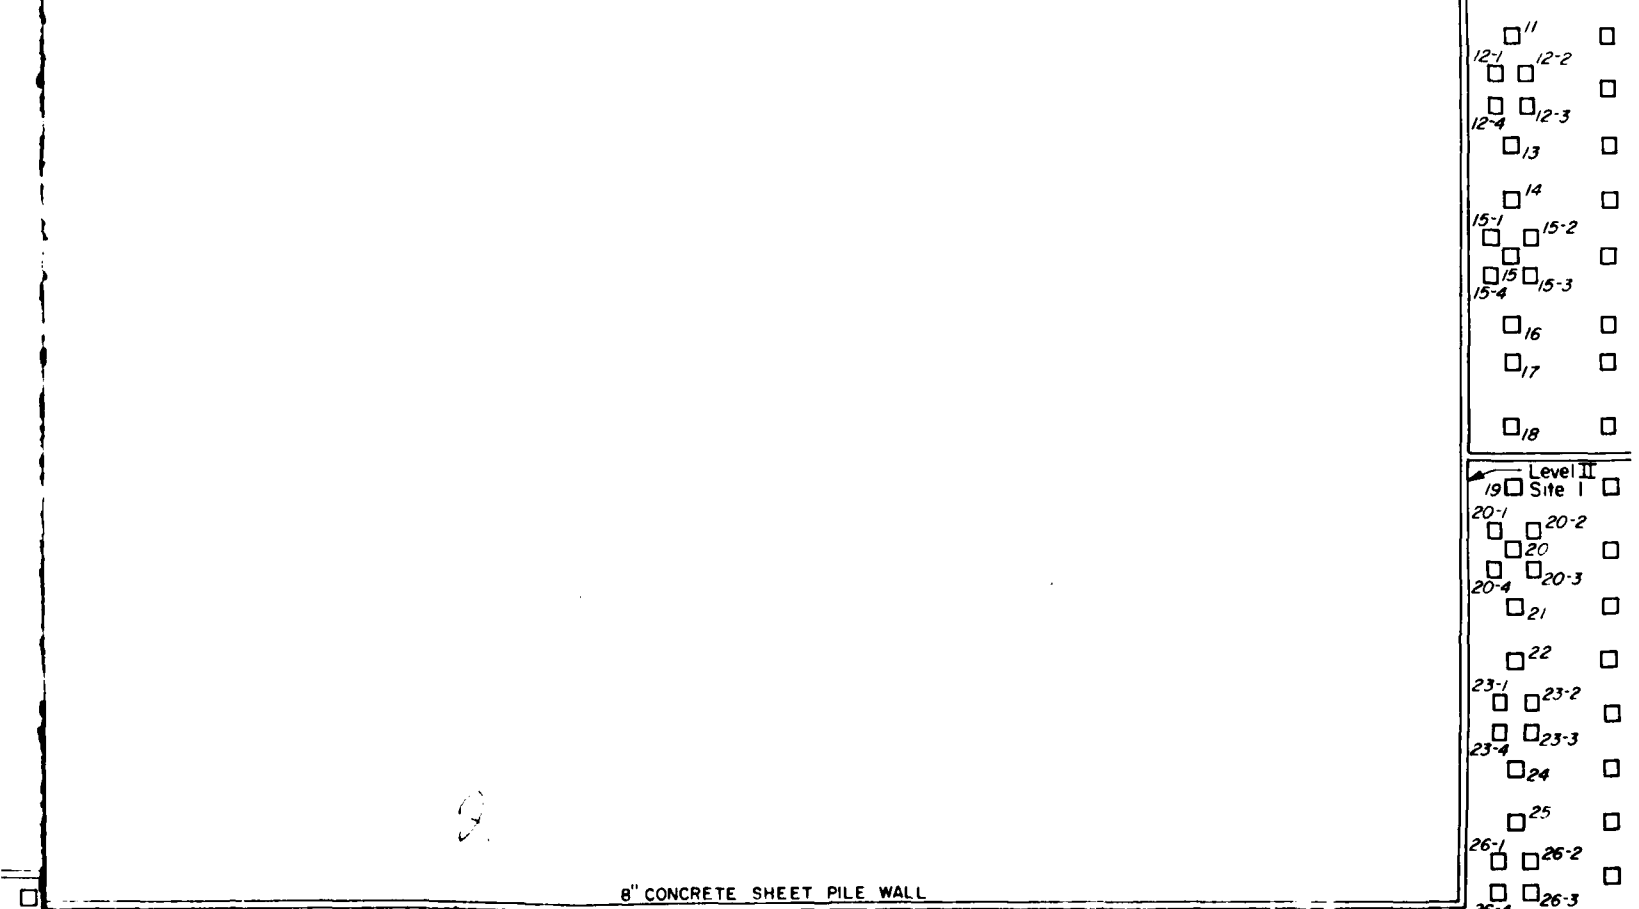
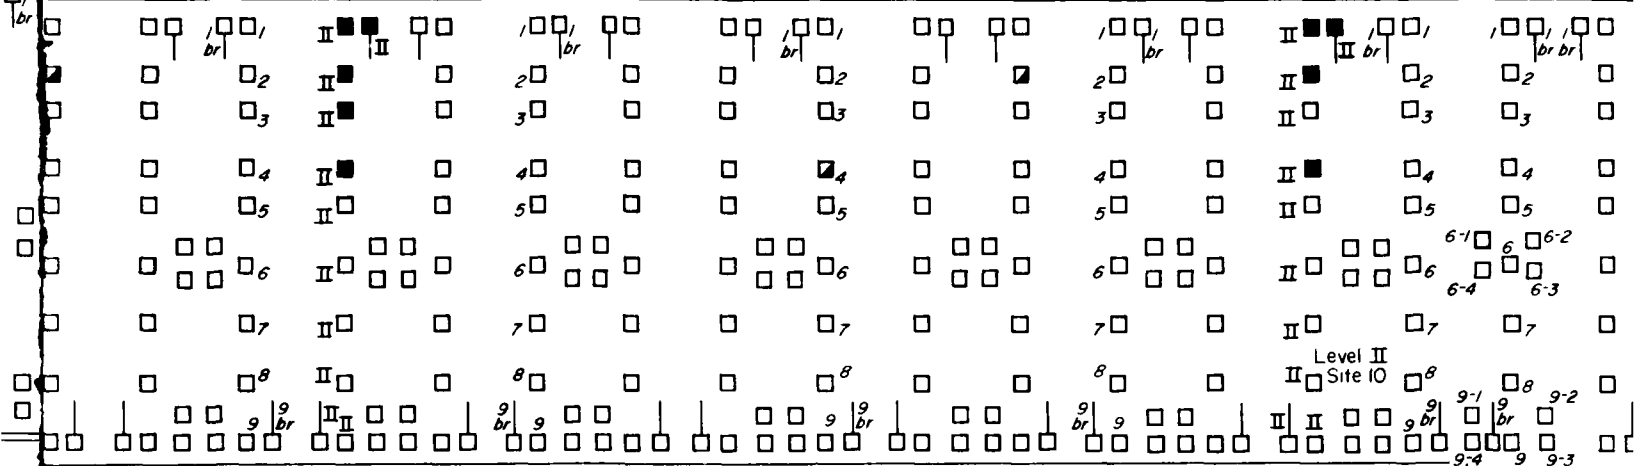
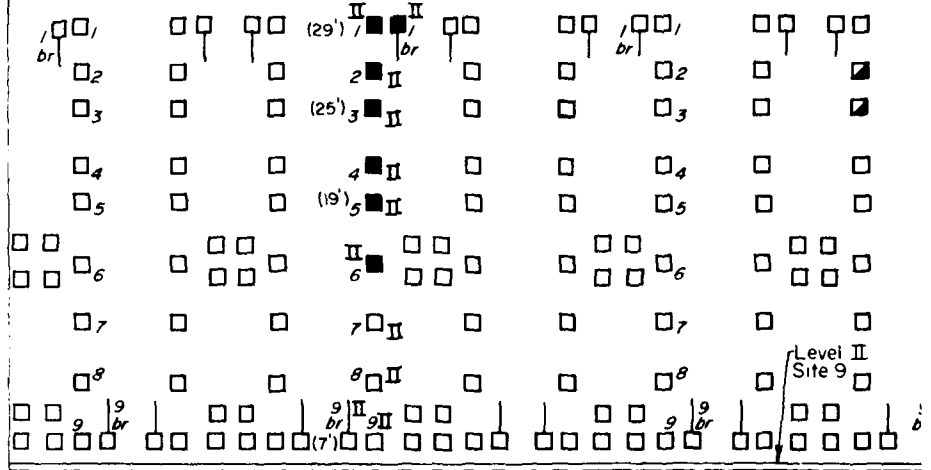
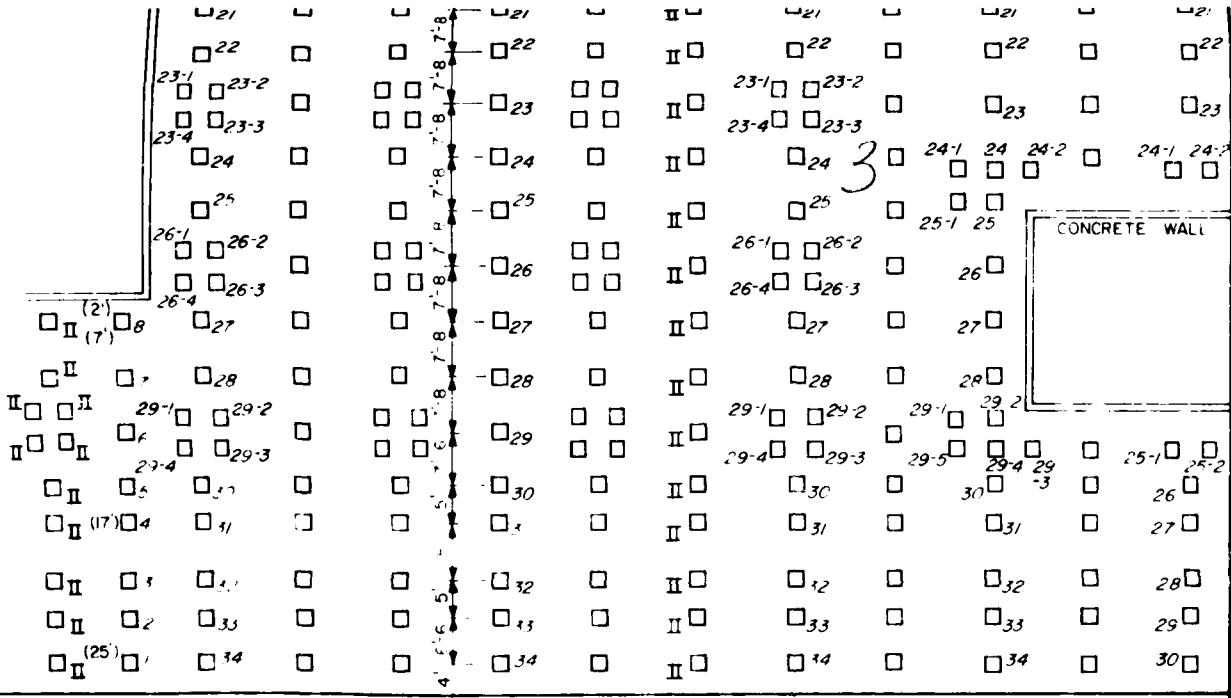
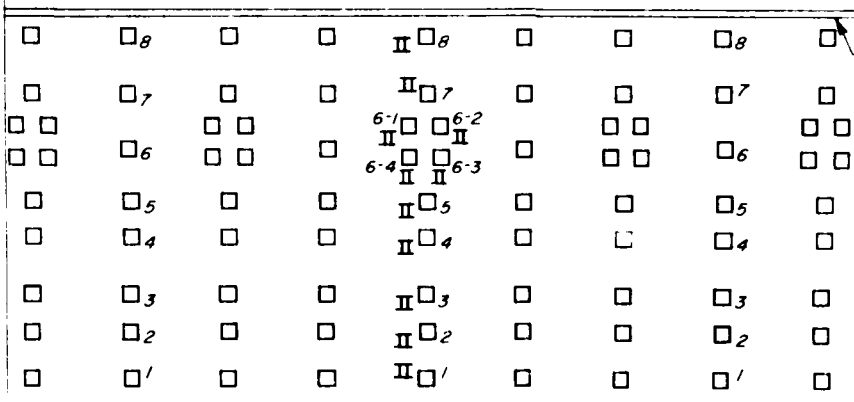
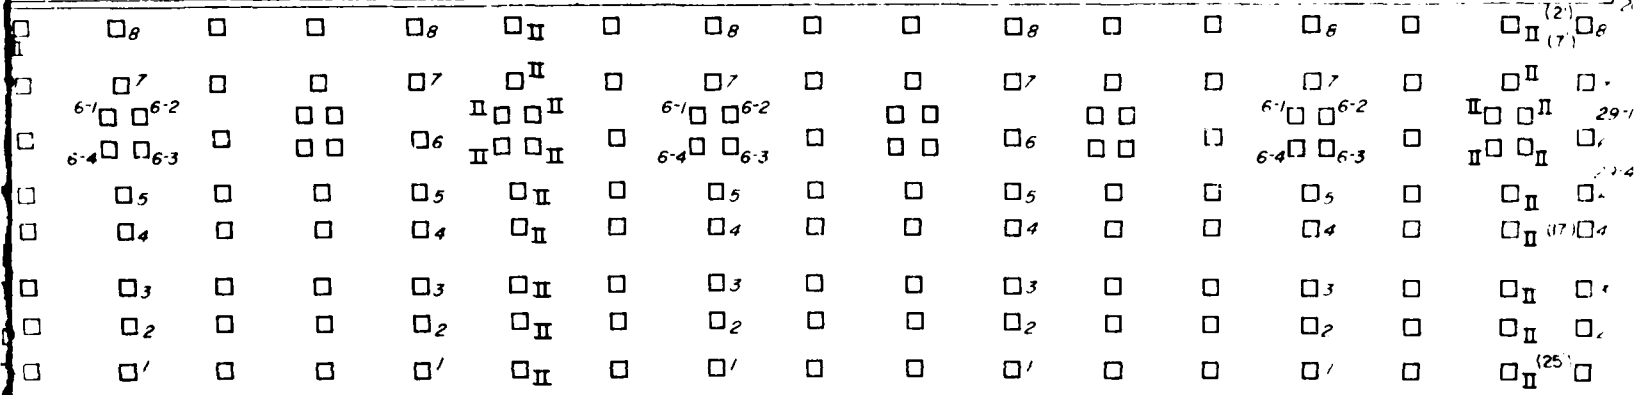
The detailed inspection results for the Level II inspection(s) of the concrete sheet wall bulkhead and the concrete bearing piles are presented in Tables 1 and 2. The location identification and the condition of the examined piles and sheet wall sites are presented graphically in the preceding Drawings 1 and 2.

piles in this area showed evidence of cracking and spalling on some piles. (see Drawing No. 1). When detailed Level II cleaning and inspection was carried out, 18 of the examined 51 piles were found to have sustained significant damage. As shown in Photograph Nos. 17 - 19, this damage consisted of cracking and/or spalling of the corner(s) of the piles. In some instances, this deterioration has resulted in the exposure and subsequent corrosion of the rebar. This damage was found to range from the lower intertidal zone to the mudline.

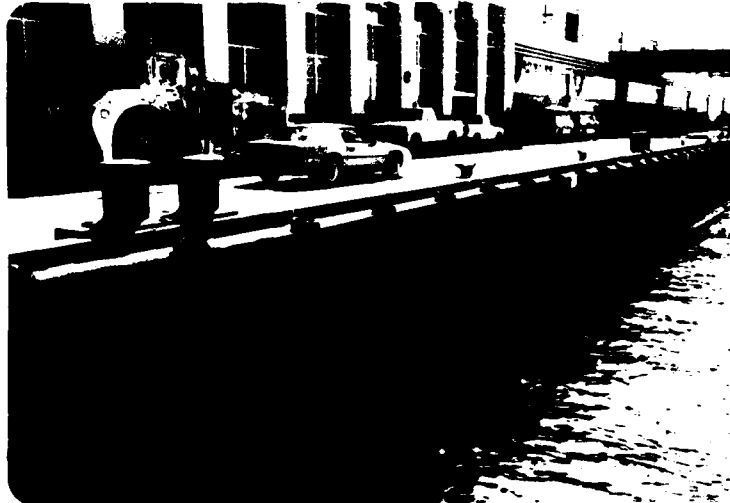
PHOTOGRAPH NO. 9

North Apron of Pier 11A. Note two story warehouse and timber fender system around perimeter of structure.
