**PNRF BARKING SANDS
CABLE INSPECTION 1983**

**FPO-1-83 (39)
OCTOBER 1983**

**ROBERT TAGGART INCORPORATED
FAIRFAX, VIRGINIA**

**OCEAN ENGINEERING AND CONSTRUCTION PROJECT OFFICE
CHESAPEAKE DIVISION
NAVAL FACILITIES ENGINEERING COMMAND
WASHINGTON, D. C. 20374**

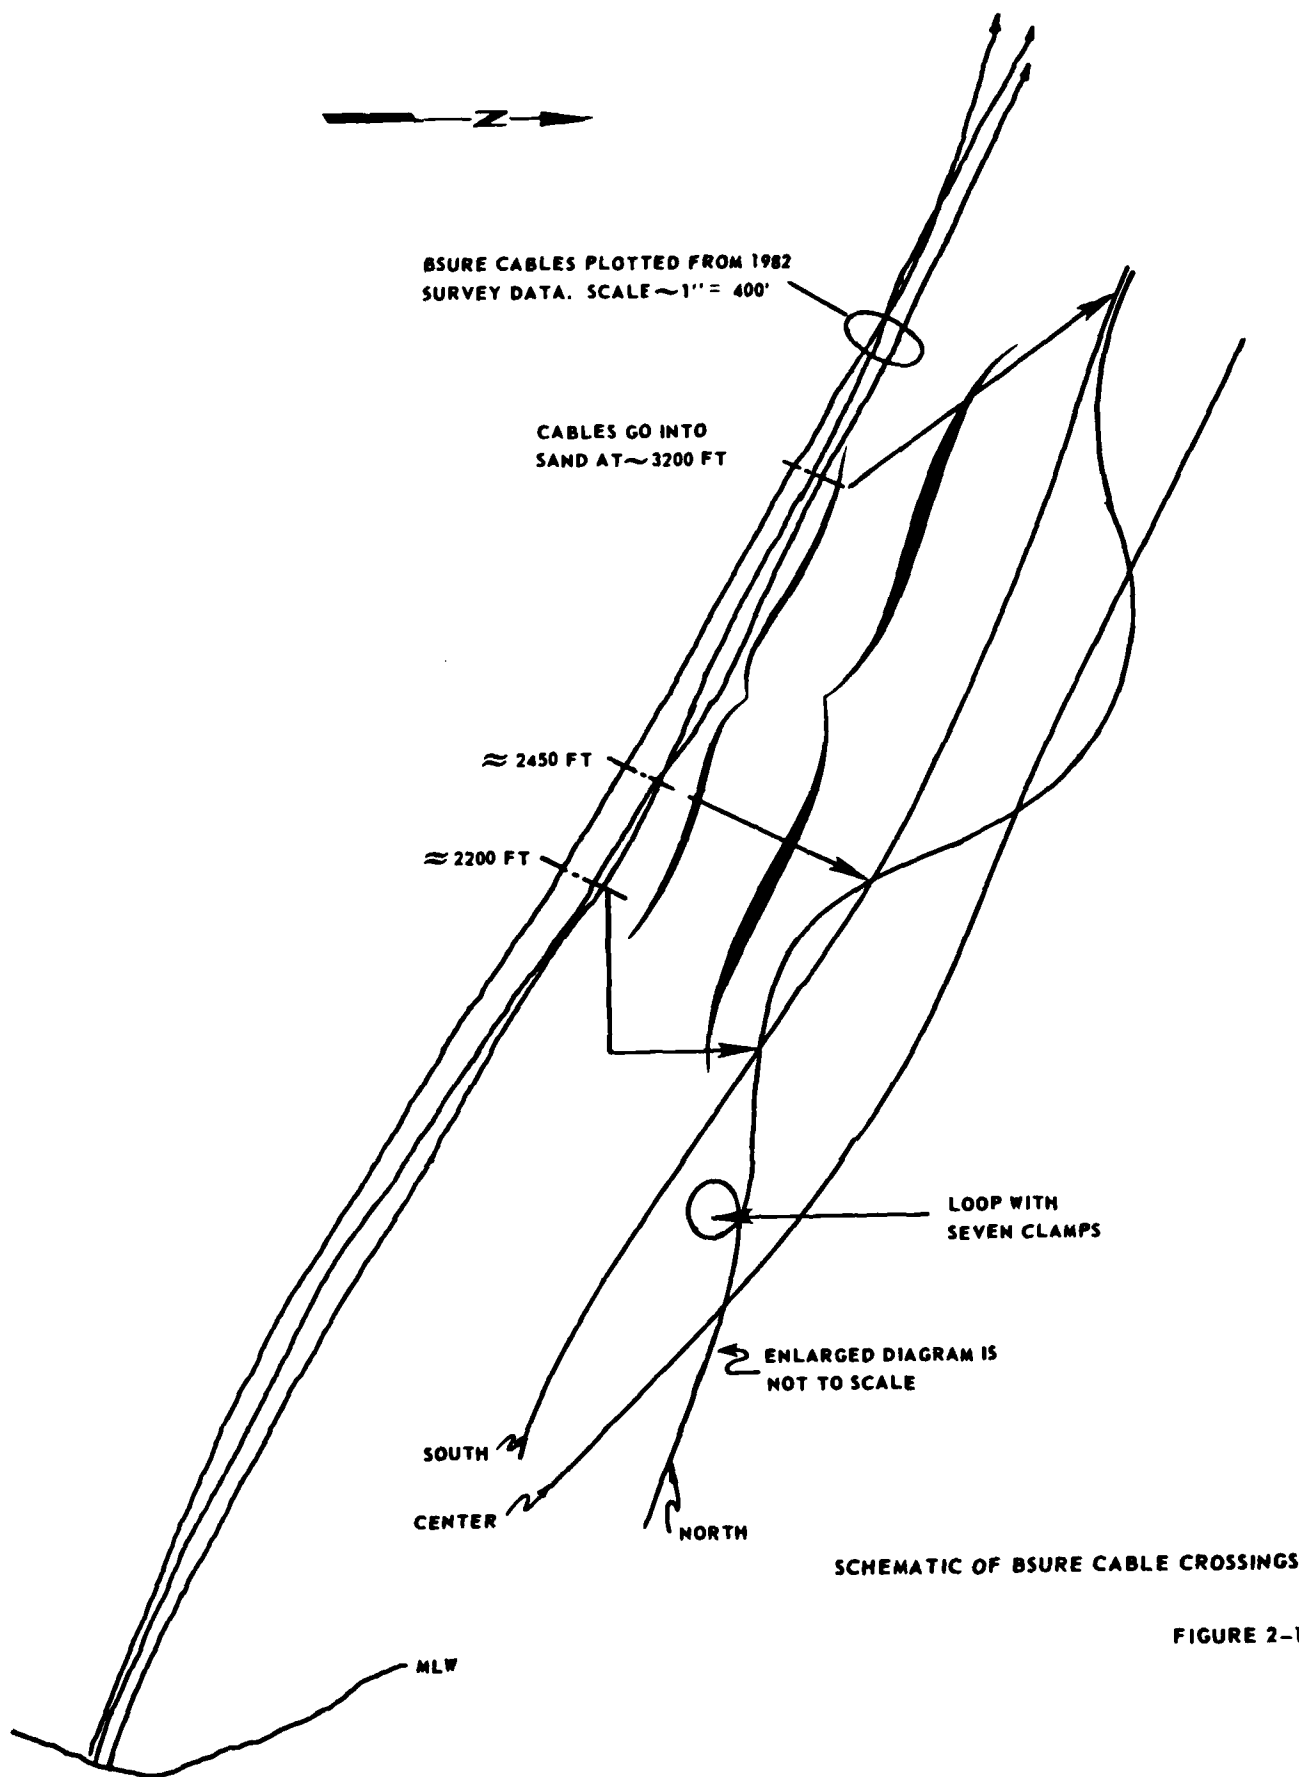
FIGURE 2-1

The inspection was begun with the BSURE cables, which were the most difficult to inspect. This was because they crossed over themselves several times. These crossings were not displayed on the plotted cable paths available at the time and caused some confusion. It was not certain whether crossings were not displayed because the cables had moved since the last survey or because the last survey was inaccurate. There was a considerable amount of slack in the cable; this would have permitted the cable to move without breaking loose any clamps. After completing the entire survey, it was noted that the crossings constituted the only difference from prior survey results. It was therefore concluded that the cable had actually moved in the interim. The additional clamping done during this project should preclude any future movement. A schematic of the BSURE cable crossings is shown in Figure 2-1.

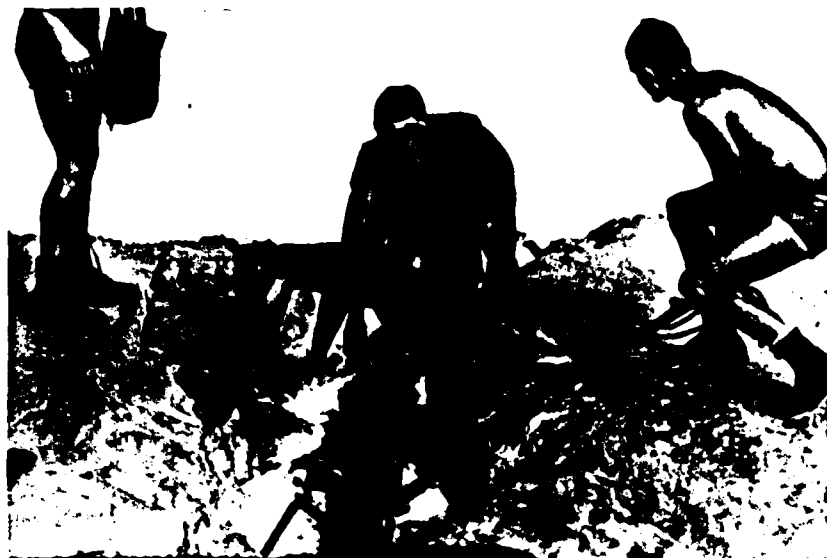
FIGURE 2-2

UCT-TWO PERSONNEL
PRY UP CABLE TO INSTALL
A NEW SECTION OF
PROTECTIVE SPLIT PIPE

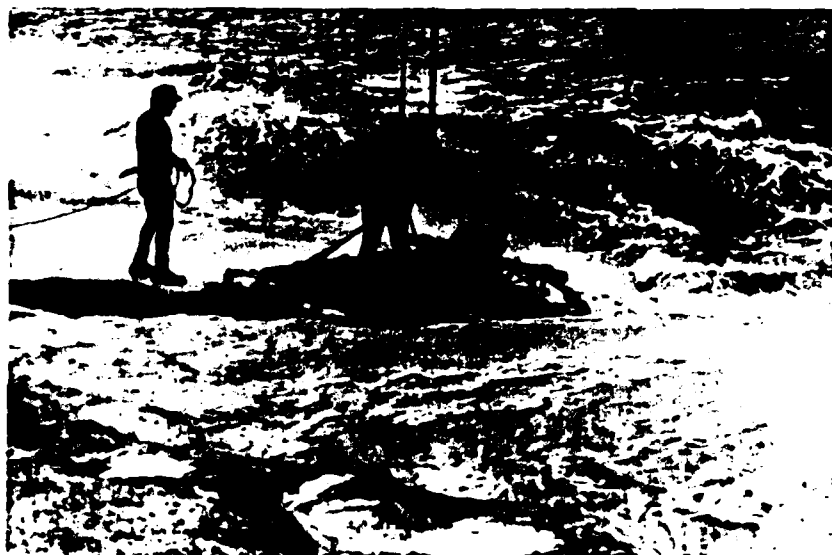
FIGURE 2-3

This operation was also unsuccessful. The pallets and anchors were readied and lowered into position using a PMRF crane. But the surf proved so strong that it actually caused the pallet to move across the beach rock even when weighted down. The operation was halted and the anchor and pallet recovered.

PALLET WITH 5000#
ANCHOR ATTACHED WITH
CARGO NET LOWERED
OVER BSURE TRENCH.
OPERATION HALTED WHEN
SURF MOVED PALLET
AND ANCHOR.

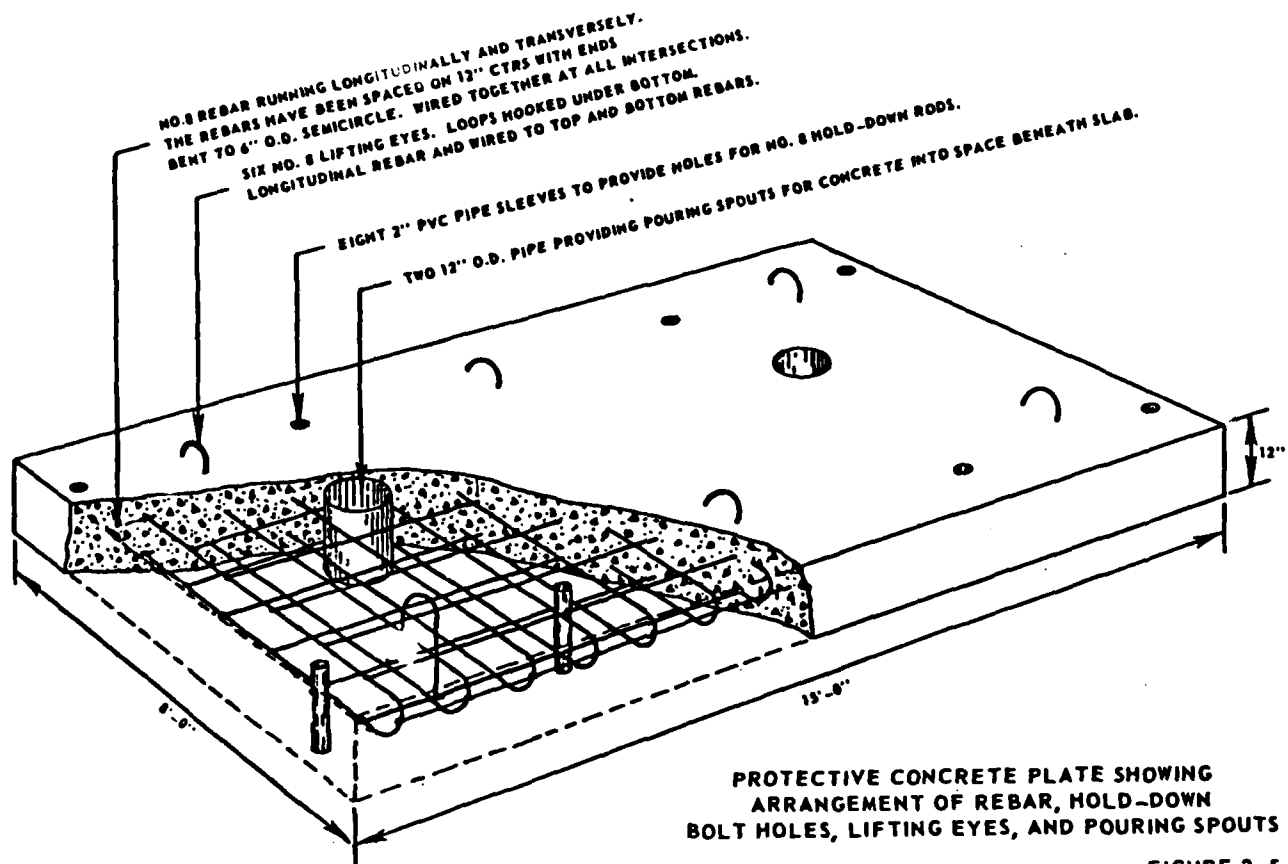
FIGURE 2-5

Each plate had eight 2-inch PVC pipe sleeves running vertically through the plate. These sleeves formed precast holes to hold the steel rods and also to act as guides for the drilling of holes into the beach rock. In each slab there also were two 12-inch diameter steel sleeves. These sleeves formed openings through which to pour concrete into the void spaces beneath the slabs. As the slabs were centered over the cable trenches, the concrete poured through these holes would fill the trench for added erosion protection. Rough gravel was cast in the bottom of the slabs to maximize the friction between the slab and the beach rock.

The new plan was to precast 15' x 8' x 1' concrete plates which would be placed over the cable trench. The plates would be held in place by their own 10-ton weight and by 8 steel rods drilled into the beach rock and epoxied to both the beach rock and the plate.

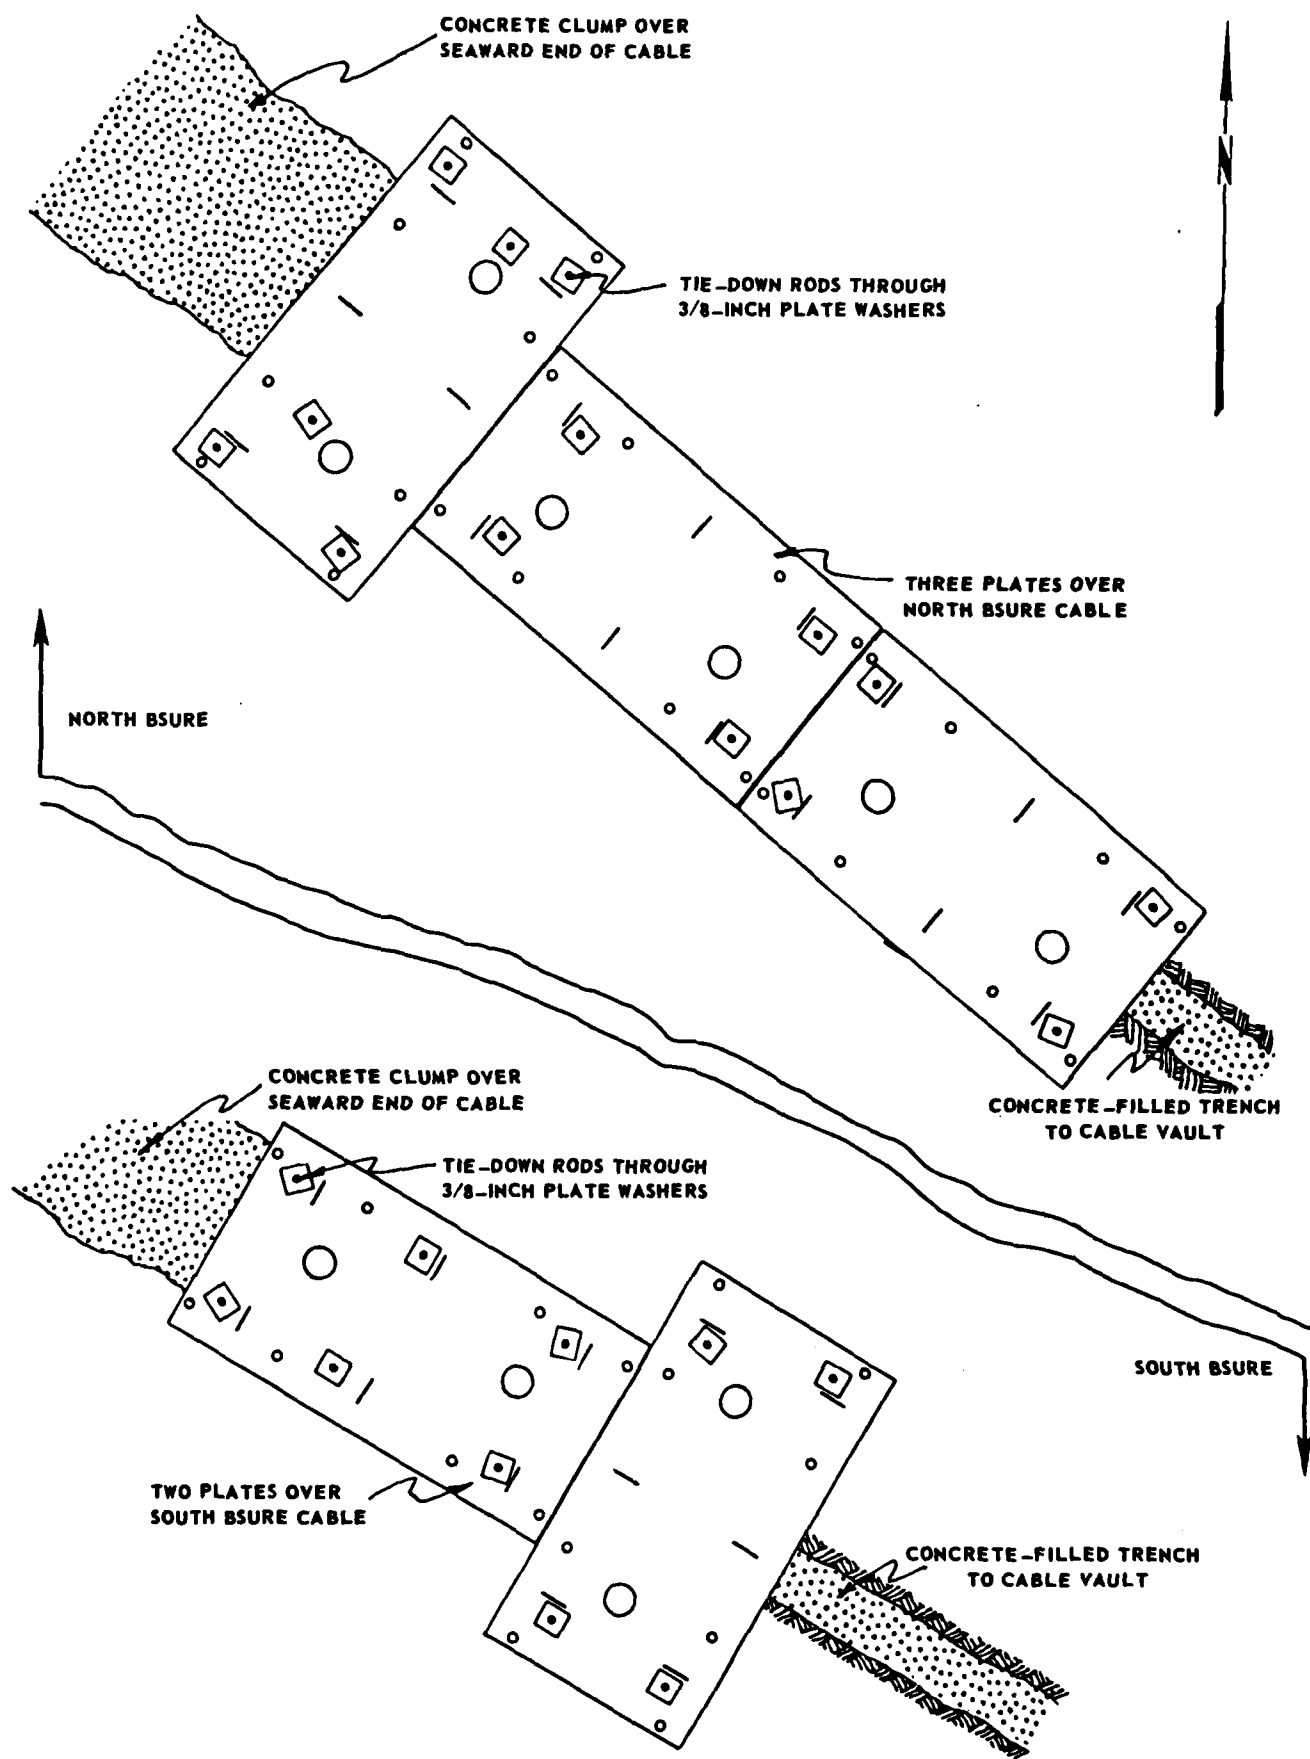
FIGURE 2-6

PLATE LOCATIONS OVER NORTH AND SOUTH BSURE CABLES

On 25 May, the slabs were put into position, Figure 2-6. As the weight of one slab was more than the crane could lift at full outreach, the slabs were put in place by lifting them by the 4 corner lifting eyes onto the beach rock about 30 feet from the crane. Then the crane boom was lowered to increase the lifting radius and the rear lifting eyes were released. Then by retracting the crane hook, the slab could be dragged out farther, with

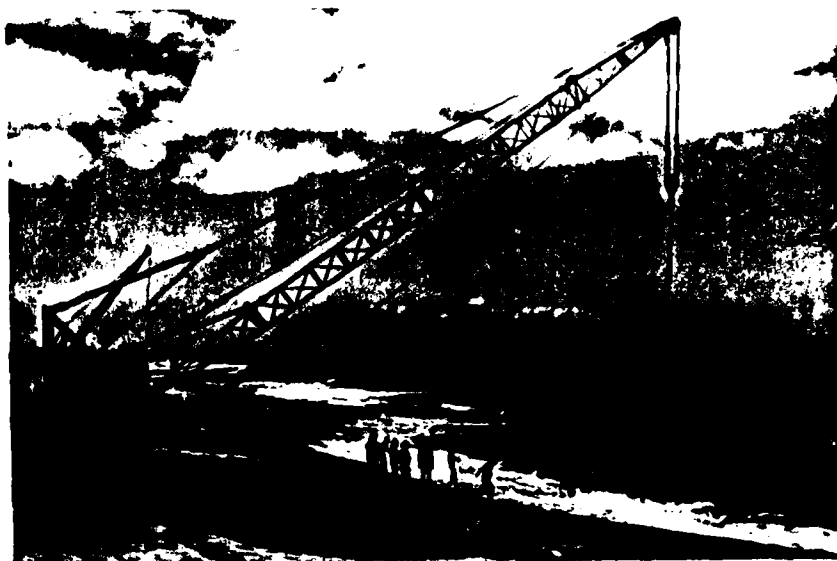
FIGURE 2-7

R-ELECTRIC CRANE
RELEASES SLAB AFTER
IT HAS BEEN PULLED
INTO POSITION BY TAG-
LINE CREWS.

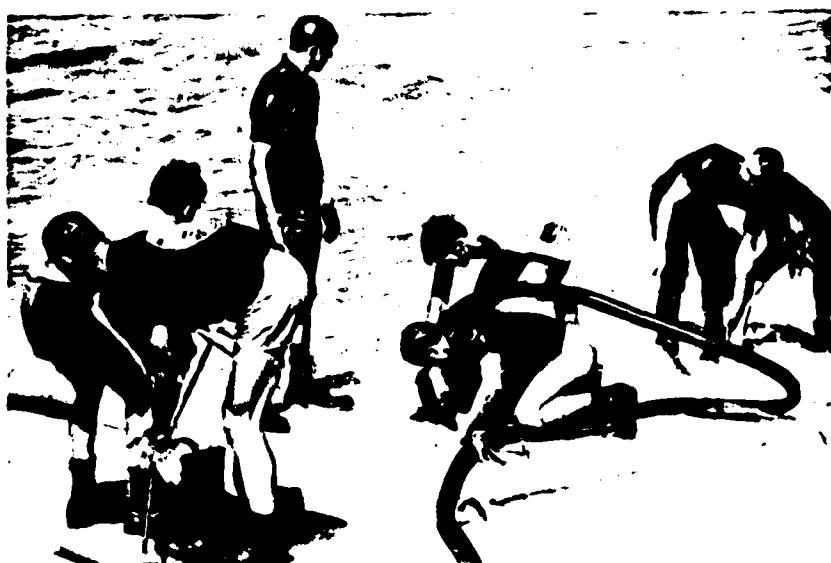
FIGURE 2-9

A check on the holes the following day showed that the concrete had remained in all but the most shoreward hole of the northern set of plates. Attempts were made to fill this gap with quick-setting cement, but these attempts failed. During later days of calm surf, epoxy was poured in the holes to fill the open spaces. The epoxy stayed in place but the process was too slow and was finally abandoned. As the gap was small and would allow little or no erosion of the cable, it was left unfilled.

PUMPING CONCRETE THROUGH
PORTS IN SLABS TO FILL
TRENCHES UNDERNEATH

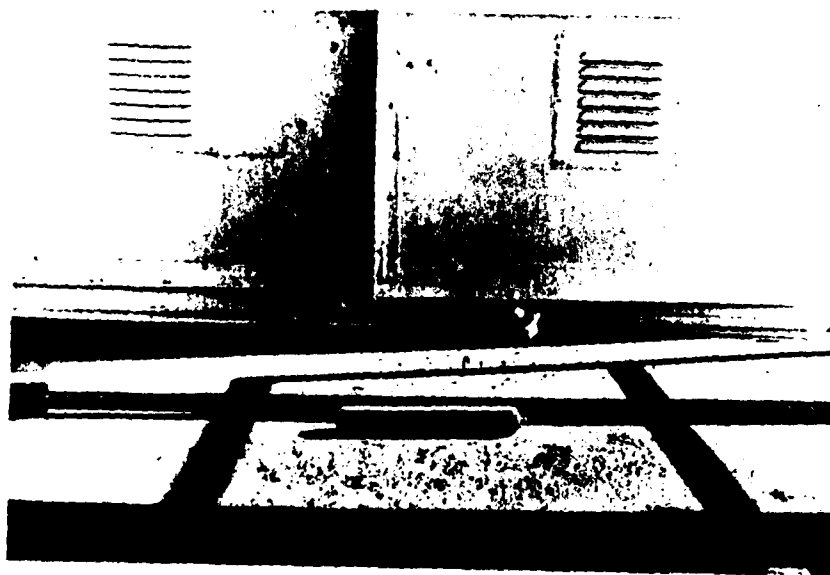
FIGURE 2-11

THREADED NO. 10 REBAR
SECTION FOR SECURING
SLABS TO BEACH ROCK.
CELTITE EPOXY PLASTIC
CARTRIDGE USED TO
CEMENT BAR TO ROCK.

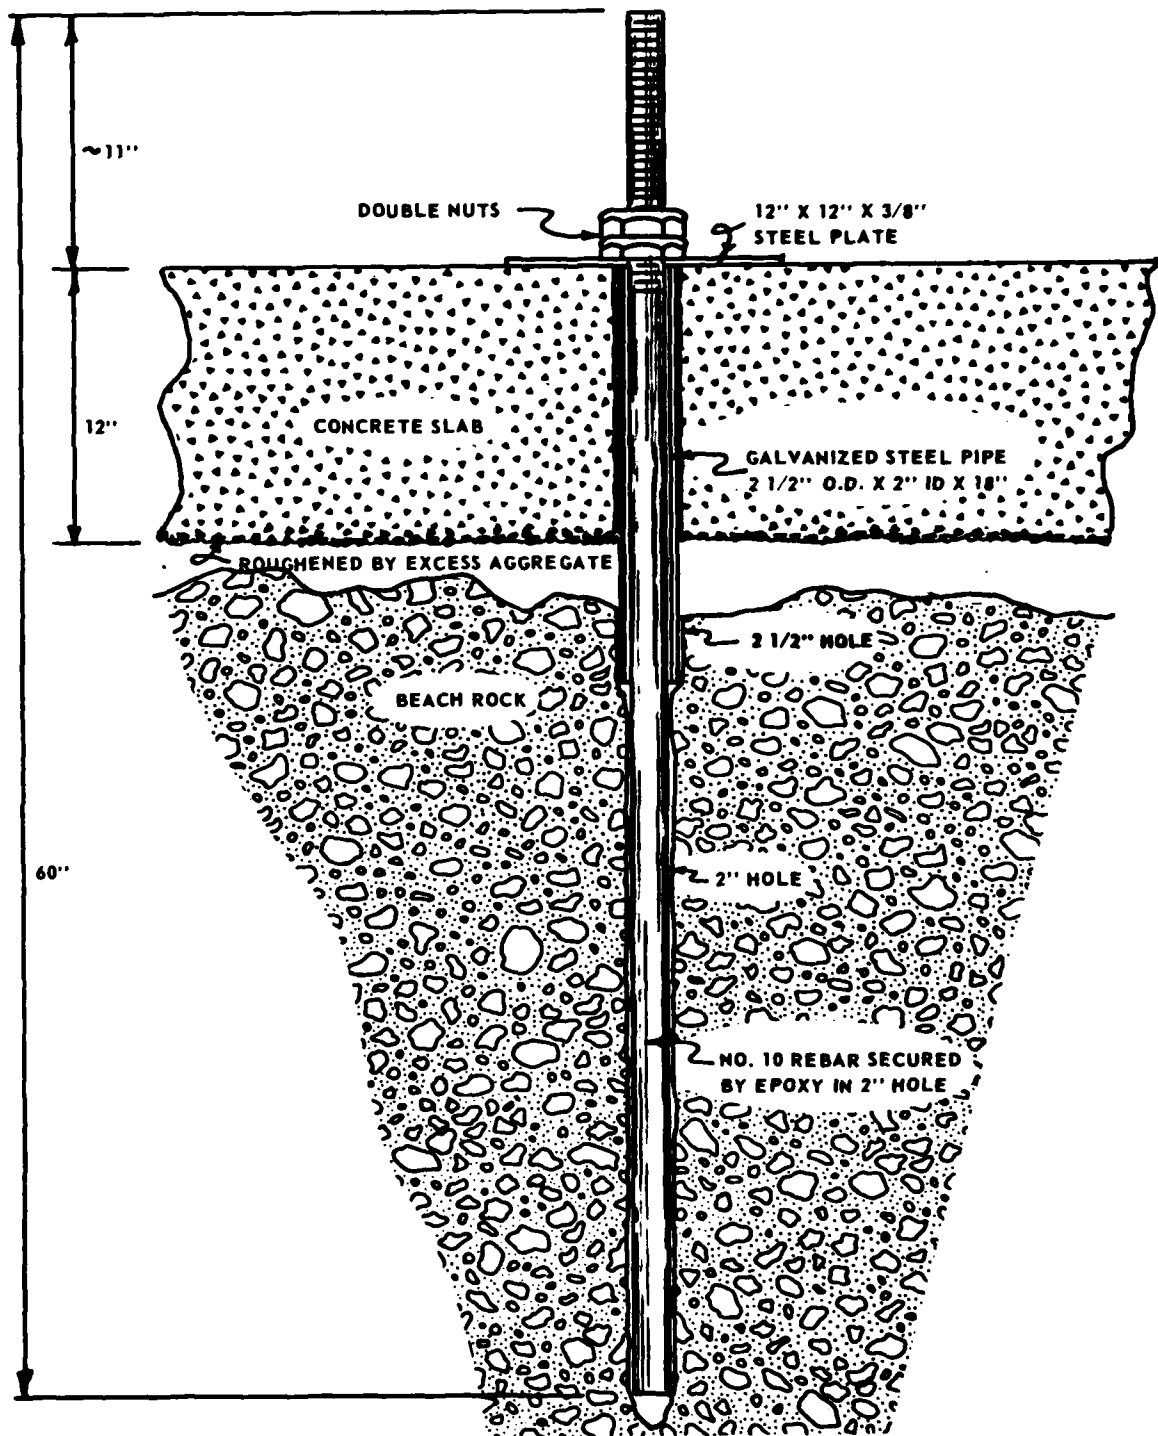
FIGURE 2-13

problem was that after drilling the 2-inch hole, sand washed in with the next wave and slid into the gap between the slab and beach rock, filling the hole that had just been drilled. The driller could not insert the cartridges or bar fast enough to prevent the hole filling up. This problem was solved by first drilling a 2.5-inch hole through the slab and about 3 inches into the beach rock. A 14-inch piece of 2-inch galvanized steel pipe was immediately inserted in this enlarged hole. This acted as a sleeve and filled the gap between the slab and rock, stopping the sand intrusion.

The second problem was that of the water from a wave shooting up the hole in the slab, and slapping the bottom of the steel plate. It was felt that this constant wave action under the plate would erode a hole through it. This splashing was stopped by filling the space around the rod in the hole with quick-setting cement. Because this had to be done after the rod and plate were in place, the nuts had to be removed. In some cases, this was not possible due to damage to the thread during installation. Eleven of the 24 rods installed had the cement placed in the hole.

It was calculated that the maximum upward force that a wave could apply to the bottom of a slab would be on the order of nine short tons. The slab weight in water was roughly 5 tons so that, in the worst case, a hold-down force of 4 tons might be required of a securing bolt. The lower graph on Figure C-1 shows that a 30-inch penetration in medium strength rocks provides about 20 short tons of anchoring force. Thus, under worst-case conditions, there would be more than adequate hold-down force available with only one bolt in place. Corrosion of these bolts and plates is a more likely mode of failure.

PIPE SLEEVE INSERTED THROUGH SLAB INTO BEACH ROCK
TO PREVENT WASHOUT OF EPOXY DURING MIXING

The sketch, Figure 2-13, illustrates this technique of preventing wash-out of the epoxy and shows the finished hold-down bolting system.
