**NAVAL AIR STATION BERMUDA
FLEET MOORINGS
UNDERWATER INSPECTION REPORT
8-15 JULY 1981**

FPO-1-81(18)
DECEMBER 1981

OCEAN ENGINEERING
AND CONSTRUCTION PROJECT OFFICE
CHESAPEAKE DIVISION
NAVAL FACILITIES ENGINEERING COMMAND
WASHINGTON, DC 20374

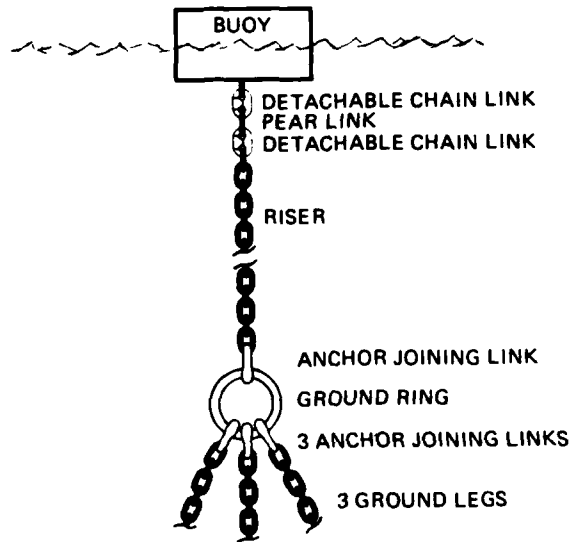
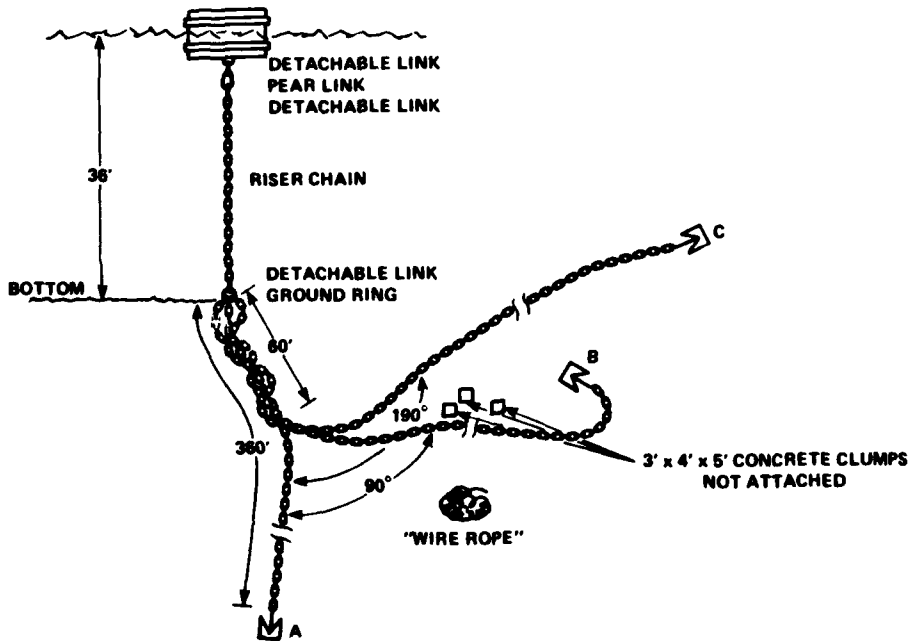
E-1

1.1 Findings. All components of this mooring installation were visible to UCT-1 divers. The buoy was found to be in satisfactory condition, and measurements of the wire diameter at three locations along the riser chain proved to be better than 90% of the specified 1 3/4" size (DM-26). The only shortfall in the riser assembly was the lack of a swivel.

Although the material condition of the ground legs appear to be satisfactory (> 90%), all three legs were intertwined for the first 60 feet from the ground ring, and below this point, all three legs were within a 190° sector of the bottom (see Plan View, page A-1-2). Three 3' x 4' x 5' unattached concrete clumps were located on the bottom between legs B and C, and the anchor for leg B was observed to be backwards (the fluke pointing away from the buoy). Assuming the mooring was correctly installed, it is probable that it was moved under load and apparently dragged legs A and C across leg B.

NOTE: ONE SWIVEL ON EACH OF LEGS A AND B FIVE FEET BELOW THE GROUND RING

TWISTED LEGS DUE TO NO SWIVEL IN RISER AND/OR DRAGGING.
LEGS NEED TO BE RE-POSITIONED. GROUND RING UNDERSIZED.

1.2 Conclusion/Recommendation. This mooring is not safe to use and is, therefore, unsatisfactory for fleet utilization. Recommend that the mooring be recovered, inspected, and overhauled as required.

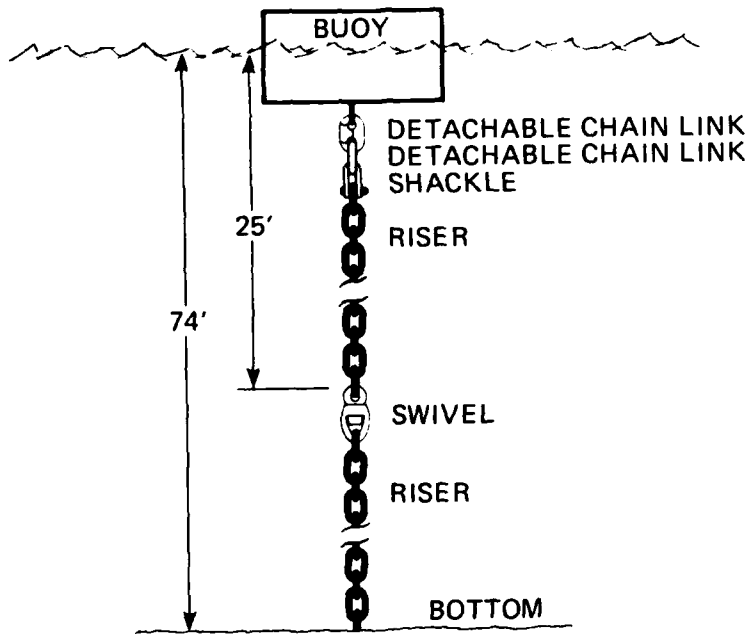
E-2
SCHEMATIC
(NOT TO SCALE)

1.1 Findings. This mooring is located in 72 feet of water, and only the buoy and riser chain were visible to the divers. The ground ring, ground legs, and anchors were all buried in the silt/mud bottom, and their material condition and the orientation of the three legs could not be determined. Although the buoy was in satisfactory condition, the riser chain was in unsatisfactory condition. Single link measurements near the tidal wear point revealed that some links were worn down to 7/8 of an inch, 50% of their initially designed wire diameter (1 3/4"). Although the orientation of the legs and anchors could not be determined, PWD personnel advised that this mooring may have been dragged off location by a ship.

RISER WORN TO 7/8" (50% REQUIRED DIAMETER)

RECORDS INDICATE MOORING HAS BEEN DRAGGED FROM ORIGINAL LOCATION AND THAT ANCHORS ARE PROBABLY CLUMPED TOGETHER.

1.2 Conclusion/Recommendation. Due to the unsatisfactory wire diameter of some links in the riser, this mooring is unsafe for fleet use. Recommend that the mooring be completely overhauled.

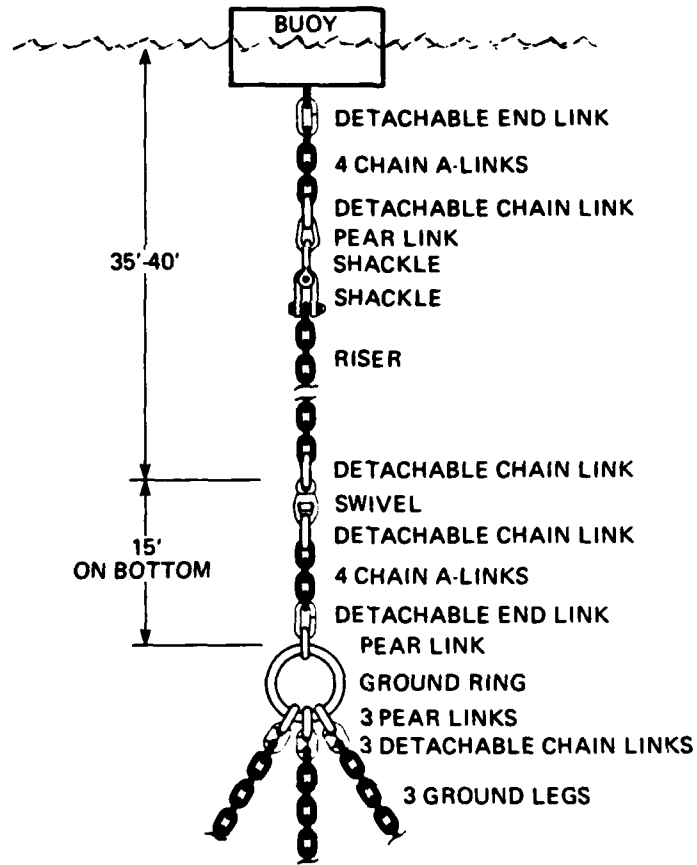
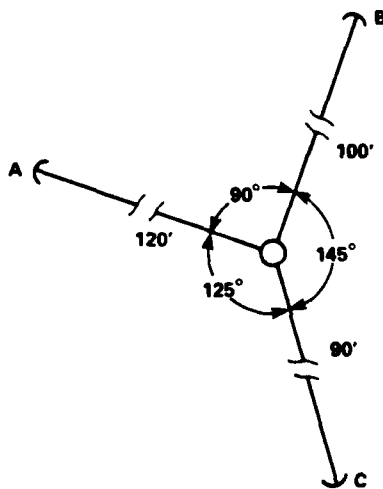
E-3
 SCHEMATIC
 (NOT TO SCALE)

1.1 Findings. This mooring is in 40 feet of water. The buoy is in satisfactory condition except for being numbered "E-5". The riser is in unsatisfactory condition and badly worn with the wire diameter of some links measuring $\frac{3}{4}$ of an inch, about 43% of their original $1 \frac{3}{4}$ inch diameter. Approximately 15-20 feet of riser chain rests on the bottom with an oversized ($5 \frac{1}{16}$ " wire diameter) ground ring. Between 90' and 120' of the ground legs were visible before they disappeared into the bottom near their anchors, which were visible to the divers. The orientation of these relatively short legs is shown on page A-III-2. The wire diameter of each of the legs was measured to be greater than 90% of its designed diameter of $1 \frac{3}{4}$ inches.

RISER WORN TO 3/4" OR 43% ORIG DIAM, 1 1/4" CHAIN WHEN NEW

1.2 Conclusion/Recommendation. This mooring is unsafe for fleet use and is recommended for complete overhaul.

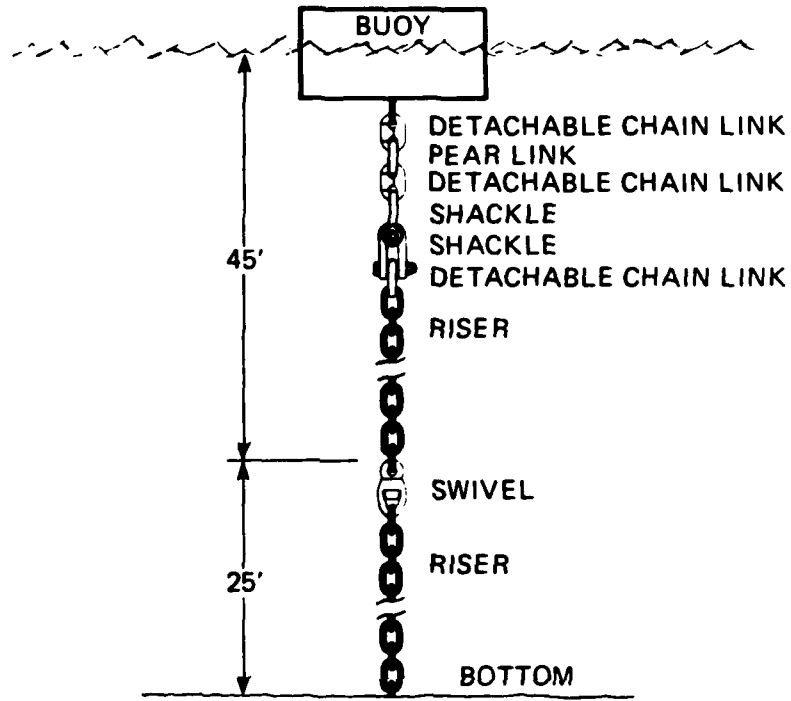
E-4

1.1 Findings. This mooring was originally installed as a Class C mooring and subsequently downgraded twice to a Class E. The buoy's condition is satisfactory, but the connecting jewelry between the buoy and the riser chain is unsatisfactory. Below the buoy, there exists a detachable chain link, a pear link, a detachable chain link, two back-to-back shackles, and a third detachable chain link attached to the riser.

The riser chain wire diameter is greater than 90% of the original oversized 2 1/4 inch diameter chain installed. The riser chain enters the bottom at 70 feet of water depth, and the ground ring, ground legs, and anchors are buried. An attempt was made to raise the ground ring and expose a portion of the ground legs using two one-ton lift bags, but this attempt failed. The condition and orientation of the ground legs were not observed.

CONDITION OF BURIED RING AND LEGS UNKNOWN. LIFT BAGS COULD NOT LIFT
GROUND RING AND LEGS FROM MUD BOTTOM.

1.2 Conclusion/Recommendation. Although the exposed portion of the riser chain shows little sign of corrosion or wear, the condition of the buried portion of the mooring is unknown. This mooring should be removed, inspected, and overhauled as required. Until this is accomplished, the degree of safety available to fleet units utilizing this mooring is uncertain.

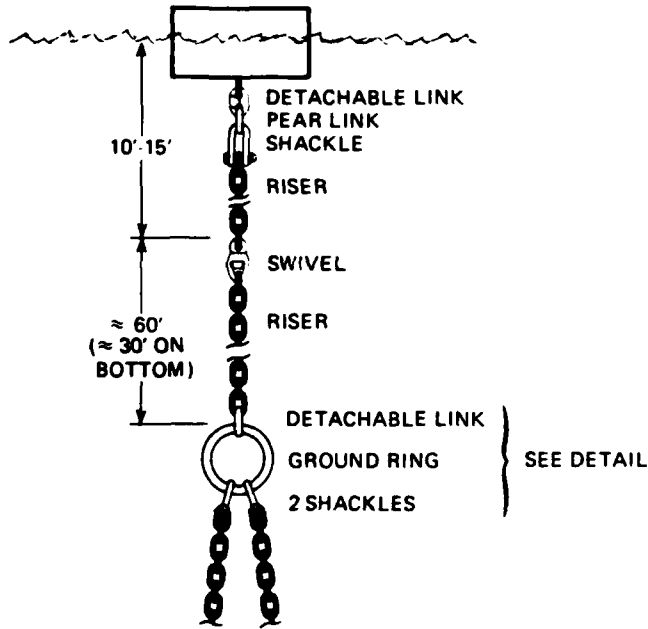
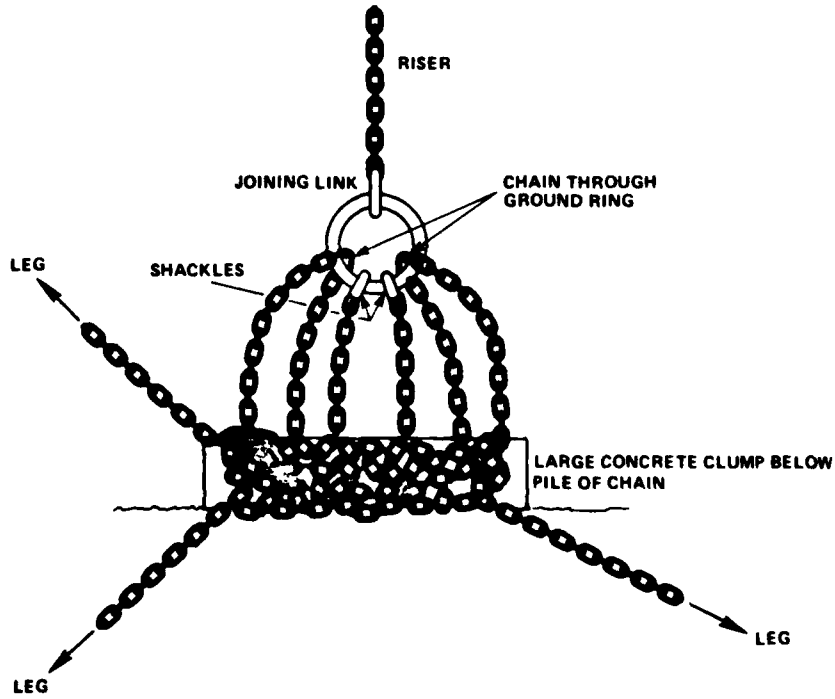
E-5

1.1 Findings. This mooring is installed in 35 feet of water depth. The condition of the buoy is satisfactory, but the riser chain is excessively worn with wire diameter sizes as small as 7/8 of an inch, about 50% of the original wire diameter (1 3/4"). The riser is also too long. Approximately 30' of riser chain is stretched out on the bottom leading to the ground ring. The ground ring was on the bottom and was determined to be in satisfactory condition. However, shackles connect only two ground legs to it, and two lengths of chain run through the ground ring (see sketch on page A-18). These two lengths of chain and the two identified ground legs lead to a nearby mound of entwined chain atop and alongside a large concrete clump. From this entwined chain, three legs were observed to run out approximately 100 feet each to their anchors. The bitter end of the leg not connected to the ground ring was not observed nor was it determined whether the concrete clump was attached to one or more of the ground legs. The reason for the chain lengths passing through the ground ring is unknown. In addition, the wire diameters of all three ground legs are less than 90% of original diameter.

1.2 Conclusion/Recommendation. This mooring is unsafe for use and is recommended for overhaul.

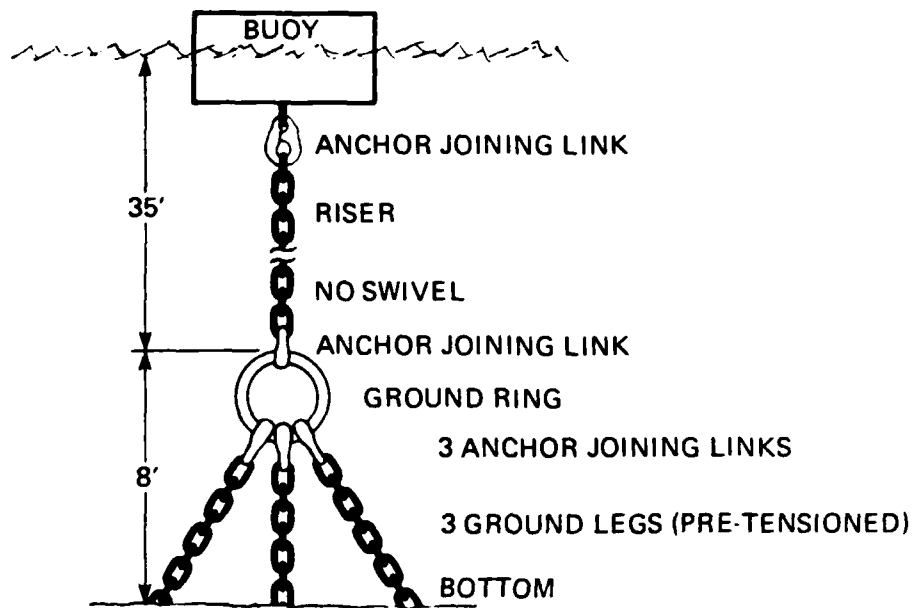
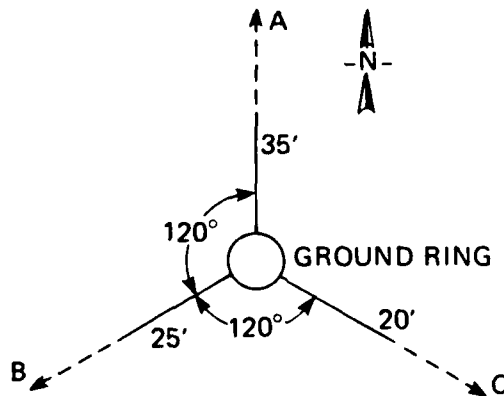
F-1

1.1 Findings. Although DM-26 requires only 1 1/4 inch chain for a Class F mooring, the riser and legs of this mooring consist of 1 3/4 inch chain. The condition of the buoy and riser is satisfactory and the ground ring is about 8-10 feet above the bottom. The ground ring was fabricated locally and is of non-standard size (8" inner diameter). Although smaller than the design requirements of DM-26, records indicate that this ring was pull tested to 50K pounds prior to installation and is, therefore, considered satisfactory for an "F" class mooring. This ground ring is made of tempered steel, and (although none was observed during this inspection) corrosion should be anticipated due to the differences in the relative galvanic potential of steels of different compositions. The condition of the 20-35 feet of pre-tensioned ground legs exposed appears to be satisfactory as is the leg orientation. The only deficiency noted was the lack of a swivel in the riser chain.

NOTE: SWIVEL IN LEG B, 12'
OUT FROM GROUND
RING

SATISFACTORY BUT NEED SWIVEL IN RISER WHEN OVERHAULED

1.2 Conclusion/Recommendation. This mooring conditionally meets the required criteria for a Class F mooring, but a swivel should be inserted in the riser chain.

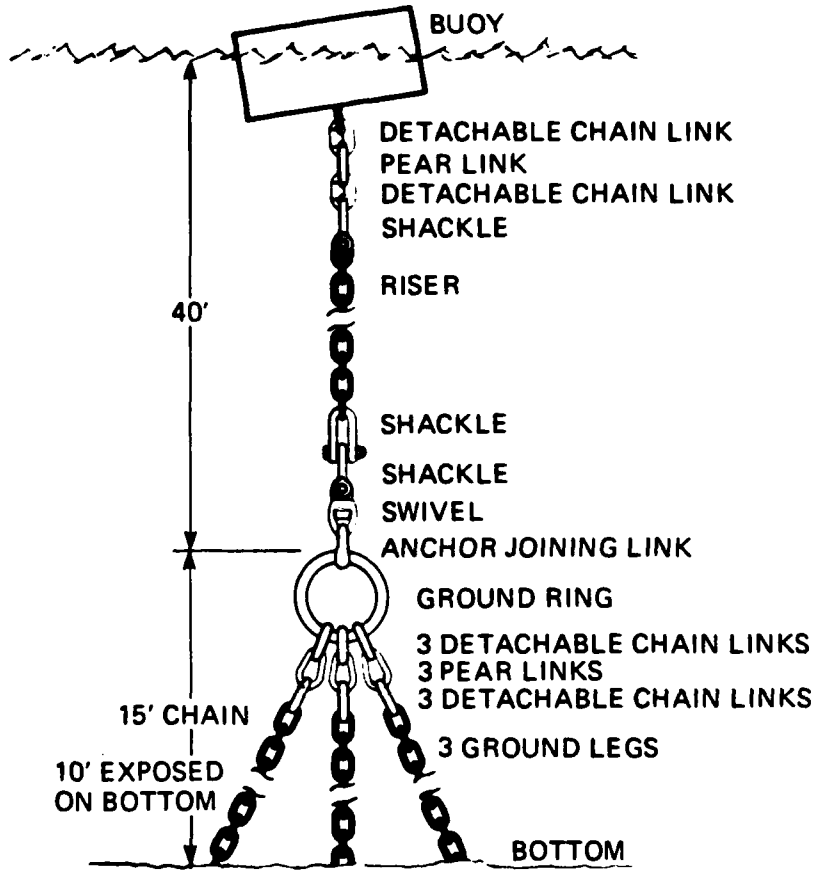
F-3
SCHEMATIC (NOT TO SCALE)

1.1 Findings. This mooring is in 45 feet of water and was initially installed using 1 1/2 inch chain in the riser and its three legs. Although the exterior condition of the buoy appears satisfactory, its internal integrity is questionable since the buoy has an 8-10 degree trim angle. The condition of the bottom jewelry is non standard, but the condition of the riser appears to be satisfactory. The ground ring is about five feet above the bottom, and about 10-15 feet of each of the three ground legs attached to it are piled on the sea floor beneath it. The wire diameter of each of the three legs measure less than 90%, but greater than 80%, of its original 1 1/2 inch diameter. The remainder of each of the legs are buried and their lengths and orientation are unknown.

8° TO 10° TRIM ANGLE ON BUOY
CONDITION OF BURIED LEGS UNKNOWN

1.2 Conclusion/Recommendation. From a safety standpoint, the use of this mooring by fleet units is questionable. The mooring should be removed, the buoy should be thoroughly inspected in order to determine the cause of its list, and the condition of the ground legs should be determined. The mooring should be overhauled as required prior to reinstallation.

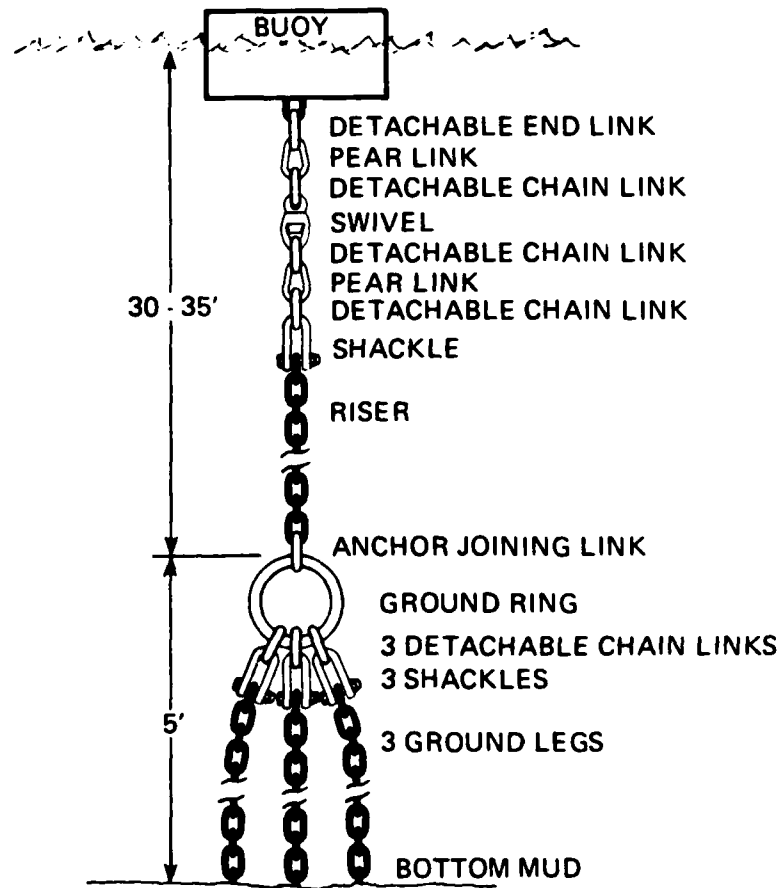
F-4
SCHEMATIC
(NOT TO SCALE)

1.1 Findings. A water depth of 40 feet exists at the mooring site. The buoy's condition is satisfactory, but its bottom jewelry is non standard, consisting of two end links, a swivel, three detachable links and a shackle. The wire diameter of the riser chain is greater than 90% of its original 1 3/4 inch diameter. The ground ring is suspended by the riser about five feet above the sea floor. The three ground legs attached to the ground ring drop parallel into the bottom. The wire diameters of the few feet of each 1 1/2" diameter ground leg observed satisfactorily met the over 90% criteria, but the lengths and orientation of these legs, and the positions of their anchors are unknown.

LEG ORIENTATION AND CONDITION BELOW BOTTOM UNKNOWN

1.2 Conclusion/Recommendation. This mooring should be used with caution due to the uncertainty concerning the positions and conditions of its ground legs. Recommend that this mooring be recovered, inspected, and overhauled as required.

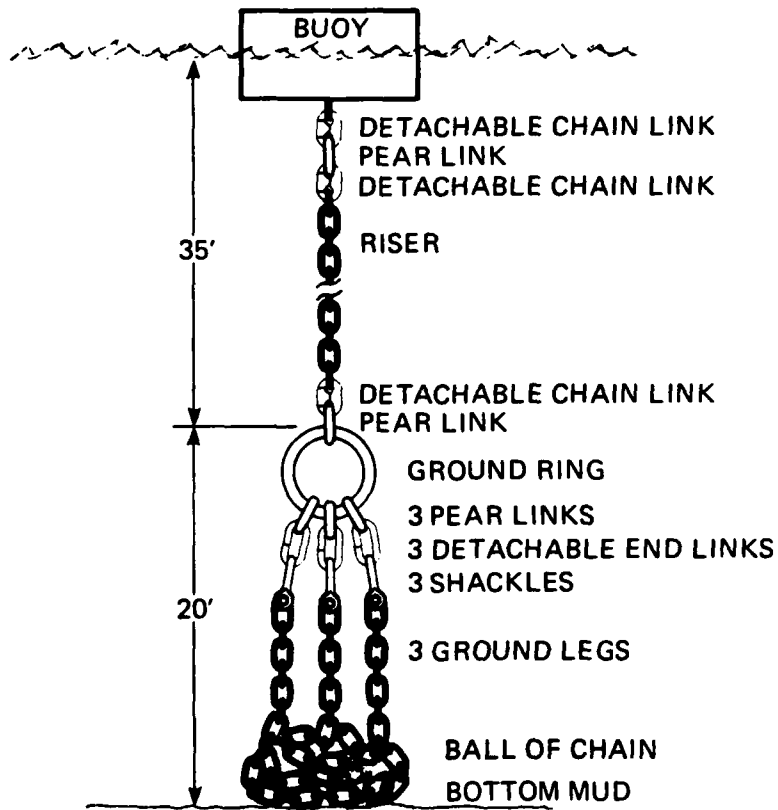
F-6
SCHEMATIC
(NOT TO SCALE)

1.1 Findings. As with most other moorings, the condition of this buoy is satisfactory. The riser chain wire diameter meets acceptable standards, but the riser does not contain a swivel. In addition, the riser is too short. The water depth at the site is 55 feet. The ground ring is approximately 20 feet above the bottom. The three ground legs attached to the ground ring drop parallel to the bottom where a pile of intertwined chain exists. The three chain legs apparently enter the mud bottom from under this pile of chain.

The twenty plus feet of each ground leg exposed below the ground ring are heavily corroded and pitted. Two of the three ground legs failed the 80% wire diameter measurement test.

NOTE: 5' OF EACH LEG IN BALL AT FLOOR

GROUND LEGS WORN TO BELOW 80% OF REQUIRED 1 1/4" WIRE DIAMETER
AREA LESS THAN 65% OF THAT REQUIRED

1.2 Conclusion/Recommendation. This mooring is unsatisfactory for fleet use and is recommended for complete overhaul.

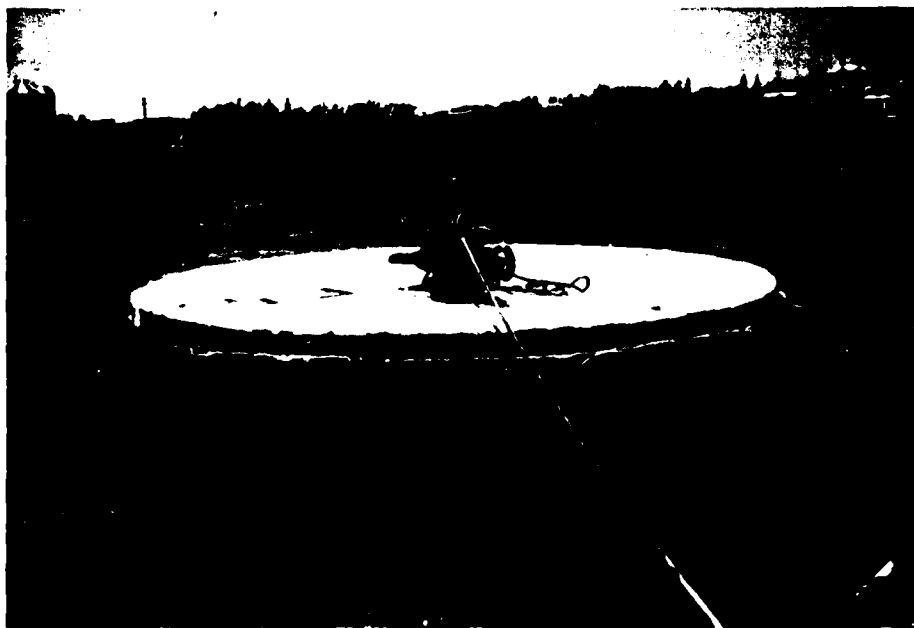
Figure C-4. Buoy F-4 - A Sample of the Typical Buoy Condition
