UNDERWATER FACILITIES AND INSPECTIONS AND ASSESSMENTS

NAVAL AIR STATION

PENSACOLA, FLA.

JANUARY 1983

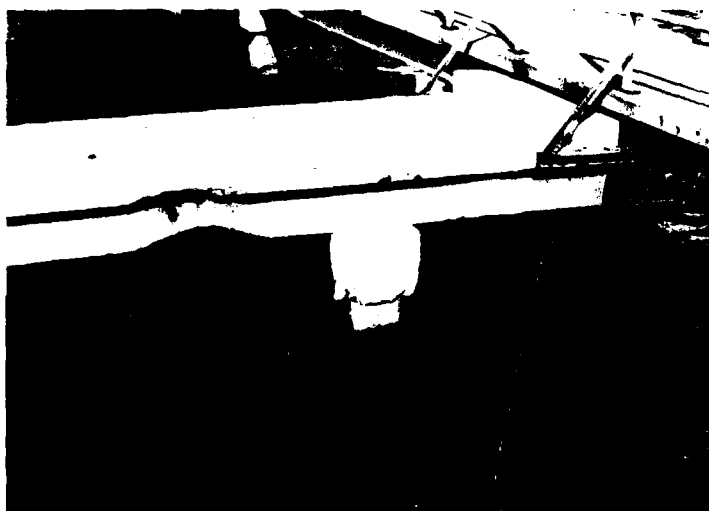
PHOTO NO. 18

Pier 3238 - Spalled edge of pile cap and  
spalled deck unit at Bent 9.

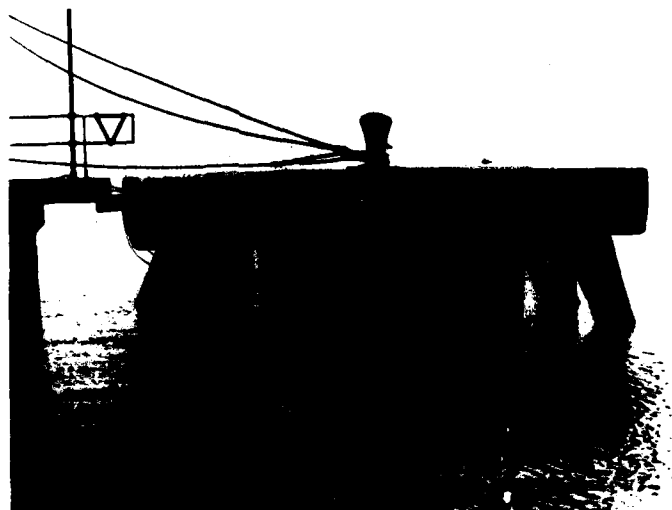
PHOTO NO. 43

Finger Pier 303 - View of west bollard cluster and cracked encasement at north-west batter pile.
