ST JULIENS CREEK OCEAN CONSTRUCTION EQUIPMENT INVENTORY 1/2

RUG 83 CHES/NAUFAC-FFO-1-83(24)-UOL-1

The purpose of this document is to present the anticipated needs of the OCEI Support Facility at St. Juliens Creek over the next five years. It is a planning document designed to provide sufficient background and data so that the reader can effectively utilize the proposed recommendations and conclusions. The scope of the document is intended to provide the information required to justify appropriation requests.

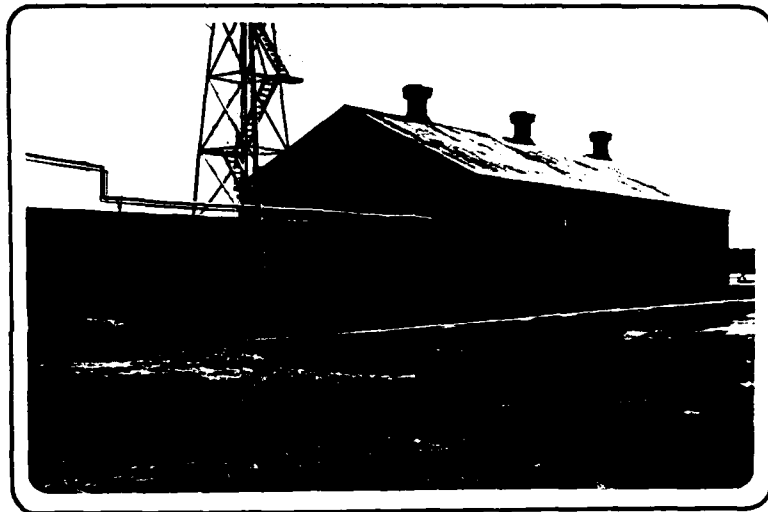
Outside, the wharf is paved with concrete on the north, east and south sides. Water lies directly off the building's west side. Three railroad tracks run along the wharf on the east side. A large steel tower is located four feet from the north loading ramp. The nearest utility pole is 50 feet to the northeast and the nearest fire main is 75 feet to the northeast. Adjacent to the building on the north side is a corrugated, metal storage shed measuring 54 feet long, 15 feet wide and 9 feet high used for storage of a forklift and petroleum products. (See Figure 3-5.) This 6000 pound capacity forklift cannot be used in the building due to the foundation's uncertain structural integrity.

Figure 3-5: View of Building 45 showing west side of building. (Spring 1983) Note storage shed and tower on left.

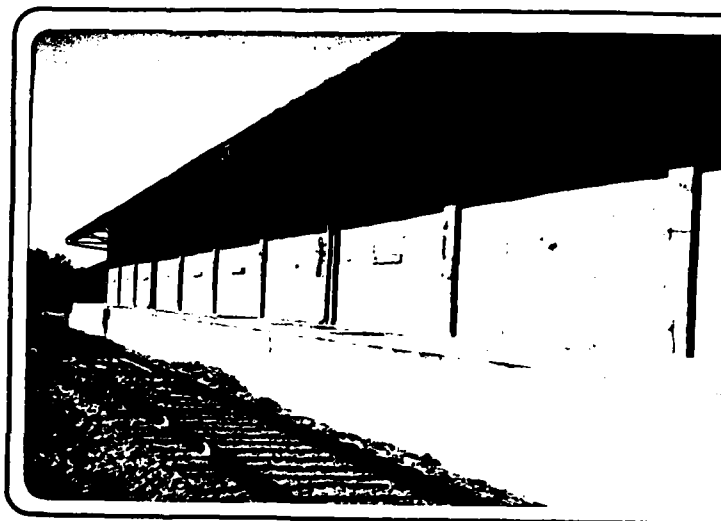
Building 169-Z is adequate in size but not in capability to accomplish its present and future requirements. Although the south wall is lined with tall, heavy-duty steel shelves which store materials efficiently, the building needs an upgrade in utilities and an improvement in equipment transfer capability. The building's present facility support equipment includes a pallet jack and a 6000 pound capacity A-frame. However, there is a need for a loading device which can efficiently transfer material to heights of 14 feet. These items are discussed in paragraph 3.2.4.2.

Figure 3-8: View of Building 169-Z showing south side (Spring 1983).

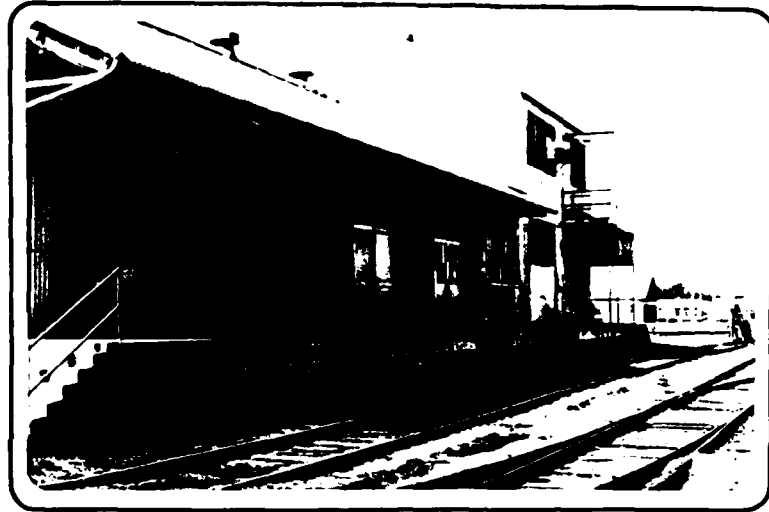
Figure 3-12: View of Building 185 showing northeast side (Spring 1983).

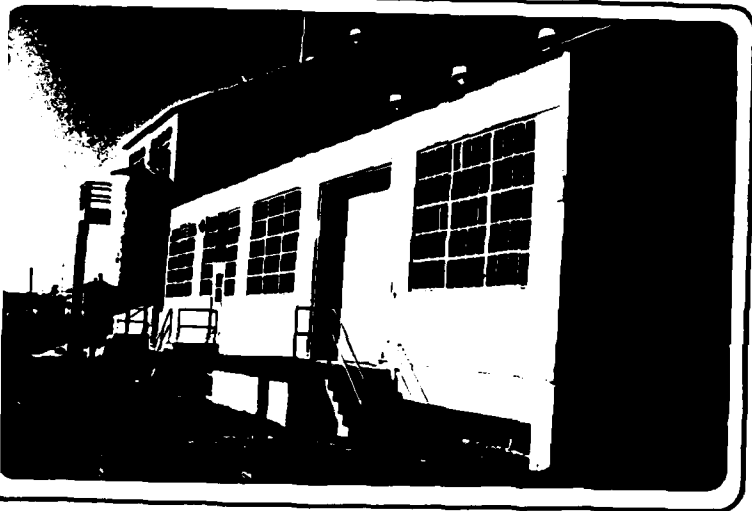
Several small problems exist in Building 185. Due to leaks in two southeast doors, the concrete floor surface is significantly degraded. This portion of the floor needs to be repaired and these doors need to be weather-proofed to prevent further leaks. All the windows and doors on the first floor should be checked and weather-proofed, if necessary. Gutters and downspouts should be checked and repaired or installed where necessary. Gutters are especially needed above the doorways. On the second floor, leaks occur at the hoist double door and at the windows north of the main door. These leaks should be repaired. All the windows and doors should

Figure 3-13: View of Building 185 showing southeast side (Spring 1983).

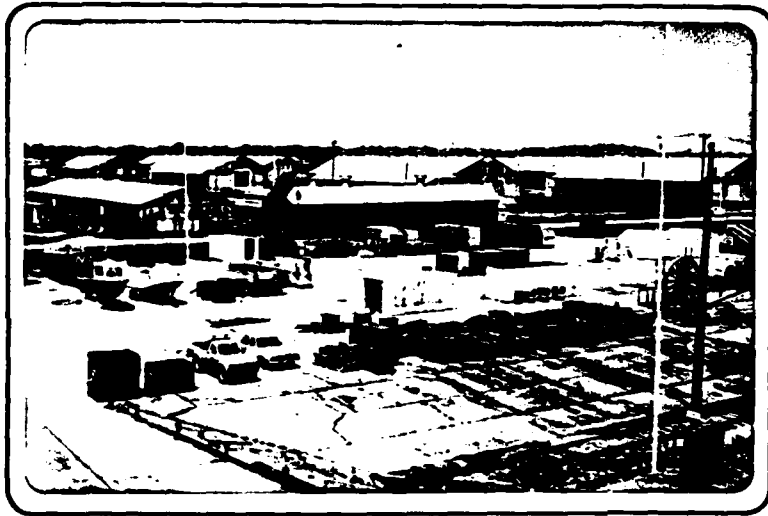
There are several changes needed to improve the Hardstand Area. The first involves the protection of the equipment and material stored there. The material and equipment stored on the Hardstand Area are arranged in no apparent order and are exposed to the deleterious effects of rain, sunlight and salt spray. Only the items that are permanently assigned to the area are being staged for a current project, or are adequately protected from the elements should be stored on the Hardstand Area. The remainder

Figure 3-21: View of Hardstand as seen from south-east corner (Spring 1983). Note Building 83-Y in the background.
