ENGINEERING INVESTIGATION REPORT
ON
LOSS OF THE SEACON'S CENTER WELL DOORS

C.E. BODEY DIRECTOR, ENGINEERING
AND DESIGN DIVISION
FPO-1

FPO-1-80(2)
DECEMBER 1979

OCEAN ENGINEERING
AND CONSTRUCTION PROJECT OFFICE
CHESAPEAKE DIVISION
NAVAL FACILITIES ENGINEERING COMMAND
WASHINGTON, D.C. 20374

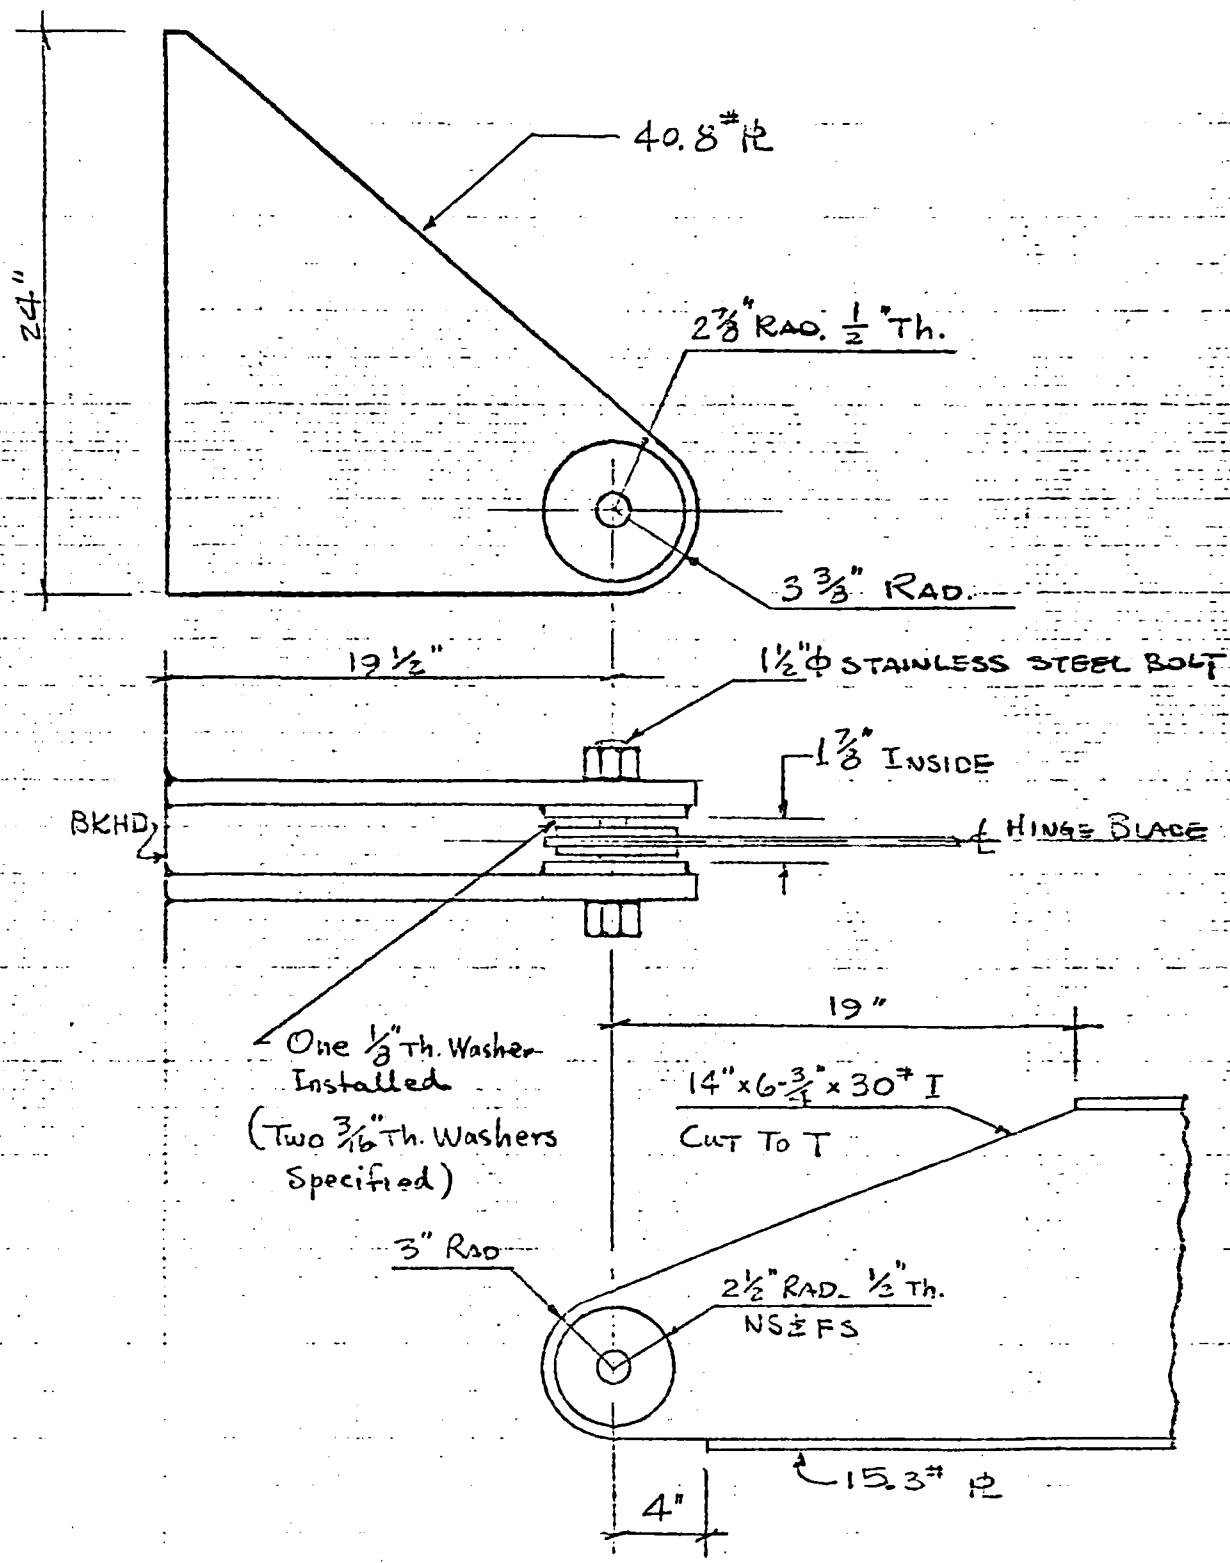
SK-01 CENTER WELL DOOR HINGES

4.1 Door Design: The door design was found to be structurally sound except for members which formed part of the door-hinges. Two 14" deep beams run longitudinally as stiffeners. These are spaced 1/3 of the door-width apart; and a portion of the web of each beam extends to form a door-hinge-blade as shown by the sketch SK-01. The beams are adequate as stiffeners; but the 1/4" web does not provide adequate material for this particular design application of a hinge.

4.2 Hinge Design: SK-01 shows some of the critical details of the hinge assembly design. The two hinge-blades welded to the bulkheads and lower sill of the well are large pieces of 1" plate which are well supported by the ship structure. On the other hand, there is only one door hinge-blade per assembly; and it is only 1/4" thick. The design provides a poor balance in both strength and stiffness between the bulkhead hinge and the door hinge blades. It provides an equal disparity between vertical load capacity of the hinge assembly and the side-load capacity of the door hinge-blade. This latter deficiency fails to accommodate side-loads on the door caused by ship roll, yaw and sway; yet no other provision was made for taking such loads at the hinge-ends of the two doors. The inability of the hold down mechanisms, at the opposite end of the doors, to help alleviate this is discussed below. These hinge elements accumulated several million cycles of side load in the period between 1976 and the present. The condition exists whether the doors are in the up position, or in the down position. Even though this did not result in any noticeable permanent-set bending of the blades, they were certainly exposed to cyclic loads that under a combination of conditions could (and did) cause the failure of the door hinges. This design deficiency could only be aggravated by the omission of the spacer washers by the shipyard. Thus an increment of cyclic shock loading was added to the cyclic flexural loading on the hinge assembly (and the door hinge-blade in particular). The designer either overlooked this side loading condition, or he assumed that the hold down mechanisms at the opposite end of the doors would prevent side motion of the doors and side-loading of the hinge blades. In any case, the brilliance of hindsight shows that he was wrong in selecting this hinge configuration.

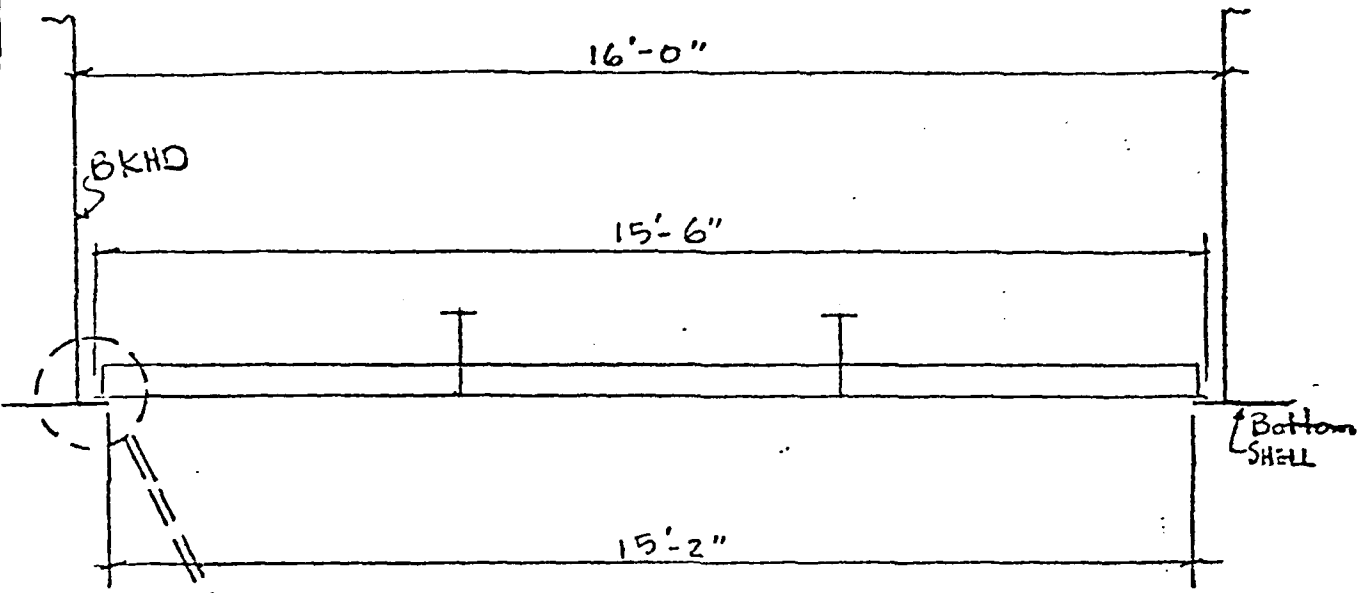
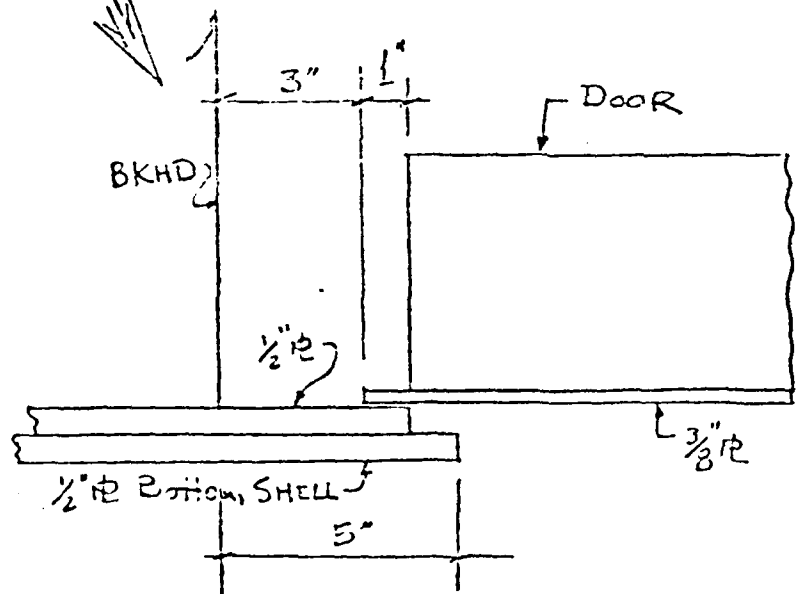
SK-02 DOOR SILL INTERFACE

4.3 Door Sill Design: SK-02 shows the interface of the doors and the door side-sills based on nominal dimensions. It can be seen that if the side motion of the doors is not restrained by the hinges at one end, and the hold down mechanisms at the other, the door can escape the door sill and fall out. Note: there is no overlap between the doors and the fore and aft "sills". Thus the failure of the door hinges at one end, and

inability of the hold downs to prevent side motion at the other end, can permit a door to drop out of the well (and it did). It should also be noticed that the bearing between the door and the sill is greatly weakened by the 1" setback between the doublers and the shell plating on the two parts. Also note that this discussion is without any consideration as to the unknown tolerances and fit-up of the ship and the doors.

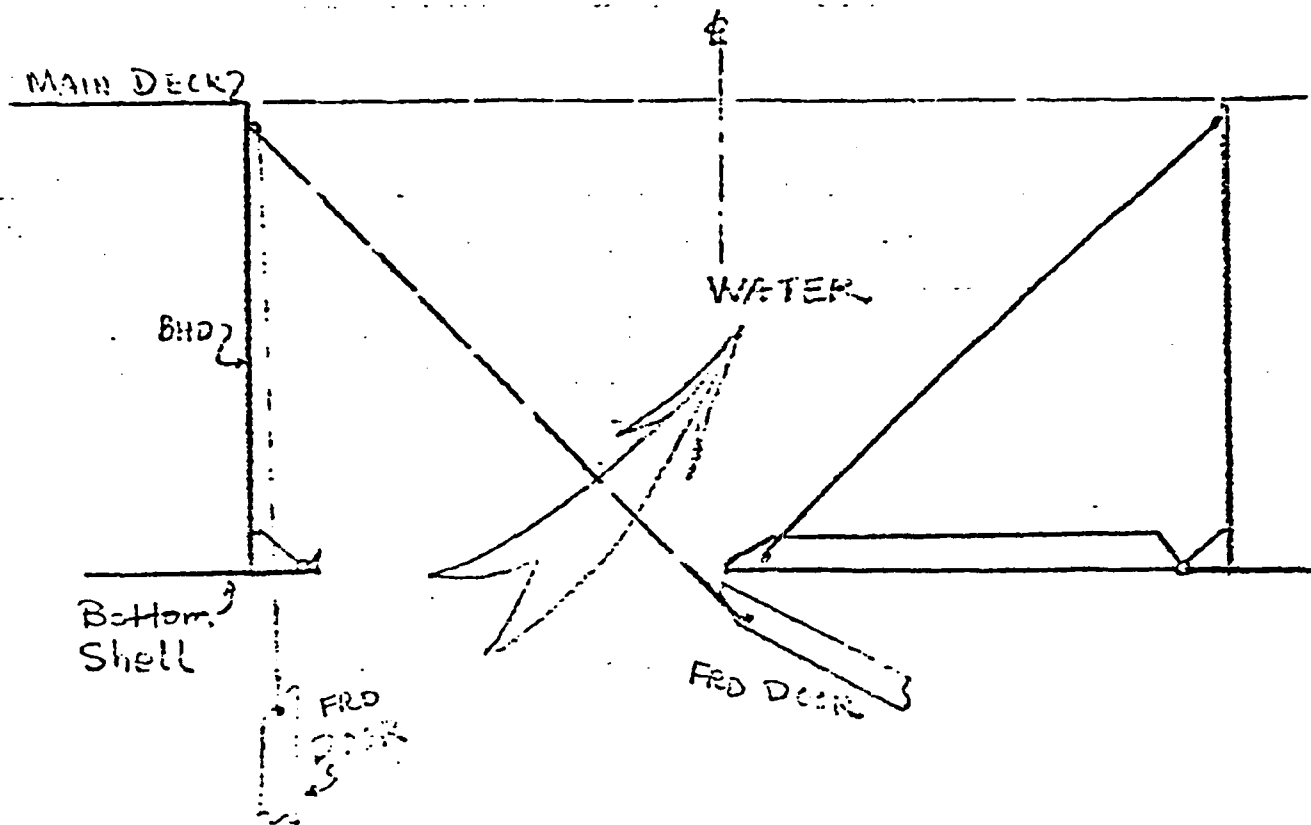
SK-03 FORWARD DOOR FALL-OUT

5.1 Loss of Forward Door: The door hinge-blades of both doors had suffered progressive deterioration due to cyclic side loads during past operations; so that while under tow in fairly high following seas the forward door hinge blades broke off. The hold downs did not have sufficient clamping power to restrain the side loads on the hinges; and when the hinges broke, the clamping action was not sufficient to restrain the door from sliding sidewise, escaping the sills and falling out of the well. The falling door was restrained by its' two lift cables and brought up against the leading edge of the aft door as shown in SK-03. Here the two lift cables were abraded and broken away and the door was released and lost.
